COCHISE CONSERVATION AND RECHARGE NETWORK (CCRN)

Ephemeral Streamflow, Groundwater, and Palominas Facility Monitoring

Presentation to Upper San Pedro Partnership (USPP)

June 19, 2019

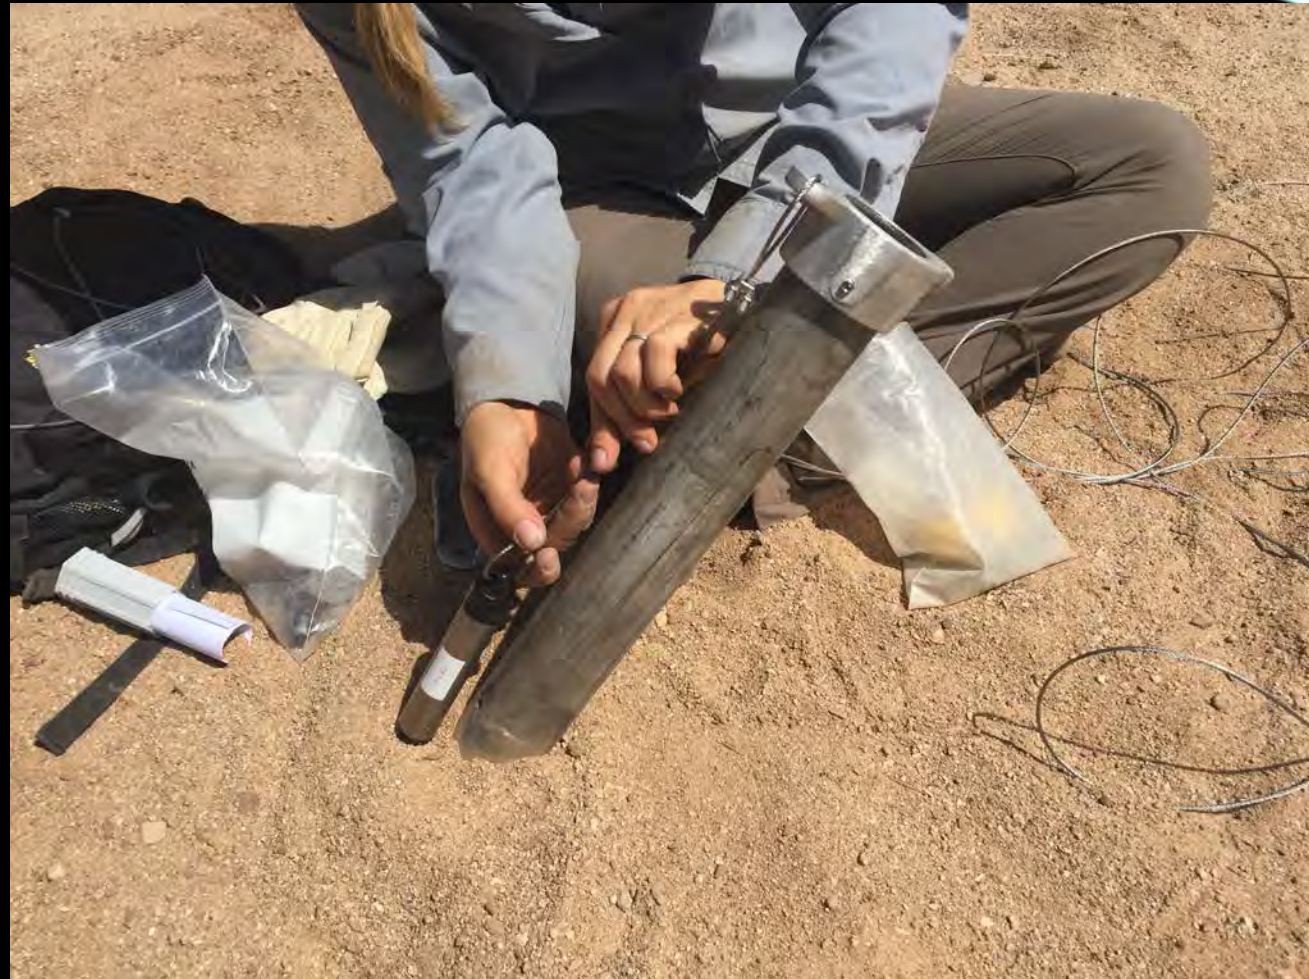
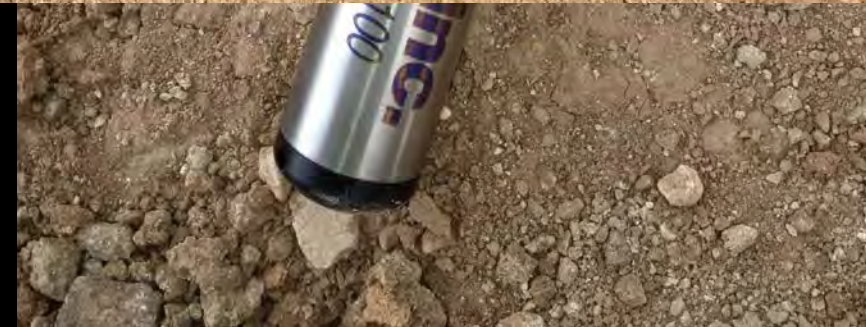
PRESSURE TRANSDUCERS

- Installed in vented steel pipe housing
- Measure weight of water above sensor, derive depth
- Deployed at various locations throughout monitored watersheds
- Co-located (generally) with barometric pressure PT to compensate for atmospheric pressure

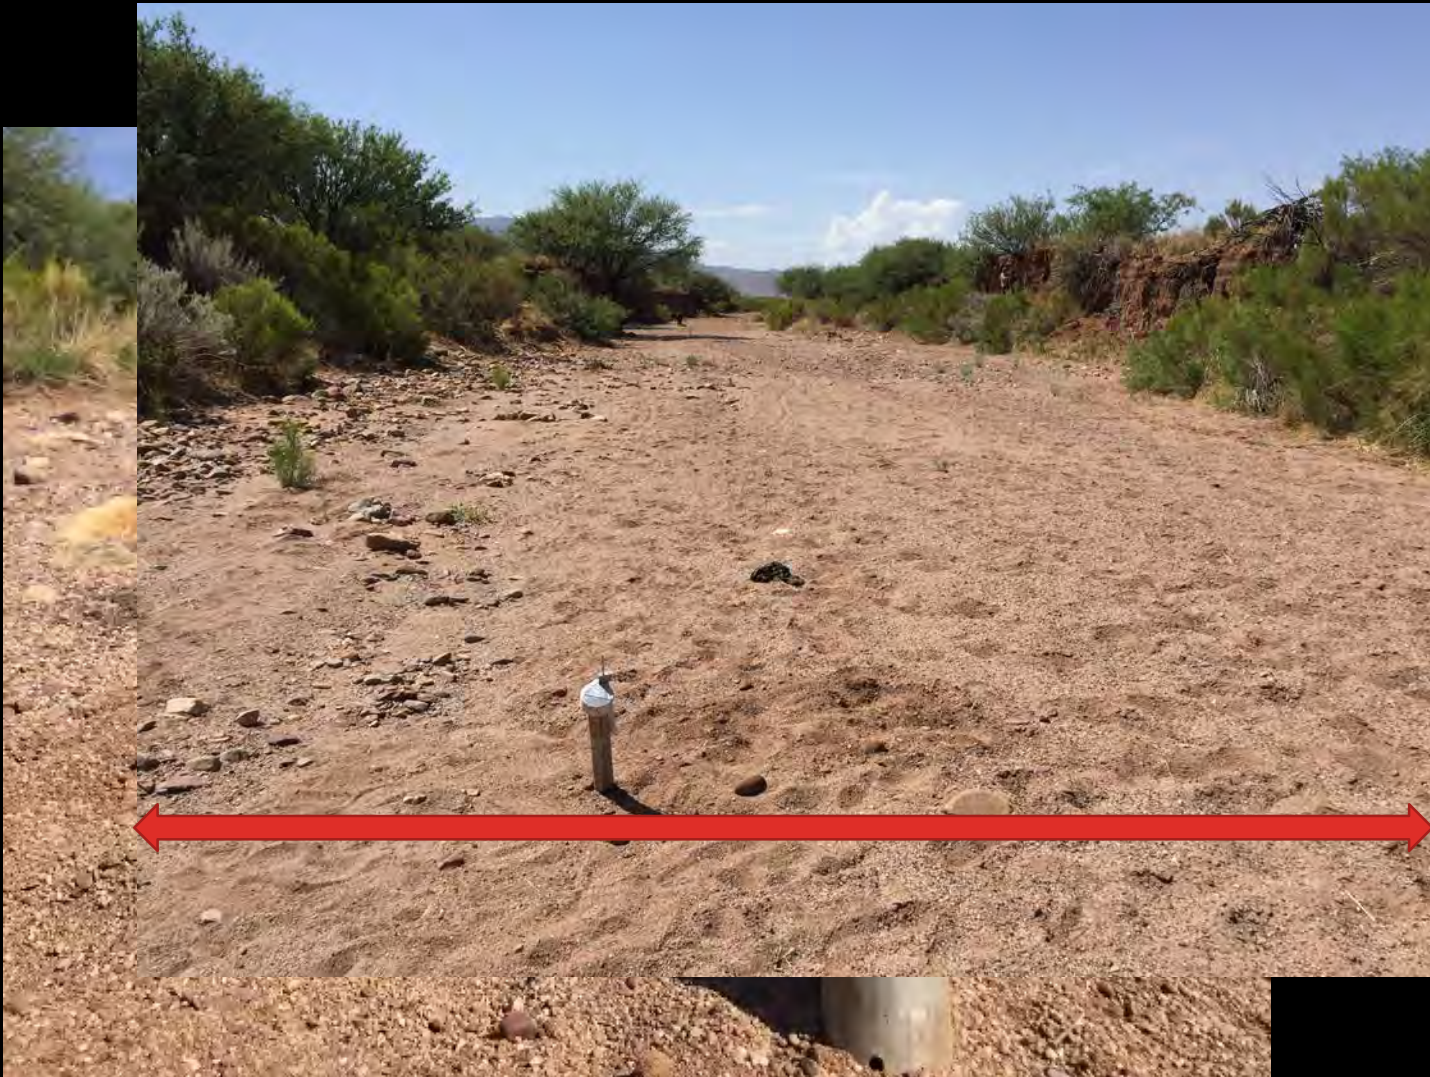
CONTINUOUS SLOPE-AREA METHOD

- Pressure Transducers (4 min.) on channel cross sections

PT data are analyzed using program called Slope-Area Method Discharge Calculator (SAMDC)

Output from program provides complete-event hydrograph, including runoff volumes, peak Q , duration

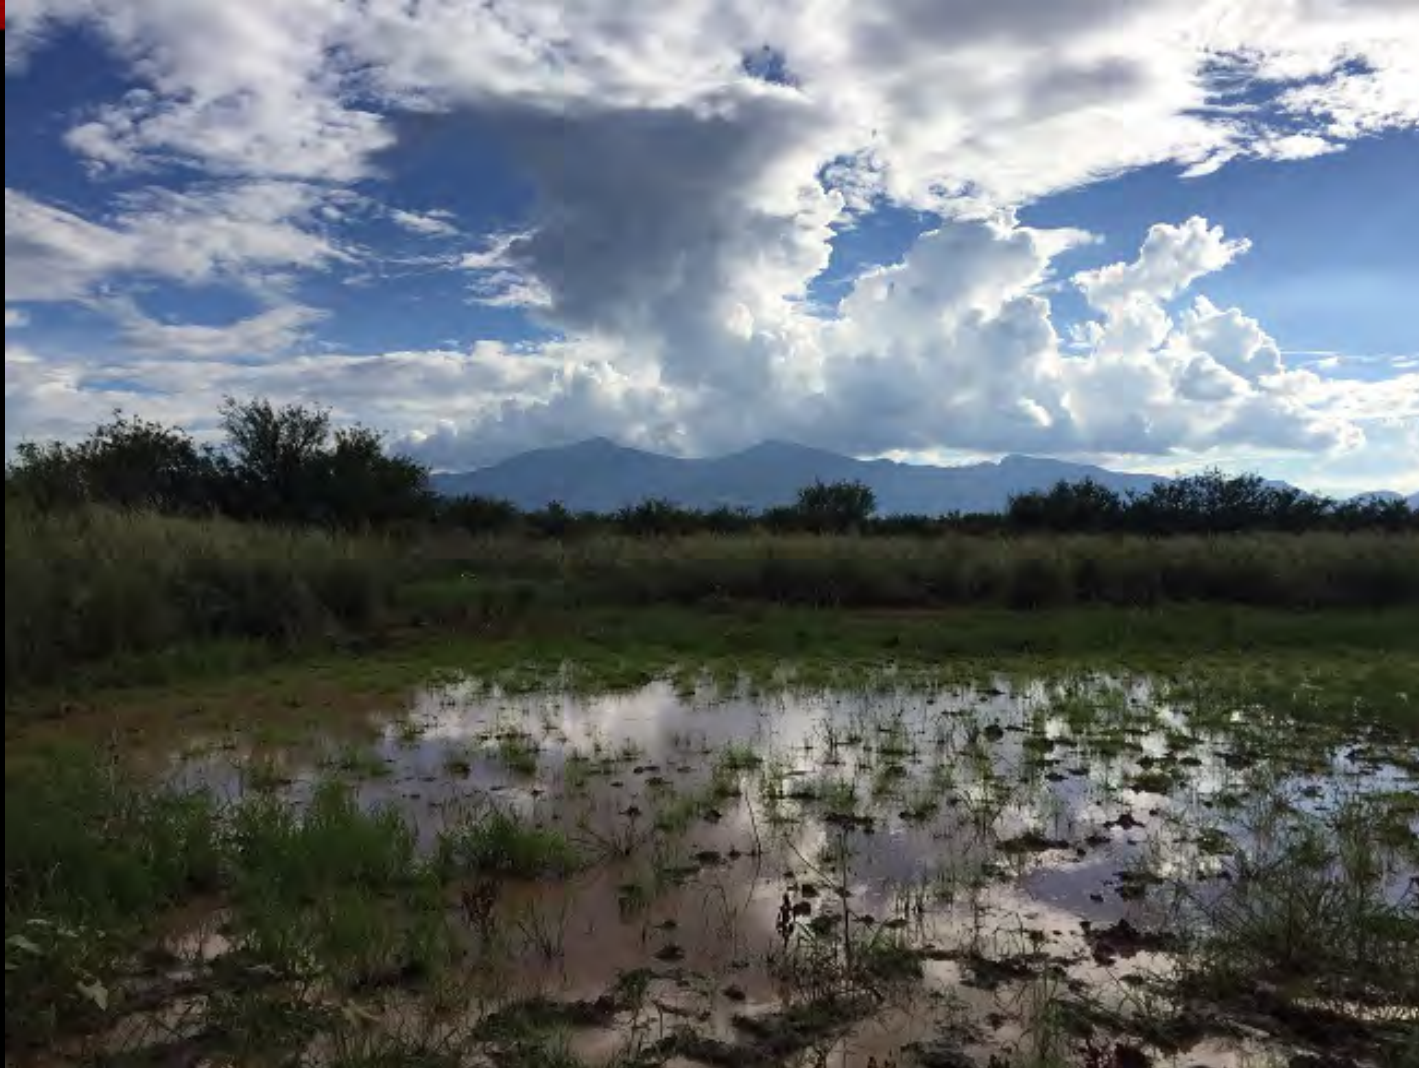
UPLAND BASIN

- 1 Pressure Transducer in Stock Ponds

Using topography data provided by the County, a regression equation relating Area (A) and Depth (d) was developed

PT data is analyzed by integrating areas from depth data up to end of rising limb, to estimate and sum incremental volumes

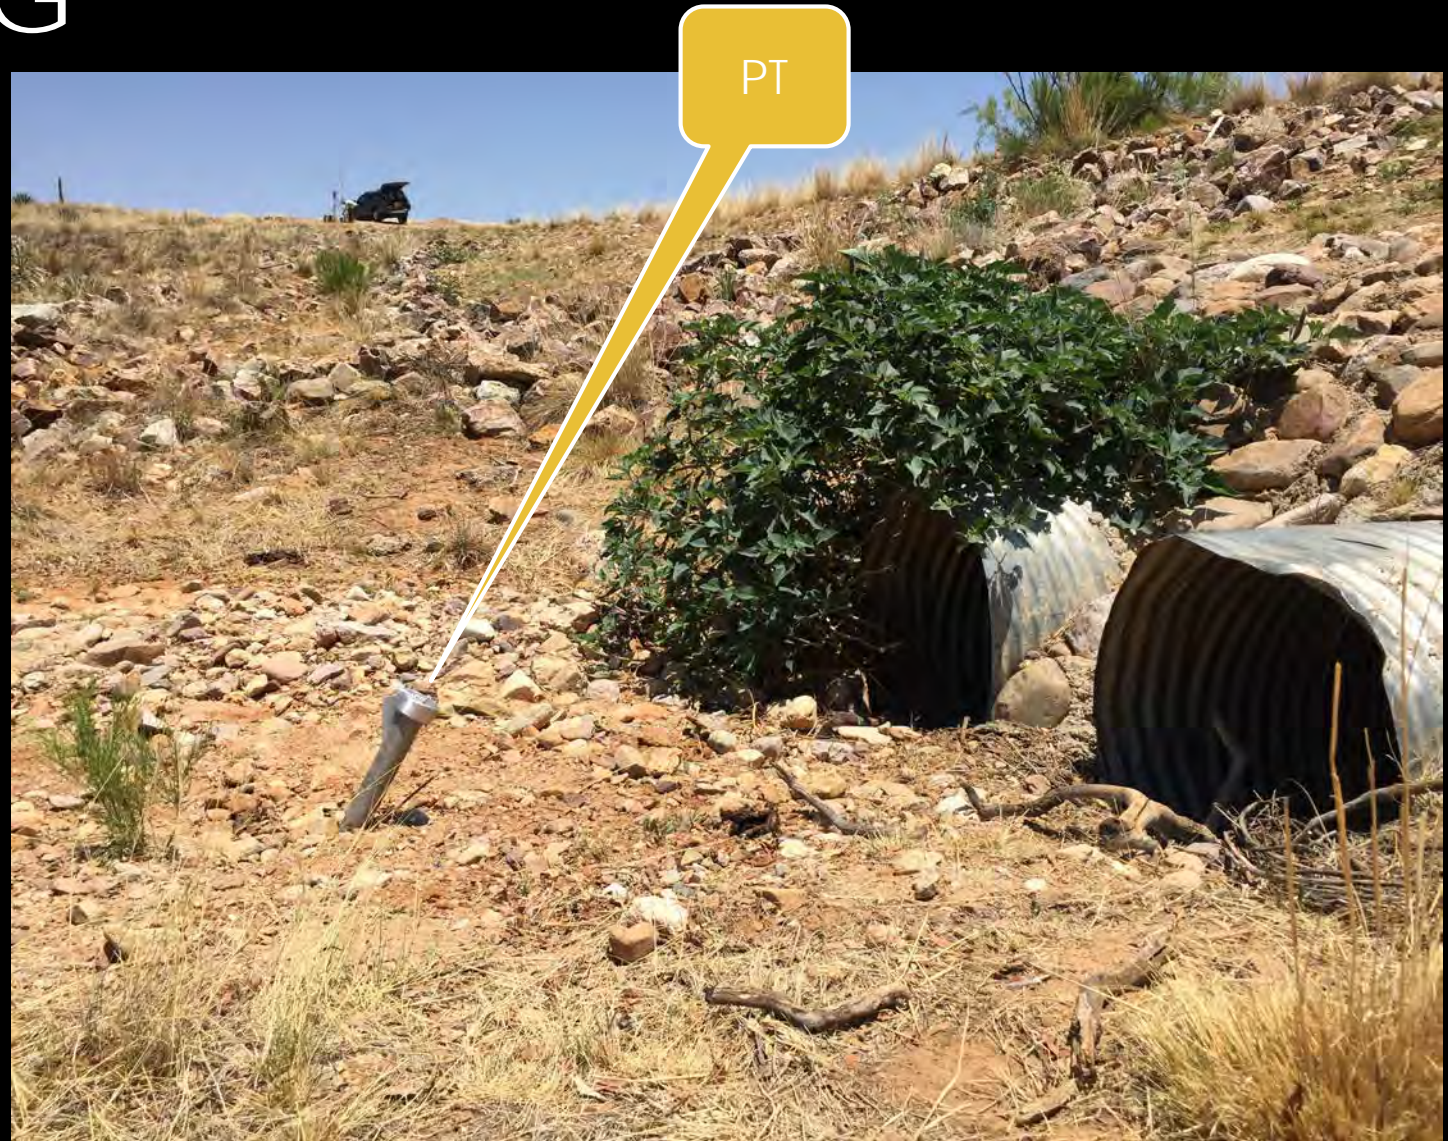
CULVERT CROSSING

- 1 Pressure Transducer at Culvert Inlet

HY-8 rating of culvert to develop regression equation of discharge given flow depth

Volumes estimated by integrating hydrograph

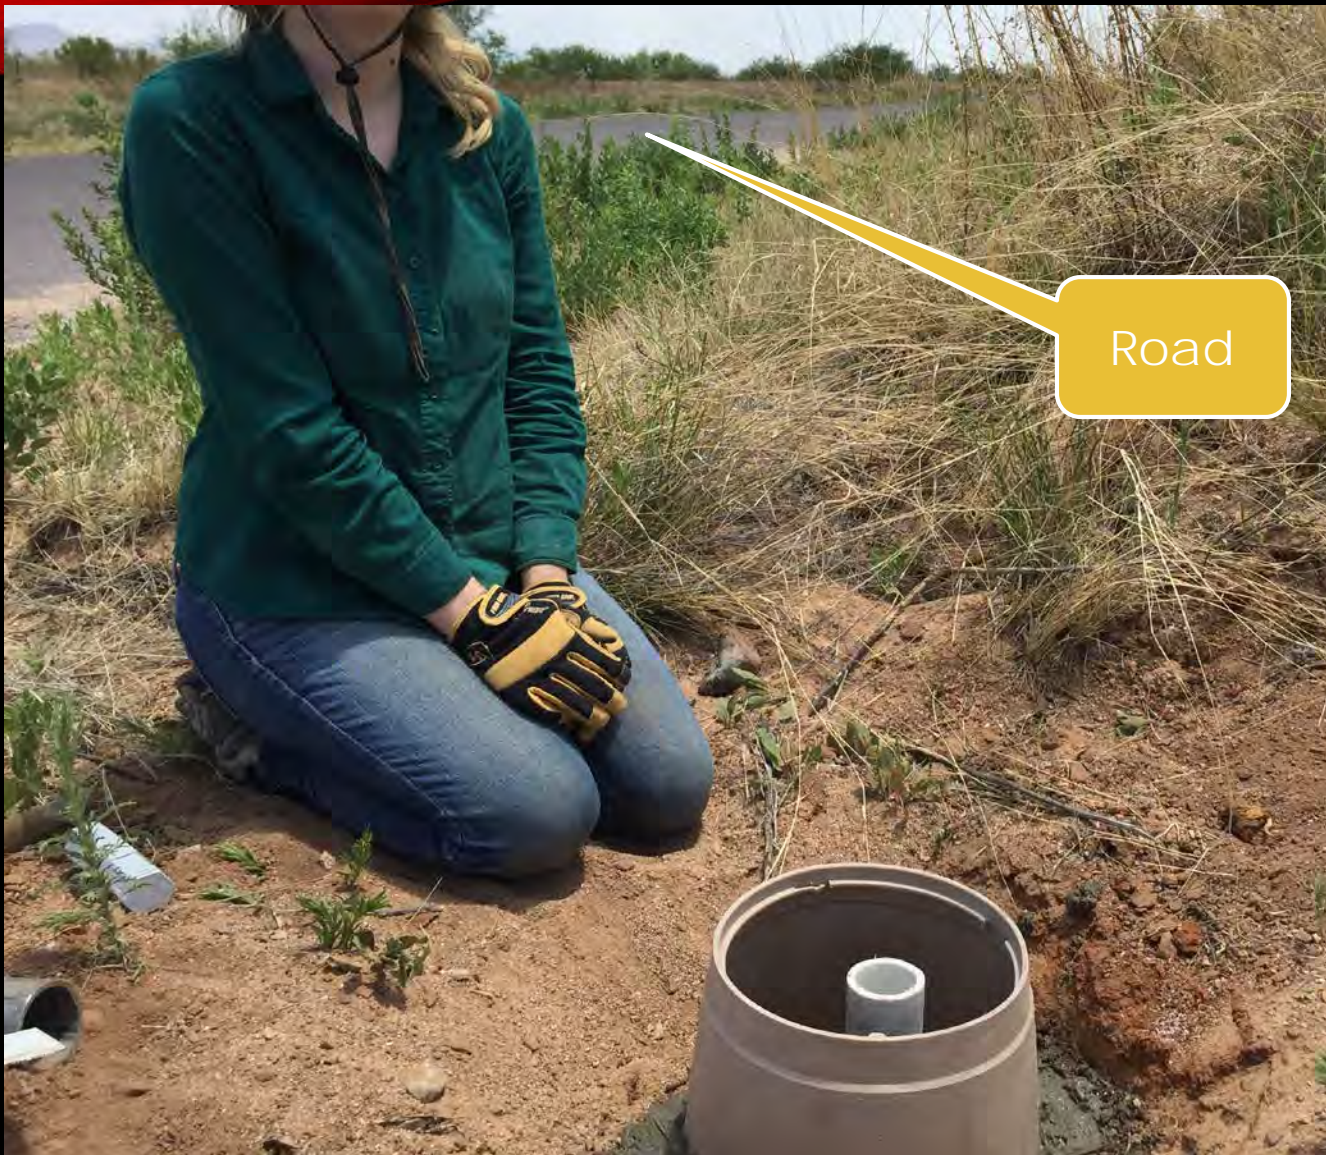
ROAD CROSSING

- 1 Pressure Transducers at a dip section (at-grade crossing)

Weir rating of dip geometry to develop regression equation of discharge given flow depth

Volumes estimated by integrating hydrograph

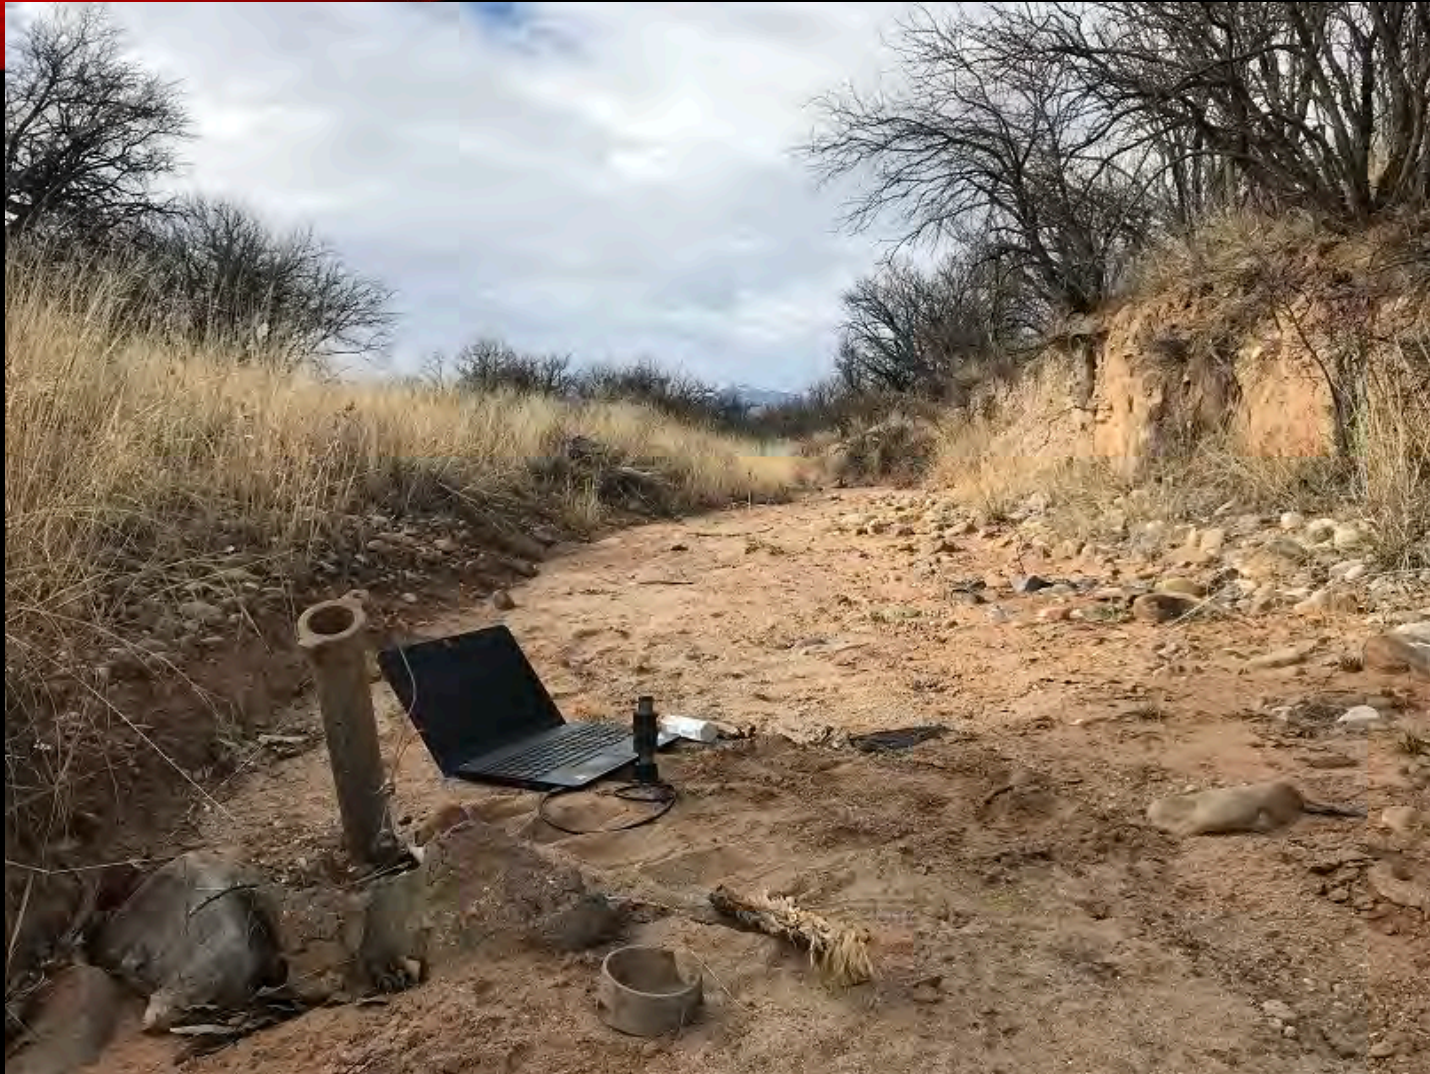
HEC-RAS STATION

- 2 Pressure Transducers on 3 channel cross sections (downstream used for setting boundary condition)

HEC-RAS rating of cross sections to develop regression equation of discharge given flow depth

Volumes estimated by integrating hydrographs at each sensor

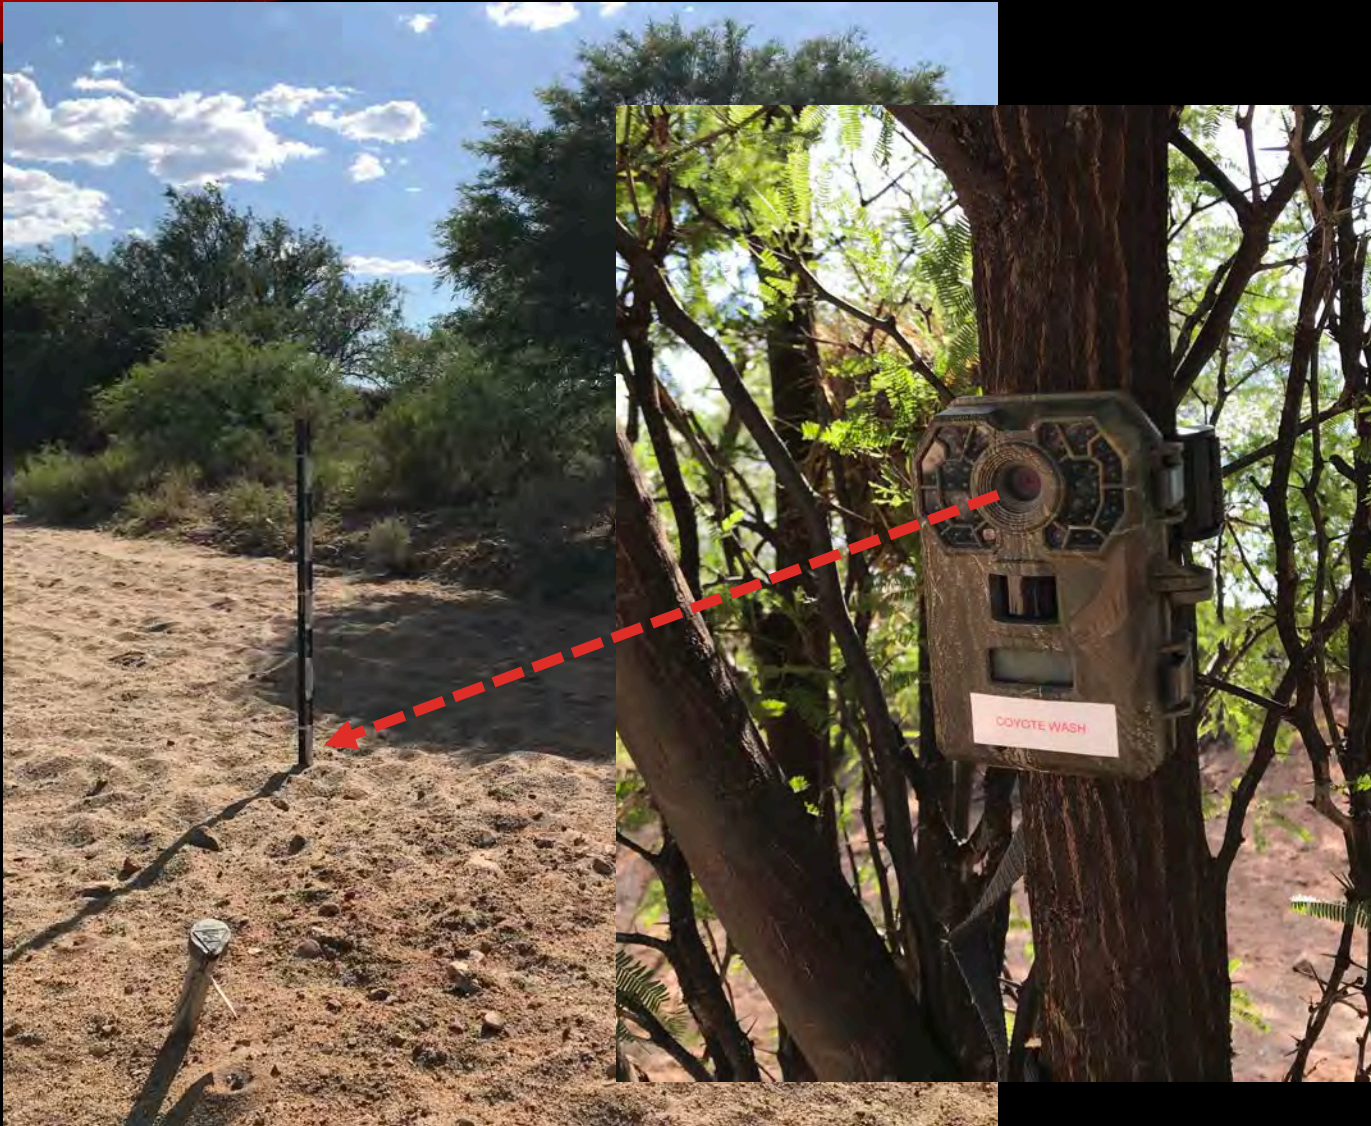
SURFACE WATER IMAGERY

- Staff Gauge
- Remote Camera, Internal Image Storage

Images are collected every 15 minutes and reviewed to estimate maximum depths, durations of flows.

Beneficial for verifying PT data, and for observing flow characteristics.

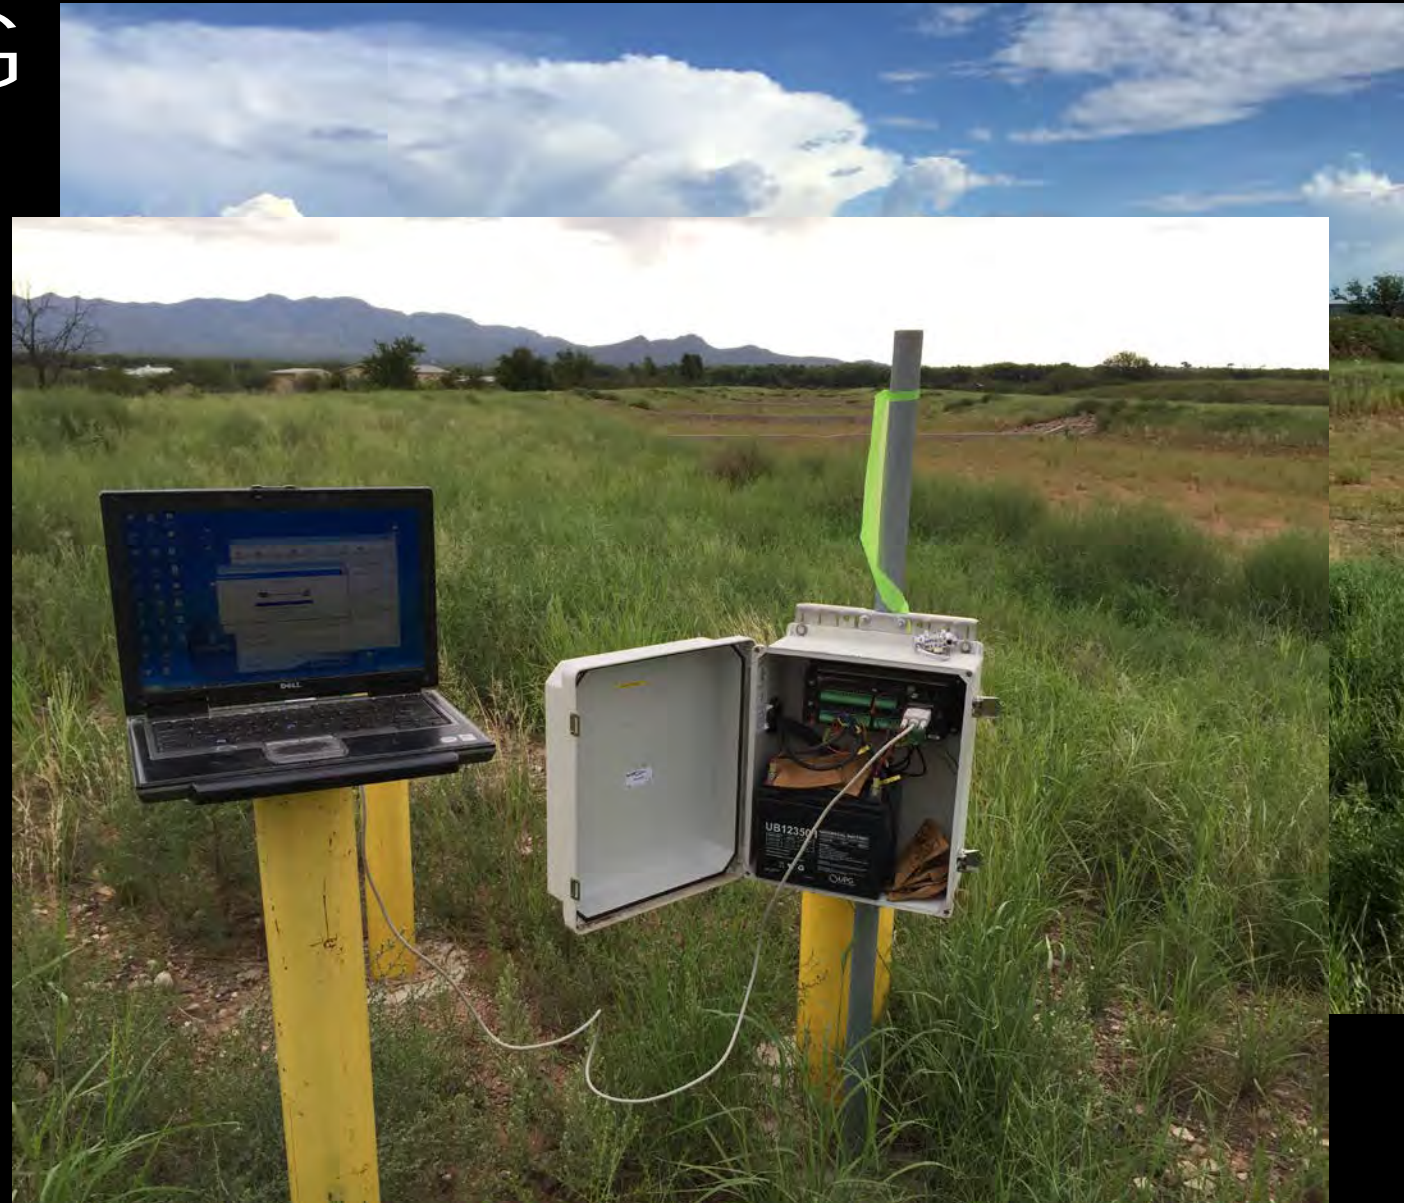
INSTRUMENTED BOREHOLES

- Level 1: Soil Moisture Sensors and Datalogger
- Level 2: Soil Moisture Sensor, Advanced Tensiometer and Datalogger

Level 1 Measure and record soil volumetric water content and temperature

Level 2 also measure soil moisture soil water potential

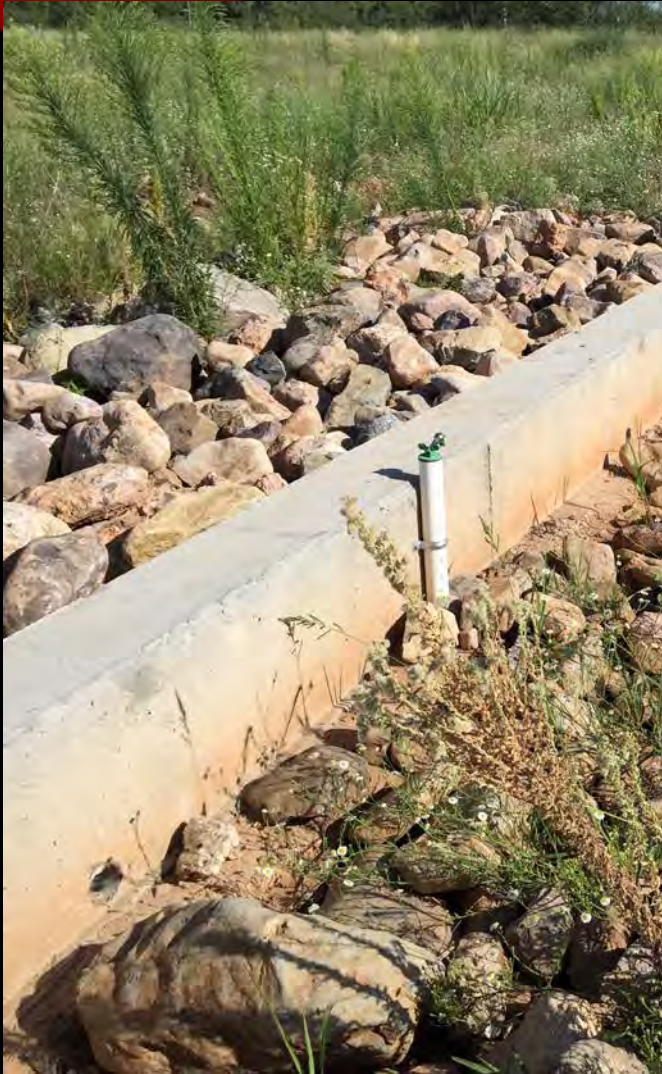
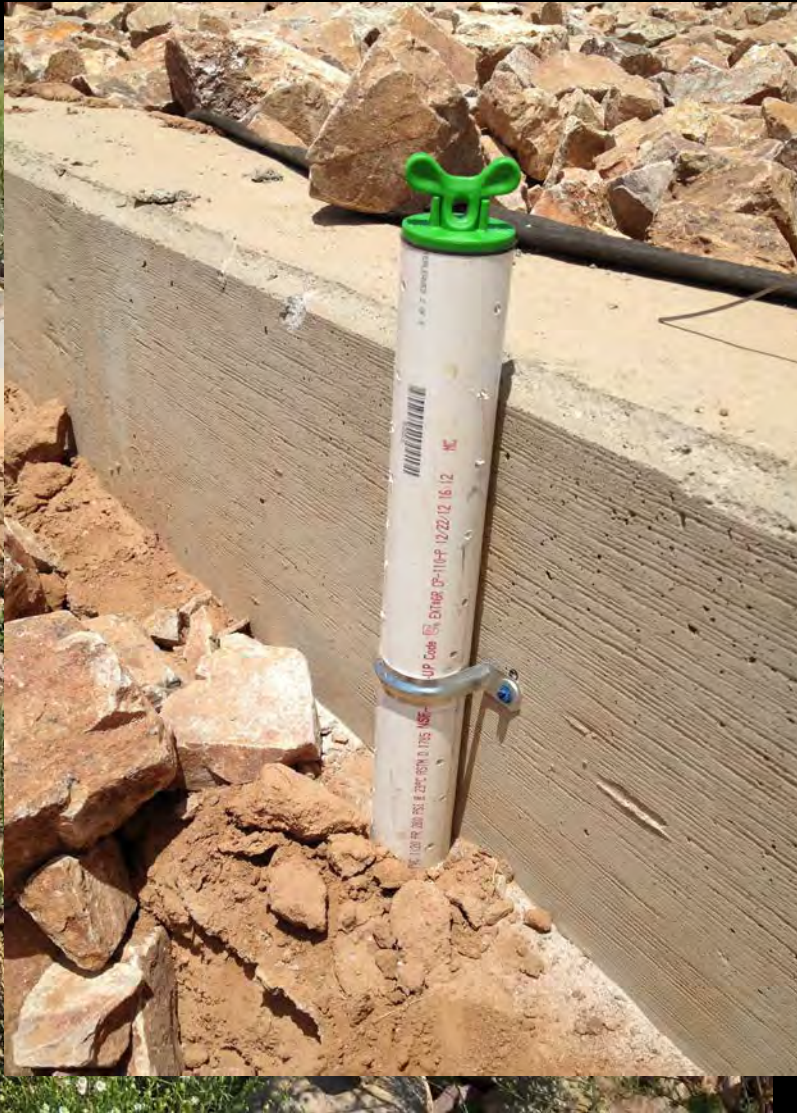
STILLING WELLS

- 1 Pressure Transducer in PVC housing

Deployed on Palominas facility at locations to measure depth of flow or ponding

Analysis methods vary depending on the installation

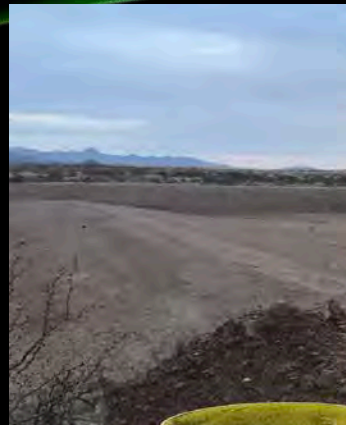
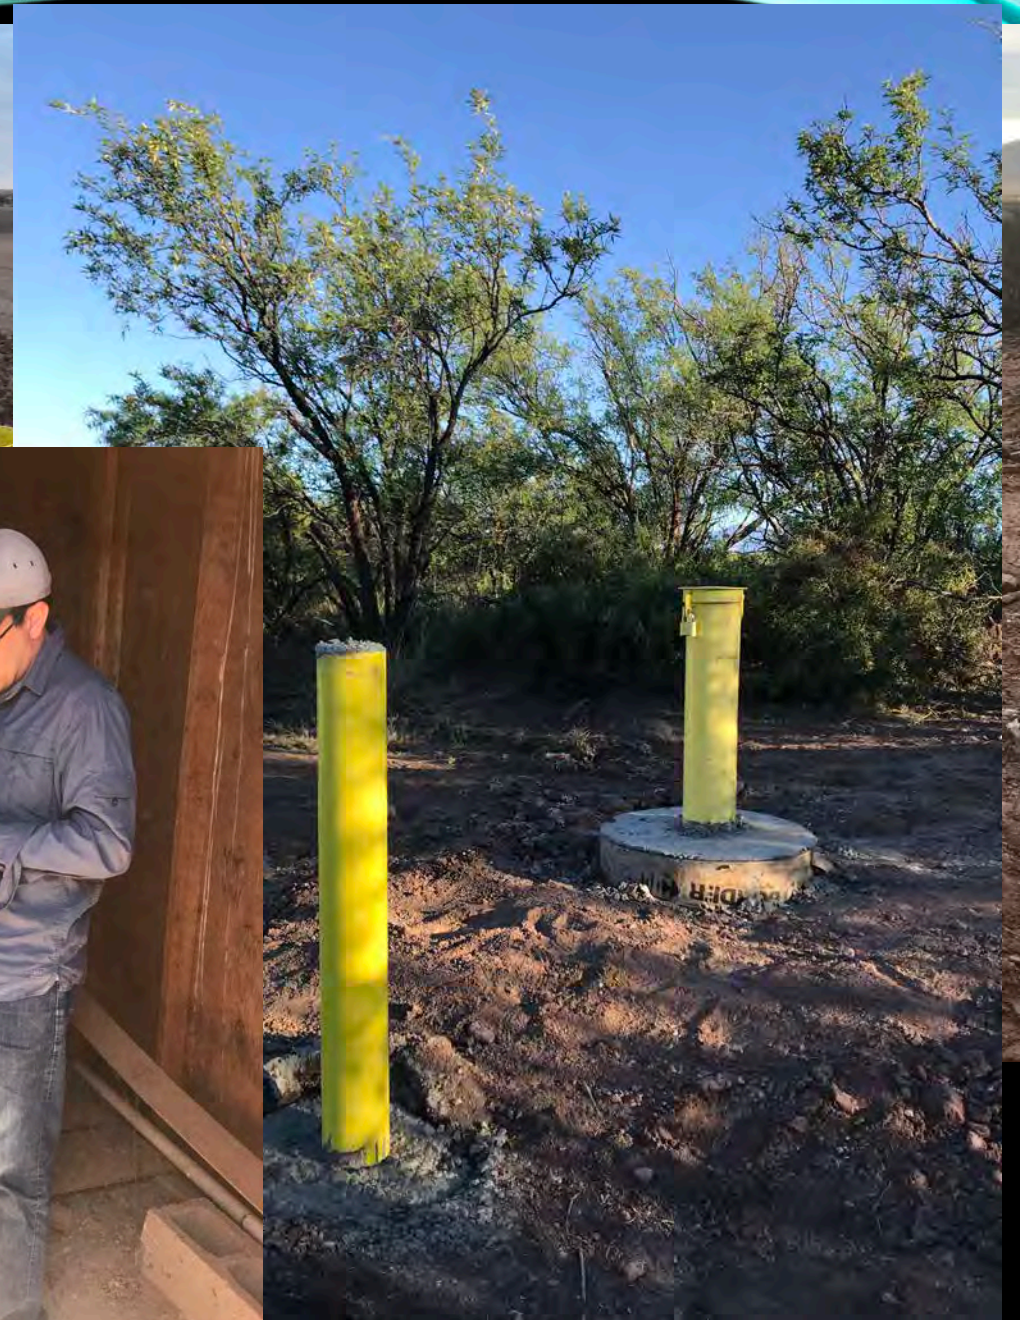
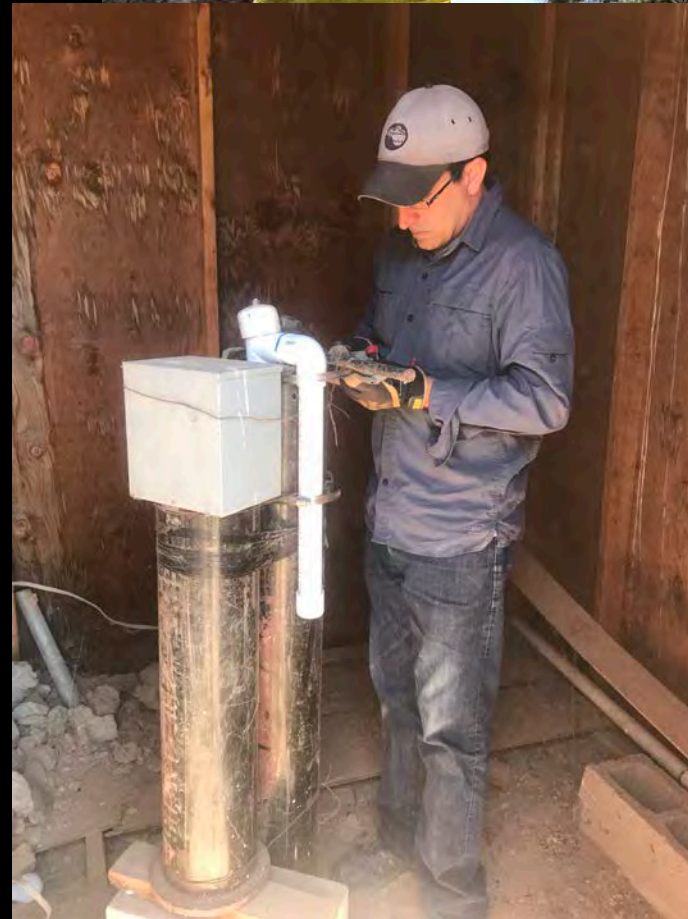
GROUNDWATER MONITORING WELL

- 1 PT lowered into well casing tethered to a cable
- (Optional) measured manually

Measure depth of groundwater above PT, over time

Based on ground elevation measurements or estimates, groundwater elevations are determined

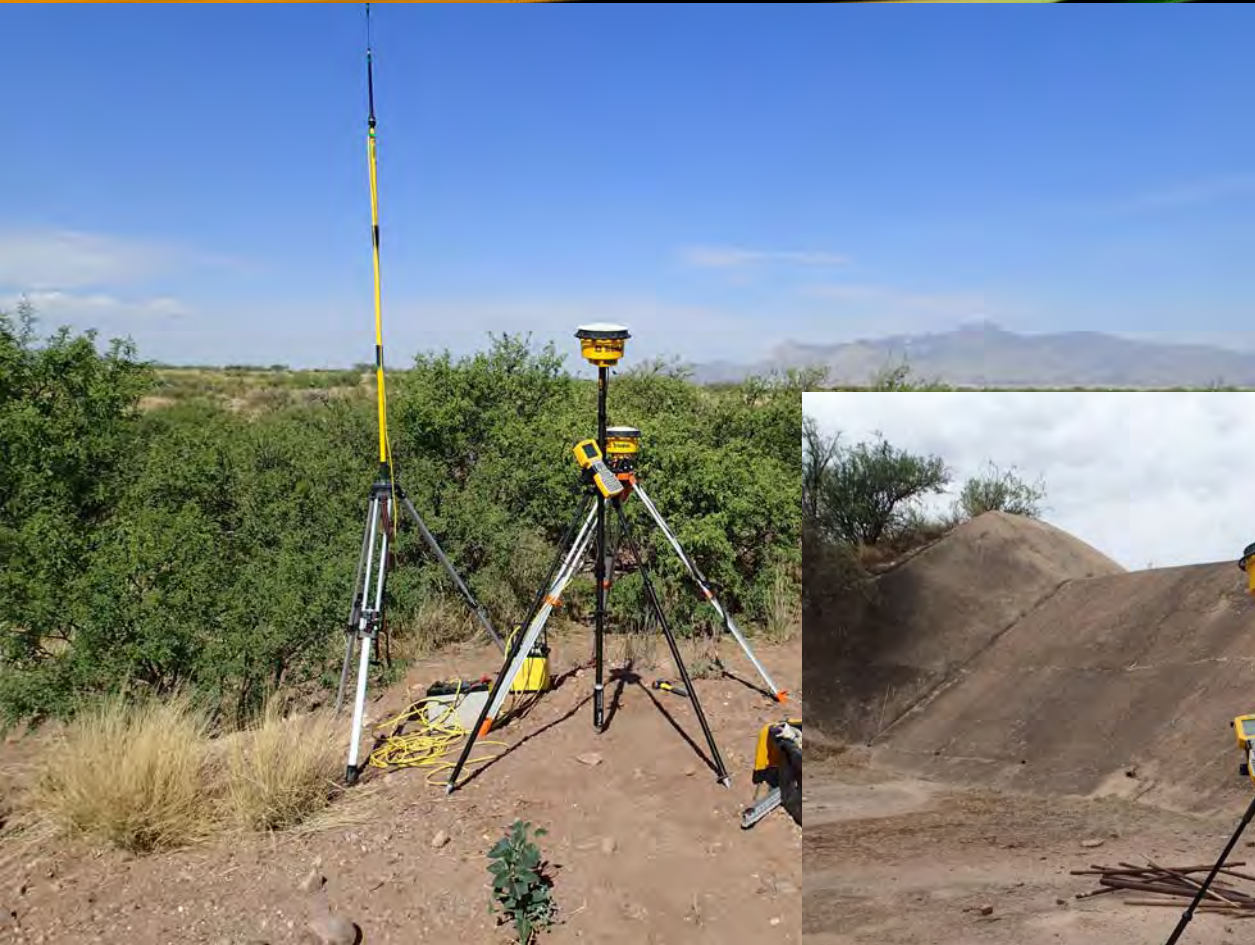
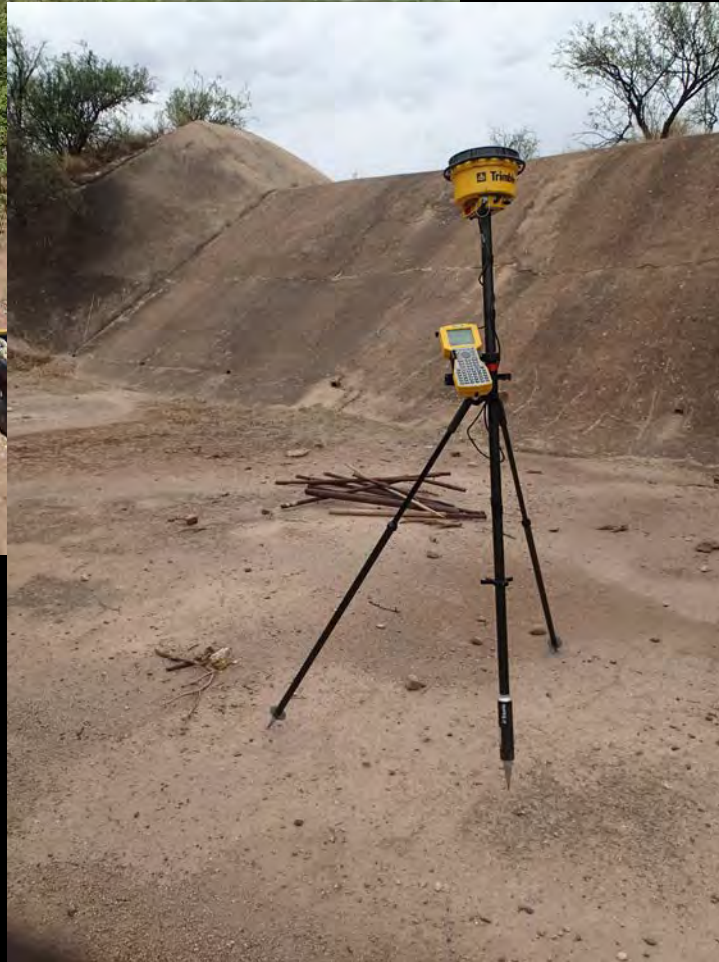
CROSS SECTION SURVEYS

- Real Time Kinetic (RTK) satellite positioning survey of channel cross sections
- Based on local benchmarks (relative)
- Repeat annual surveys to monitor channel change

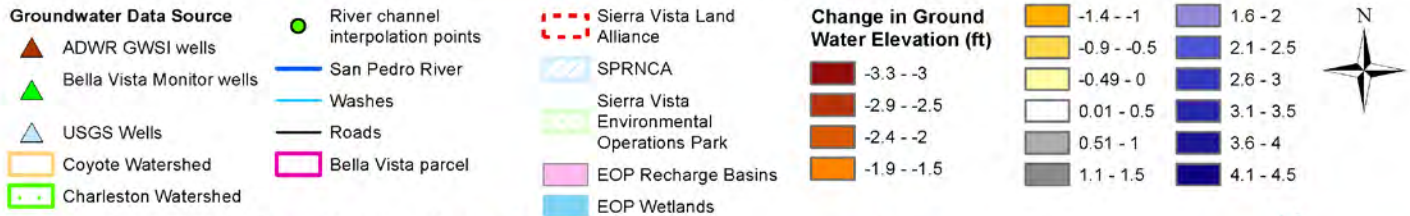
Figure 12. Estimated change in groundwater elevation at Bella Vista from November 2016 to November 2018.
