Subject: Proper Functioning Condition (PFC) Riparian Assessment Report, San Pedro River, San Pedro Riparian National Conservation Area, AZ

**RIPARIAN CONDITIONS ALONG THE SAN PEDRO RIVER
PROPER FUNCTIONING CONDITION
RIPARIAN ASSESSMENT REPORT**

**THE NATIONAL RIPARIAN SERVICE TEAM
NOVEMBER 2012**

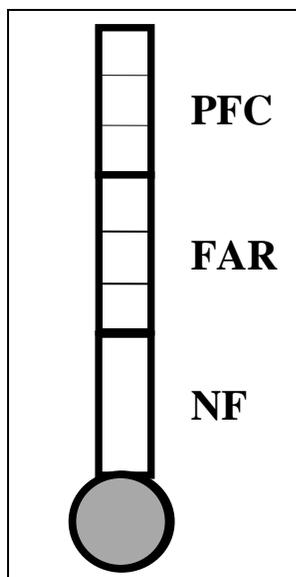
Figure 1. Stylized “thermometer” for recording where within the functional ratings a reach is considered to be.

Each rating occurs over a range; for example a reach rated PFC may be “just barely” PFC or near potential or somewhere in between. For the SPRNCA assessment, a thermometer schematic (Figure 1) was included on the PFC assessment form that enabled the interdisciplinary team to illustrate where they decided a reach was, within the range of the rating categories, based on their knowledge and experience. This is also an indication of the evolutionary stage (i.e., upper, middle or lower part of the PFC or FAR rating) of each reach. Reaches rated very high within the PFC range are approaching potential vegetation and channel characteristics, while those rated low within the PFC range are functionally capable of handling moderately high floods but need more time to reach potential.

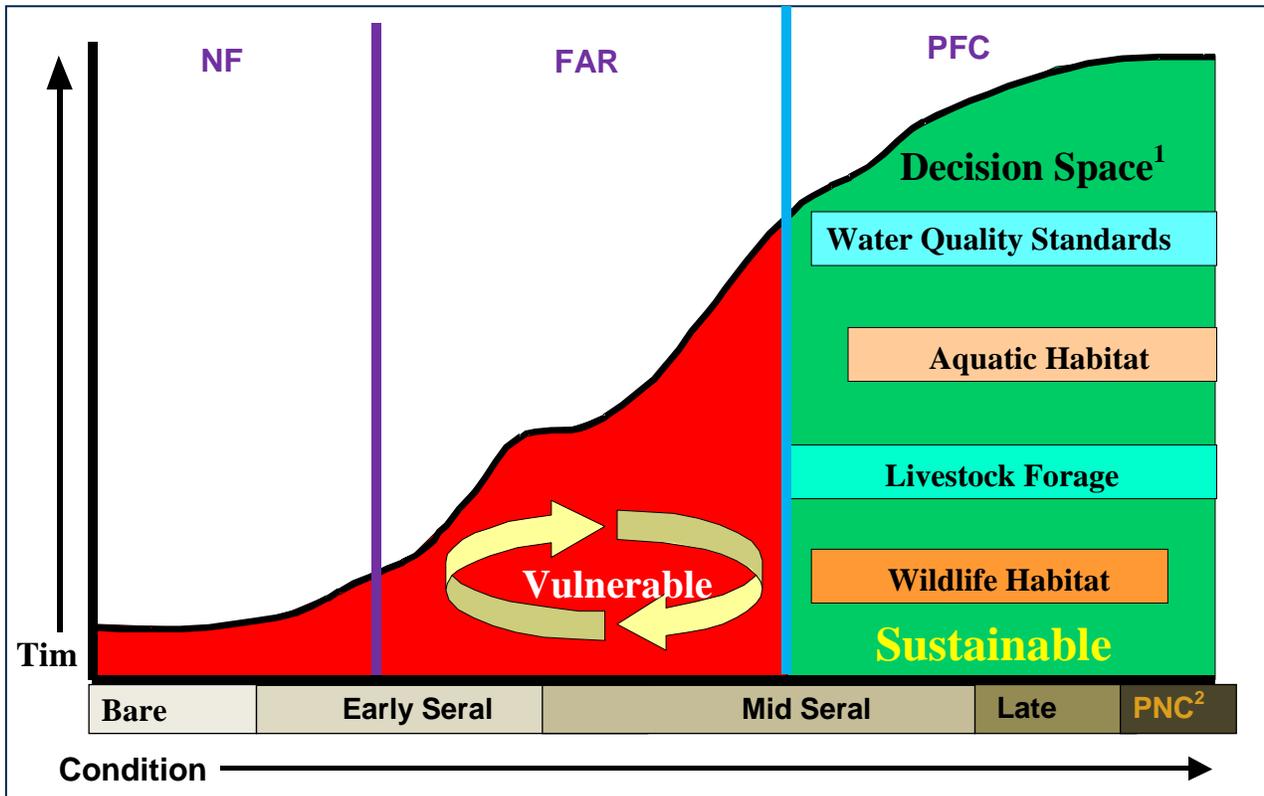
Figure 2. Example of succession as it relates to stream recovery and function.

Figure 2 shows the seral stages¹¹ associated with NF, FAR, and PFC. NF reaches have few or none of the attributes and processes necessary to dissipate stream energy or perform other needed functions. Streams that are FAR but just below PFC may rapidly progress to PFC with the right combination of management and flow events. However, FAR streams that are just above NF may take decades to develop the attributes and processes necessary to move to PFC. The values on which management should be focused occur largely at PFC because below that condition, they are not considered sustainable in moderately high floods (e.g. 5-, 10-, and 20- year events). Stream improvement is seldom a linear process and the trajectory of progress typically exhibits

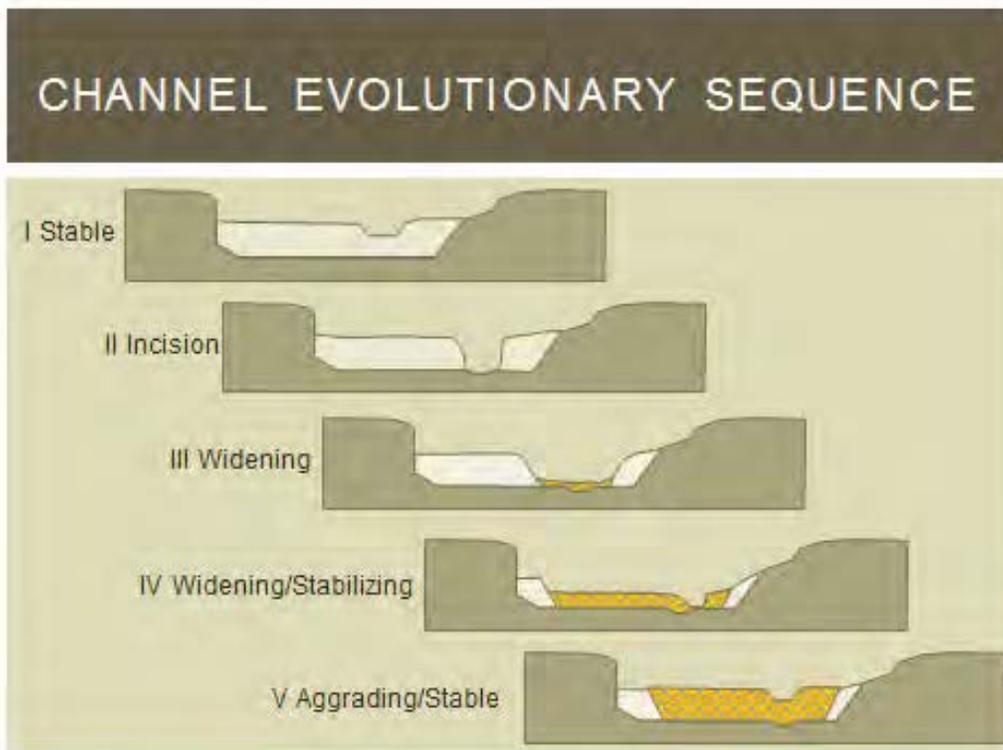
Figure 3. Simplified schematic illustrations of the channel evolutionary process that stream systems experience during an episode of channel incision and recovery to another stable form. The process of channel incision (stage I to II) can occur quickly, over a few years to a couple decades; whereas the recovery period (stage II to V) commonly occurs over a few decades to a couple centuries.

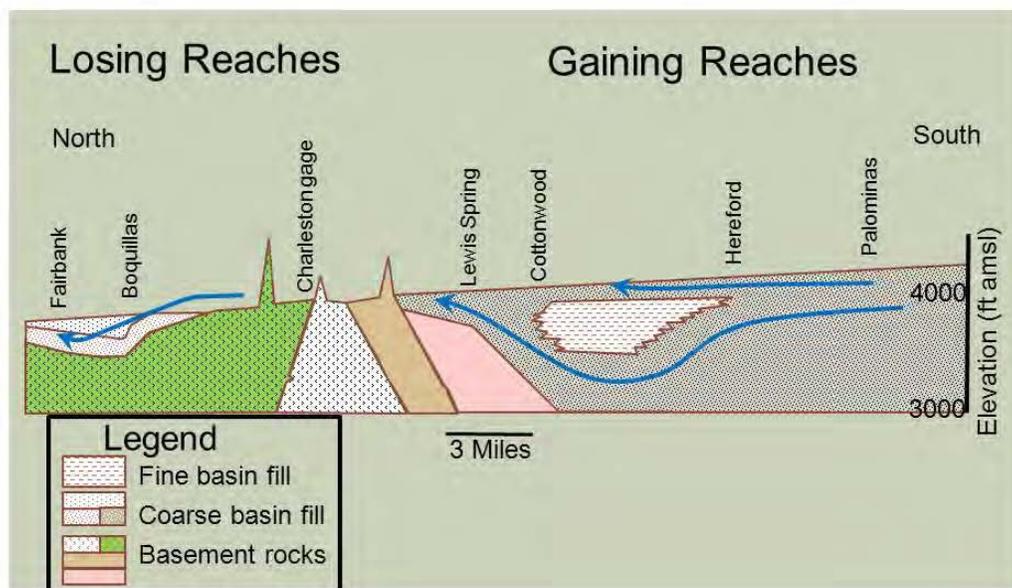
Figure 4. Simplified geologic cross-section of part of the Upper San Pedro Basin from the international border to Fairbank. Blue lines illustrate generalized water-flow patterns. Groundwater is maintained at or near the surface when it passes over restrictive units, such as fine-textured basin fill. Also, groundwater is forced upward by shallow basement rocks at the Charleston Hills. Surface water infiltrates into coarse basin fill and coarse alluvium north of the Charleston Hills.

Fogg et al. (2012) used several lines of evidence to determine potential, including the hydrogeology of regional aquifers in the upper San Pedro watershed (Figure 4), and the distribution and effect of a fine-textured (silt and clay) restrictive unit in the upper basin fill (Figures 5 and 6). Reaches A through D are gaining reaches, meaning they receive groundwater from the regional basin aquifer in the Upper San Pedro Basin. The bedrock constriction at the north end of the Charleston Hills also forces regional groundwater toward the surface and into the San Pedro River (Figure 4). In addition, the location of a fine-textured restrictive unit underlying much of the San Pedro River in these reaches affects transmission losses from the channel to the regional aquifer and the groundwater flow rate from the regional aquifer to the San Pedro River (Figures 4, 5, and 6). And in some cases when the restrictive unit is west of the San Pedro channel, it can produce artesian conditions that force groundwater to well upward into the channel (Pool and Coes 1999).¹³

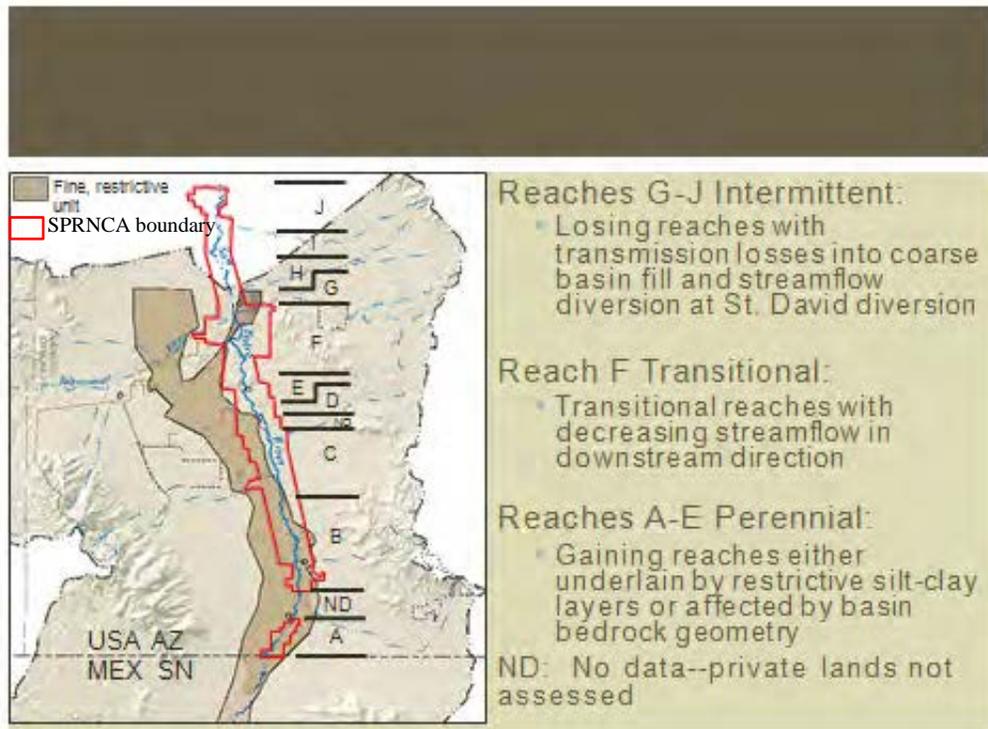
Figure 5. Map illustrates the approximate location of fine-textured (silt-clay) layer in the Upper San Pedro Basin (adapted from Leake et al. 2008).

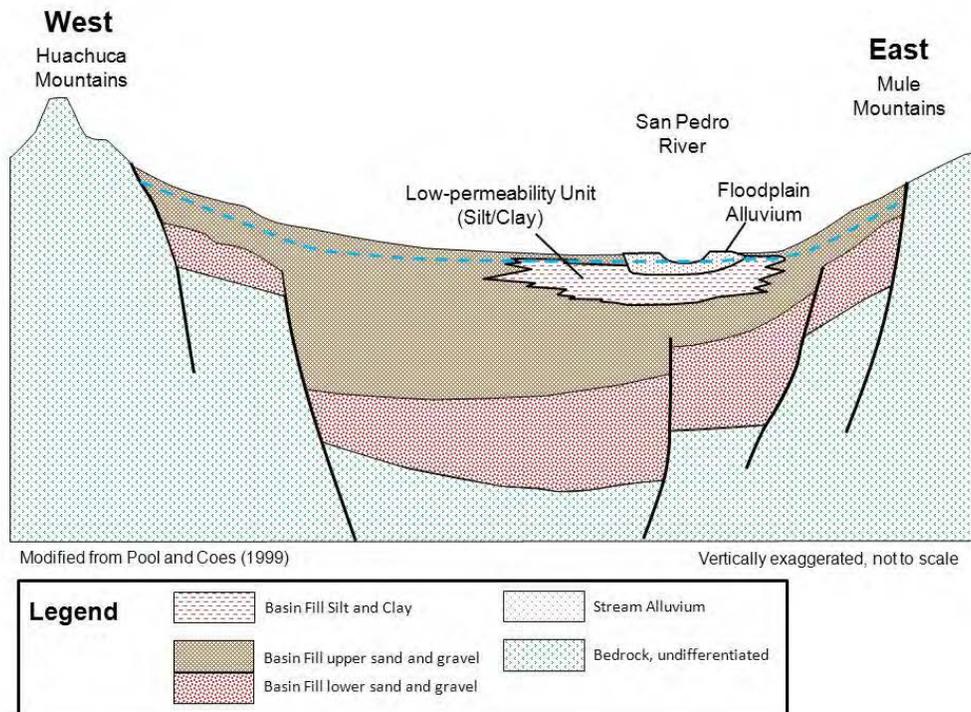
Figure 6. Simplified geologic cross-section of the Upper San Pedro Basin illustrating the role a fine-textured (silt/clay), low permeability unit can have on either isolating the San Pedro River from the regional aquifer, or reducing transmission losses from the channel to regional aquifers.

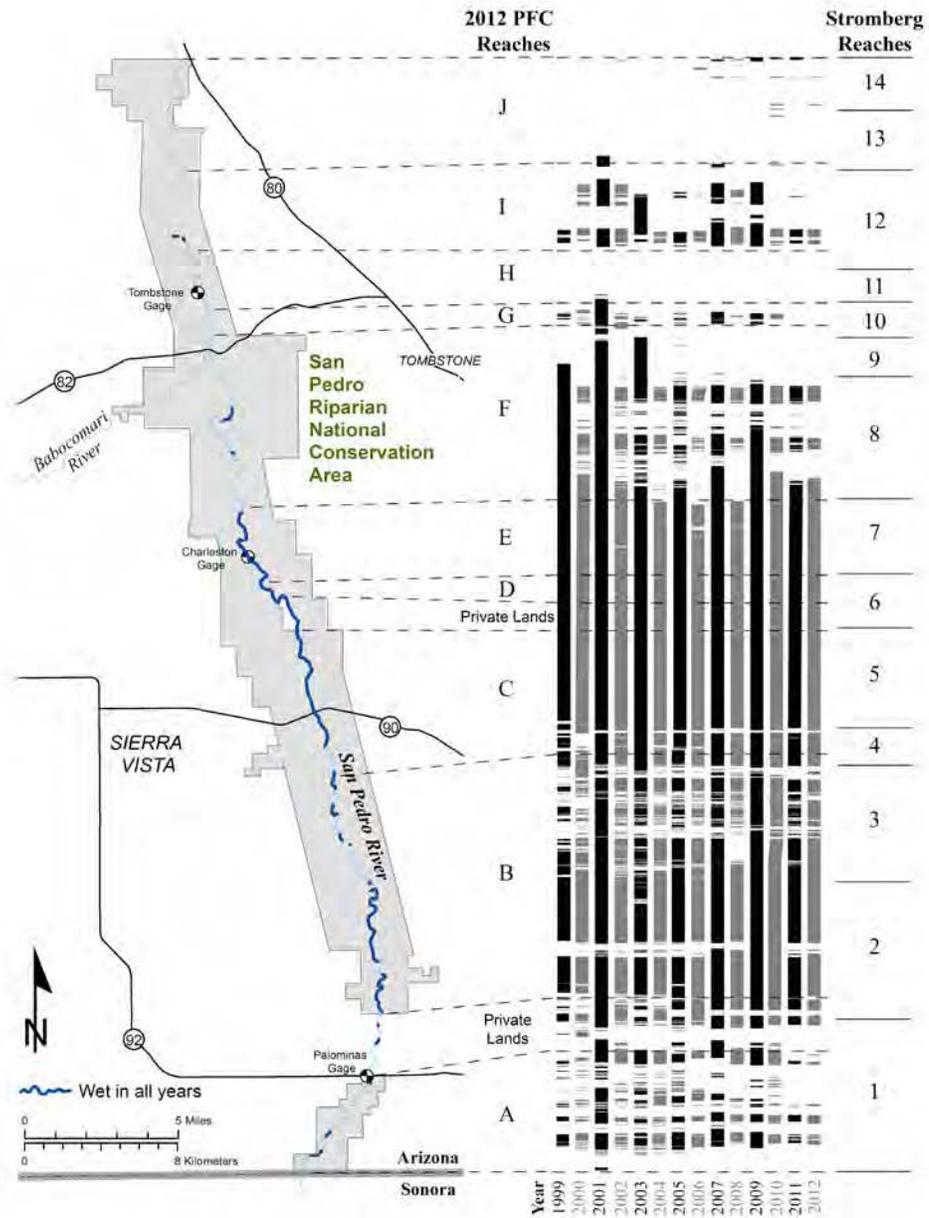
Figure 7. PFC assessment reaches, also showing Stomberg reaches from Leenhouts 2006 and wet/dry mapping results as of 2012 courtesy of The Nature Conservancy. The heavy river line (darker blue) shows reaches which were mapped as consistently wet in all 14 years surveyed. Bars on right side represent wet reaches for each year, 1999–2012. The black and gray lines are different colors simply to provide visual clarity. For more information on interpreting the wet/dry mapping results go to http://azconservation.org/projects/water/wet_dry_mapping.

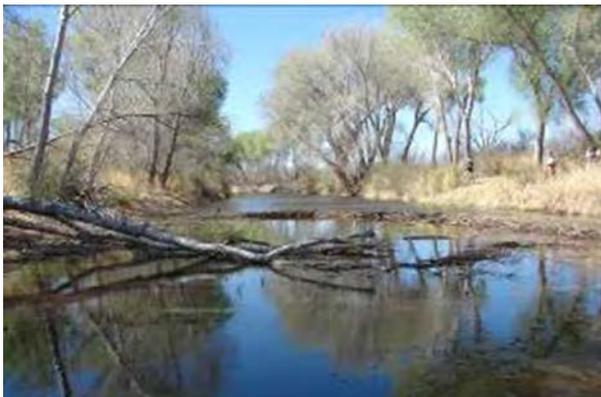
Upstream to small beaver dam; building on sediment deposit, common on much of the river.

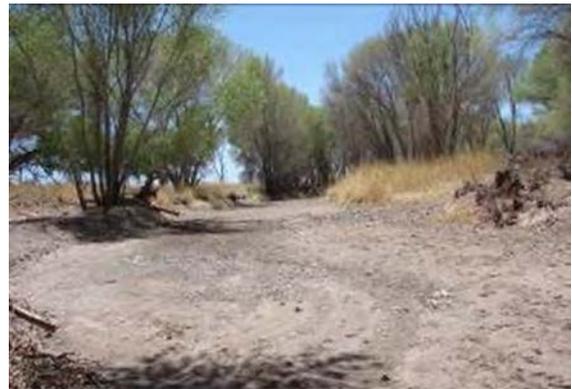
Upstream view; channel dry to waypoint 813; no surface flow due to porous sediments. sand/gravel.

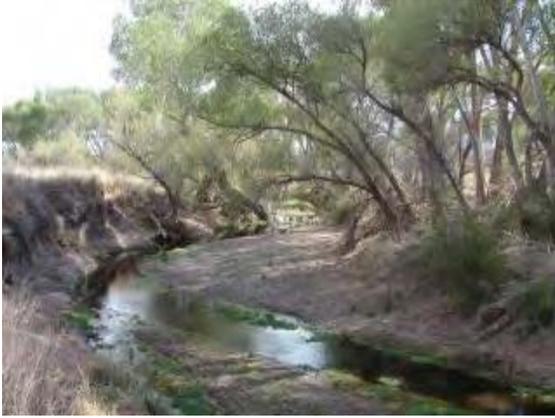
Transition form going to standard form – cottonwoods along right bank established after ones behind, leaning out over the river for sunlight.

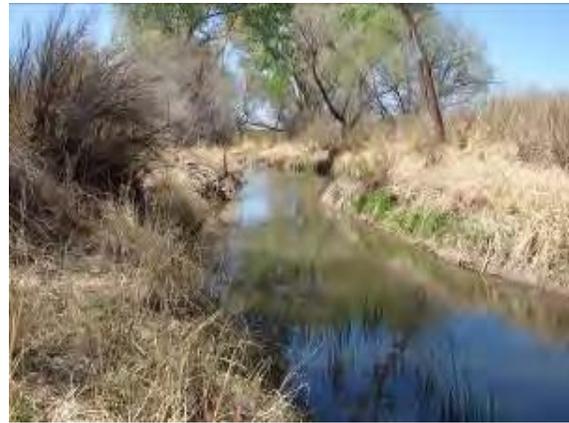
Upstream view; bulrush wading into channel and moving up the bank, narrowing channel, expanding riparian area, ponded form.

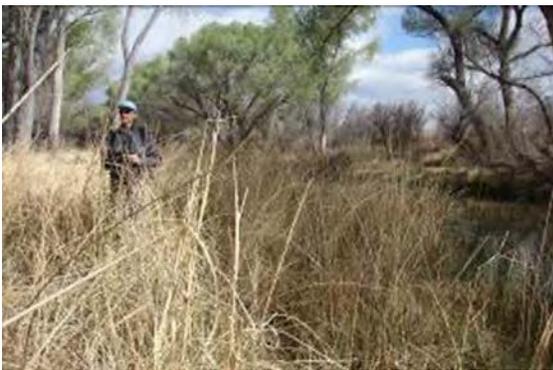
Very vigorous bulrush stand, some 6' tall, extends from channel to atop the frequent floodplain.

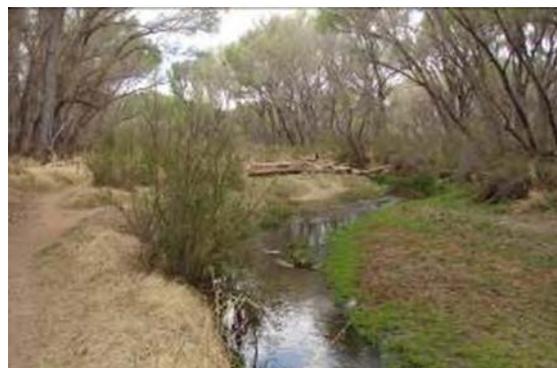
Cottonwood trees on left at base of terrace; floodplain area, active channel bar right.

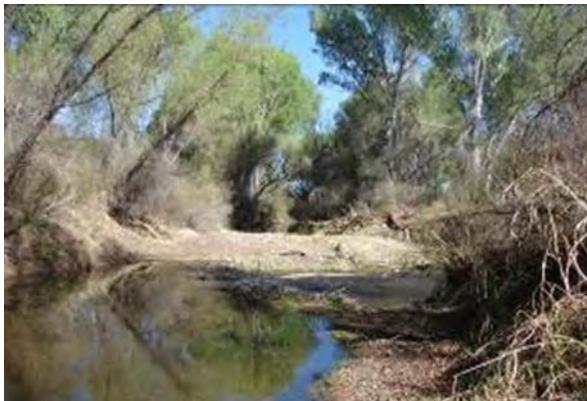
Small unstable beaver dam on tributary fan, several dams in reach, not being maintained.

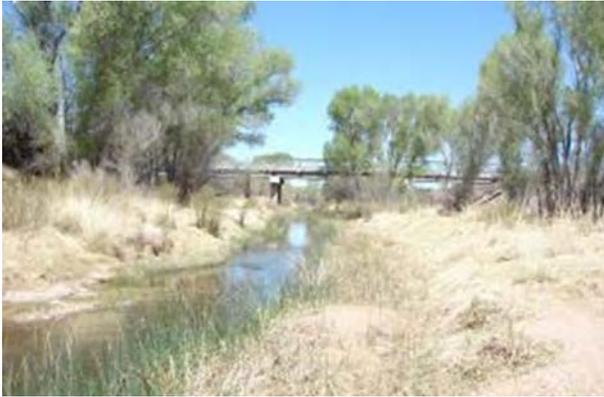
Downstream view to old Charleston Bridge showing excellent bulrush and Baltic rush growth, both banks.

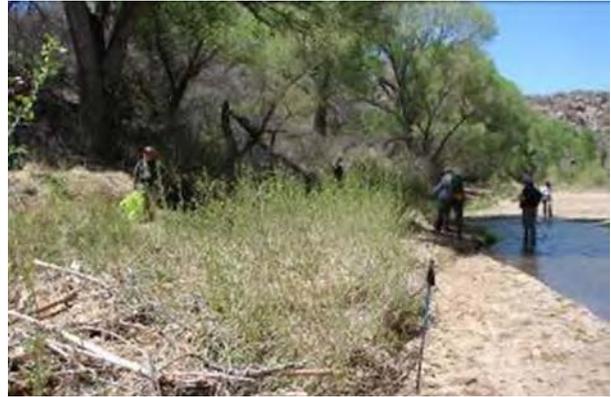
Small patch of young cottonwood trees established from seeds.

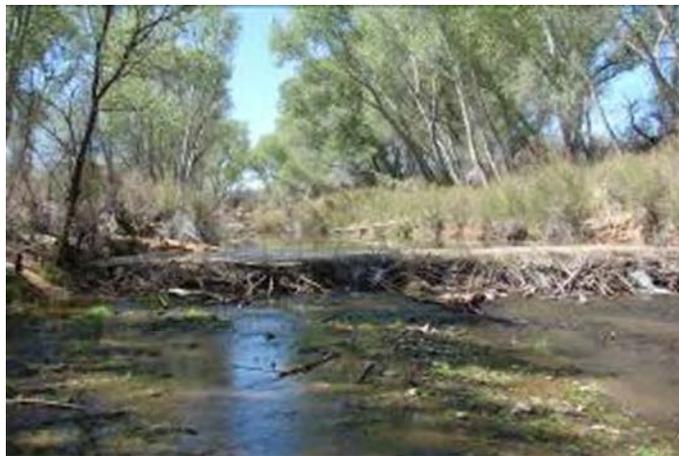
Beaver dam, upstream view, provides additional water storage for plant establishment, some vegetation growing on dam.

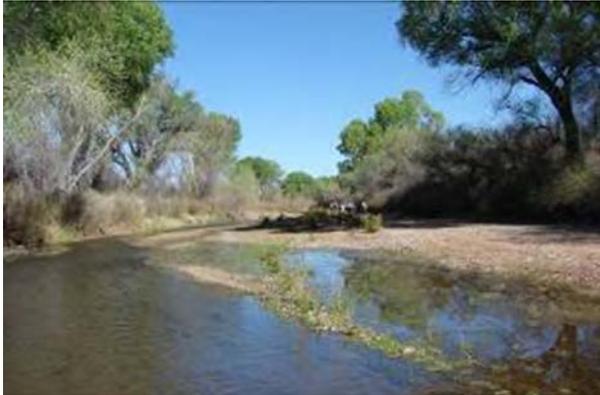
Group looking for indicators and measuring level of frequent floodplain.

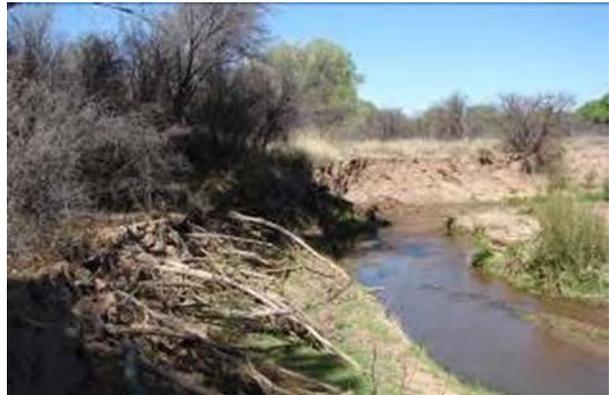
Stream cutting into terrace, strong cottonwood roots forced river to cut upstream; seep willow on point bar.

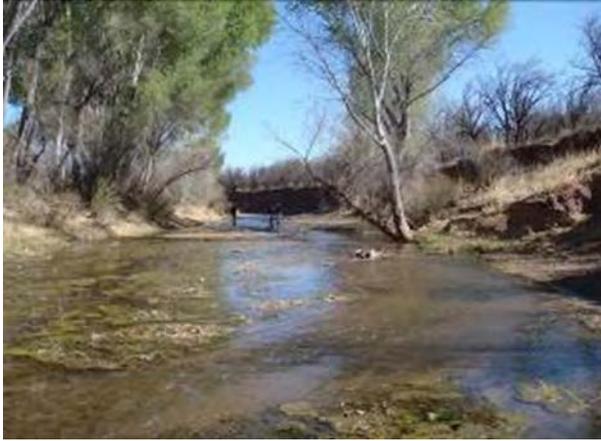
Downstream view, relatively narrow U-shaped channel.
Well-developed vegetation for intermittent reach.

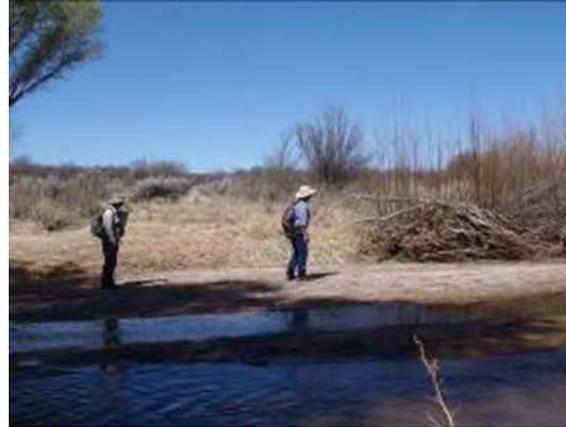
Tamarisk providing vertical structure that stops and holds large/coarse wood in place.

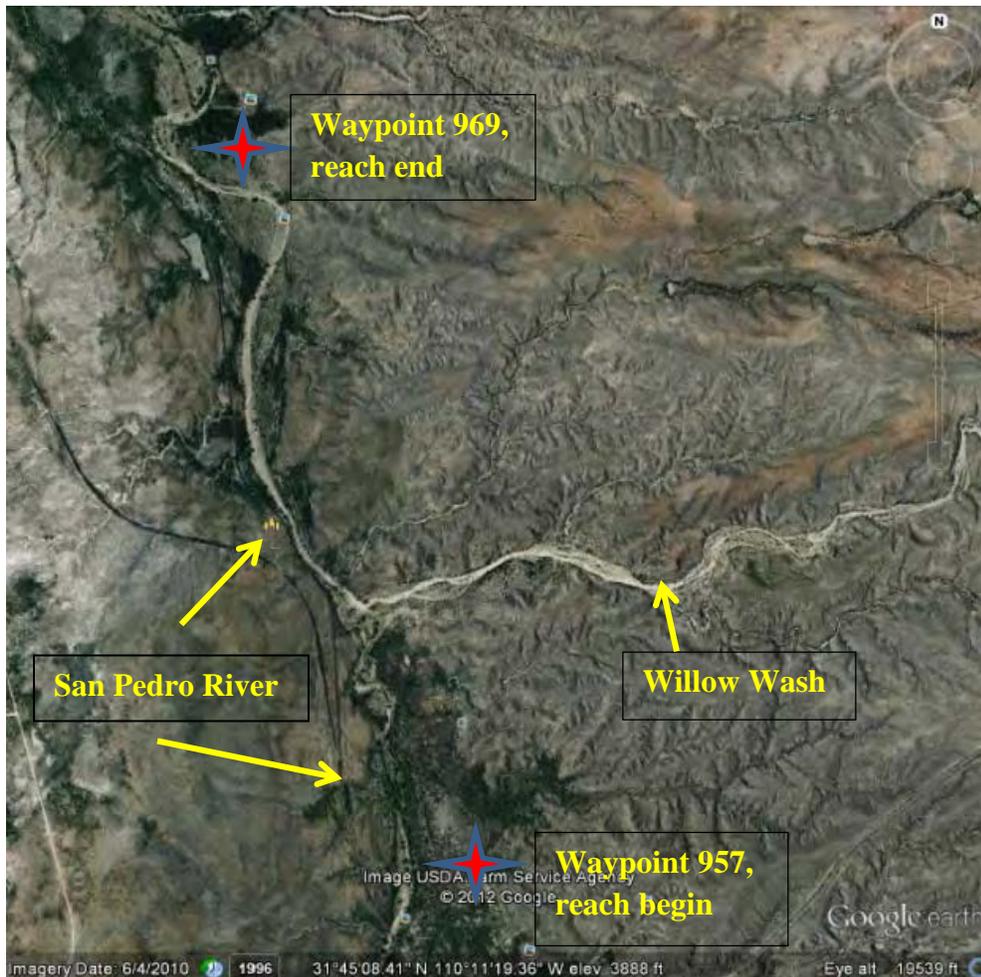
Figure 9. Google Earth image showing Willow Wash entering San Pedro River.

Bedrock is exposed at the beginning of the reach, and then shortly thereafter Willow Wash enters the San Pedro River and fundamentally alters the stream throughout the reach (Figure 9). Willow Wash is an ephemeral wash associated with a much larger watershed than Walnut Gulch, which enters a few miles upstream. As a result, it is contributing more sediment and coarser sediment to the river, than Walnut Gulch.

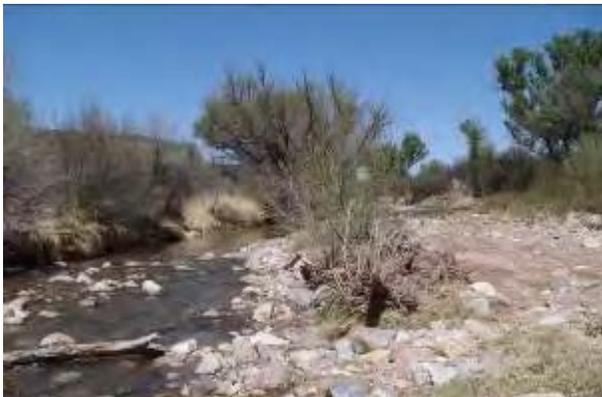
Down channel just below Willow Wash showing large cobble bed.

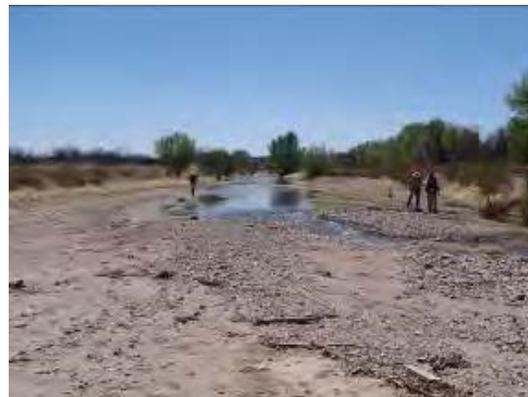
Upstream view.

The river was able to rebound and recovery is seen again between 2005 and 2008 when another flood flow occurred from Willow Wash. While there is a visible increase in riparian vegetation between the 2008 photo and the 2012 photos, it is likely inadequate at this time to establish an upward trend given the sediment from Willow Wash. Reach recovery has been essentially stalled due to repeated high flow events, thus no apparent trend was noted.

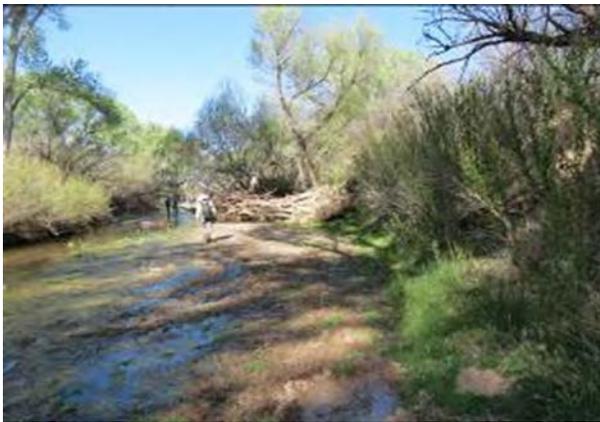
Downstream view showing very healthy vegetation and narrowed channel near beginning of reach.

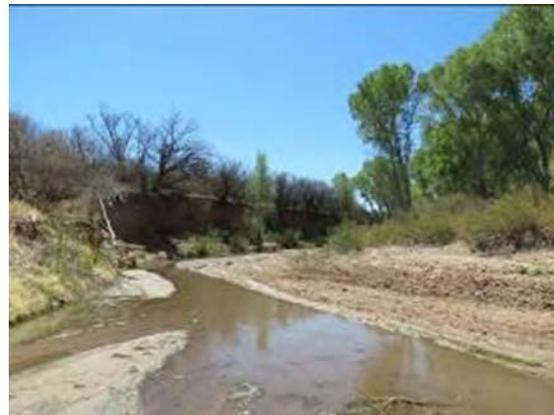
Upstream – retake of photo at Summers Well – point bar vegetating from active channel to floodplain.

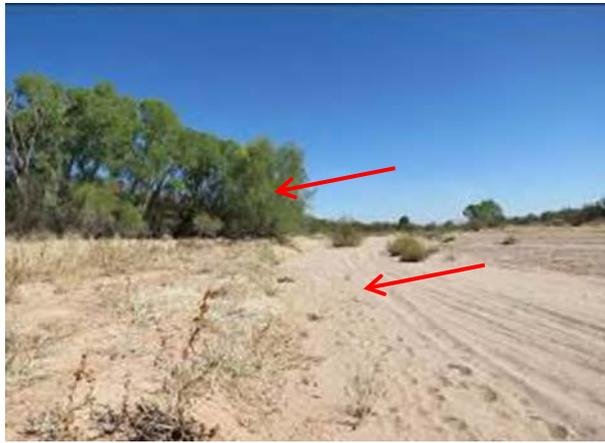
Young cottonwood with mid-age and older in back left; off-highway vehicle tracks throughout.

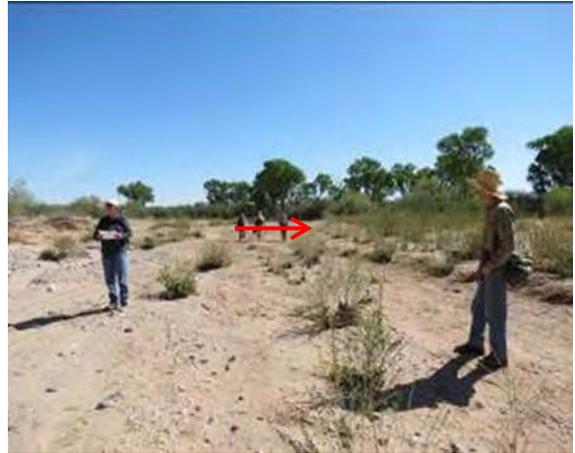
Young cottonwood appears more shrub-like than tree form from repeated grazing.

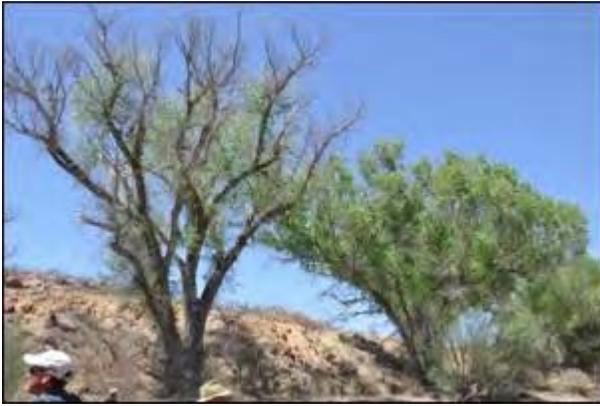
Figure 10a. An individual, mature cottonwood tree near the Tombstone gage in reach H has limited extent of live canopy. The cause of canopy reduction is unknown due to the comparative vigor of adjacent trees. The slope in the background leads up to the Presidio.

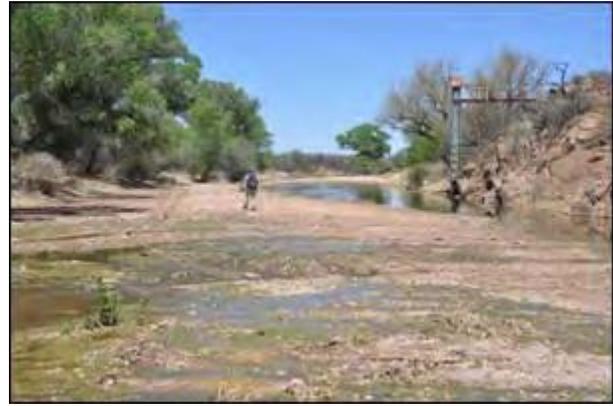
Figure 10b. All the other mature cottonwood trees observed within one-half mile downstream of the Tombstone gage (shown at right) have fully leafed canopies and appear completely vigorous.

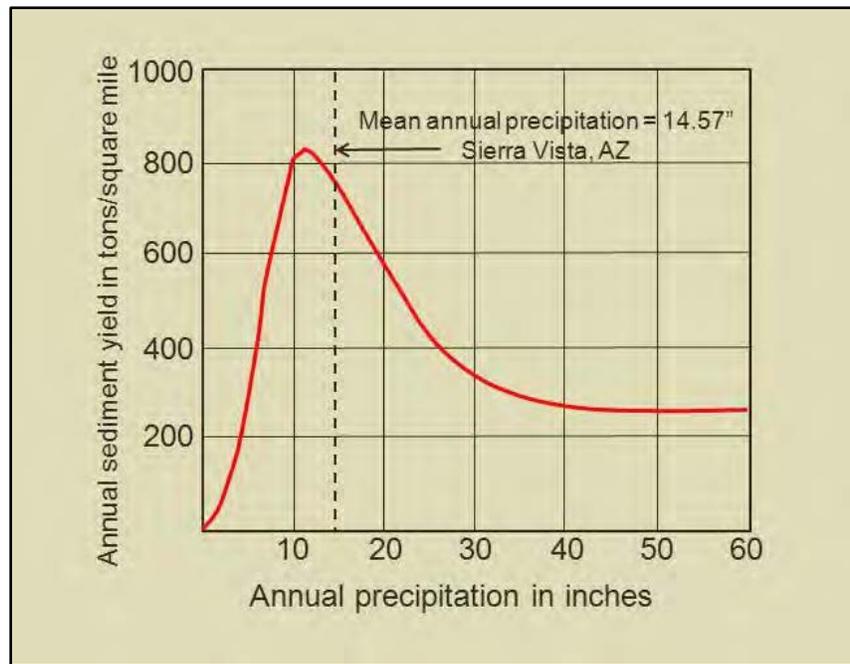
Figure 11. Langbein-Schumm (1958) sediment-yield curve illustrates that the highest natural sediment yields occur in semiarid environments where the potential for precipitation to move sediment is high, yet the vegetative cover in uplands is relatively sparse. When annual precipitation increases above the mean levels of semiarid environments, it supports more vegetation cover, which in turn protects the land surface and decreases erosion and sediment yield.

The idea of excessive sedimentation must be evaluated in terms of whether the San Pedro River has the transport capacity to process the sediment delivered by ephemeral channels. When sediment load exceeds transport capacity, then one expects to see a continuum of conditions reflecting transport deficiencies. A first indicator of excessive sediment load is a change in particle size of the stream bed, followed next by construction of mid-channel bars, then streambed aggradation (Parker 1990; Wilcock et al. 2009). Very late, or advanced, indicators of excessive sediment load include changes in stream pattern (e.g., shift from single-thread to braided channel) and finally channel slope, as these changes require much time and rearrangement of large volumes of sediment (Parker 1990; Wilcock et al. 2009).

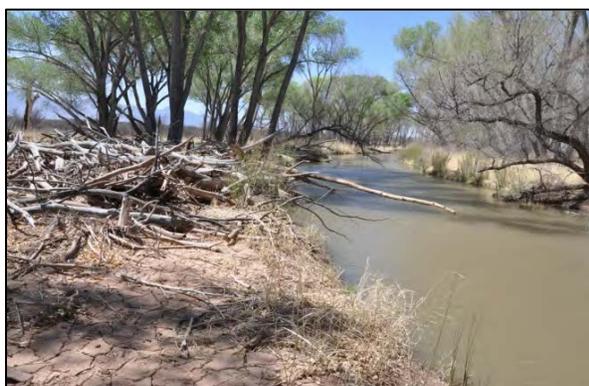
Figure 12a. Recent accumulations of woody material and mud-cracked, fine-textured sediments (left foreground) are ubiquitous on the floodplain and streambank, particularly in reaches A through E, G, and I.

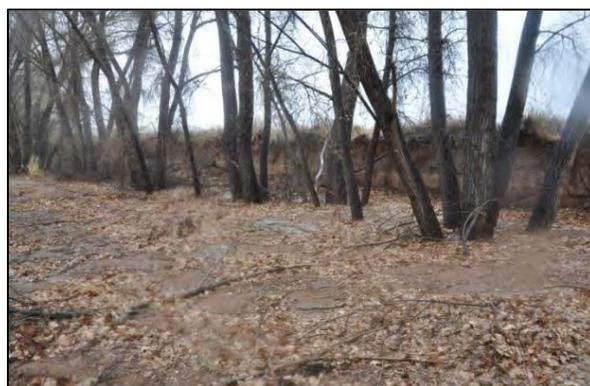
Figure 12b. The visible bases of tree trunks are straight and lack the flared morphology that occurs when the root crown is at the ground surface. Straight trunk morphology indicates floodplain aggradation since tree germination. Some root crowns are buried by several feet of sediment.

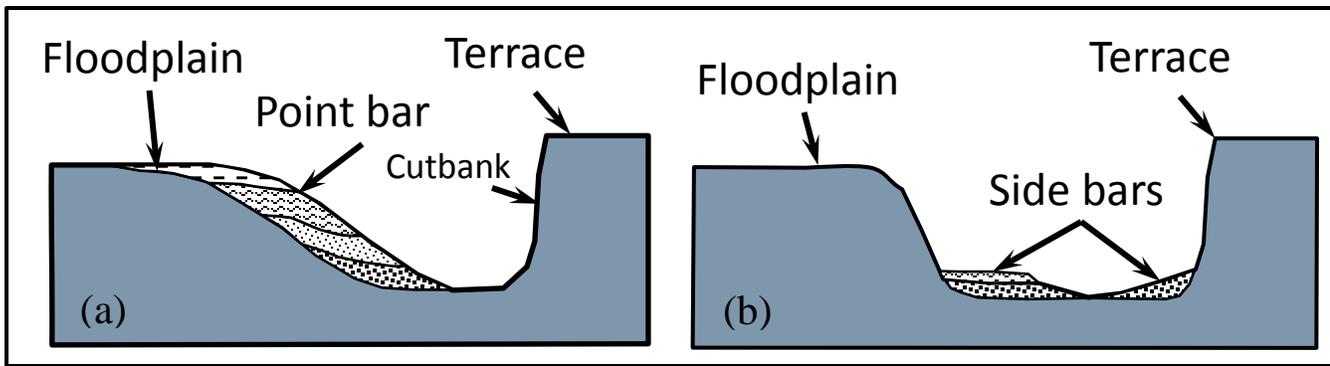
Figure 13. Channel cross-sectional diagrams illustrating (a) point-bar deposits grade upward from coarse to fine sediment and merge at their top with the floodplain; and (b) side, alternating, or active-channel bars occur on the channel bed and do not form a streambank deposit that merges with the floodplain.

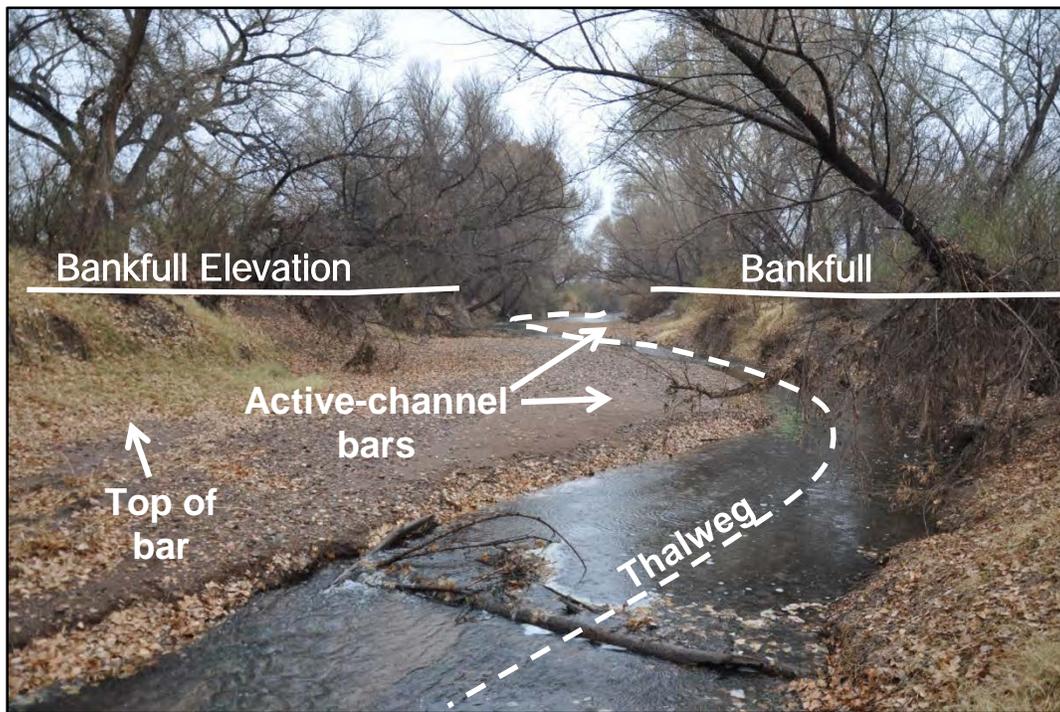
Figure 14. A low-flow thalweg (dashed line) illustrates sinuosity within a straight channel. The alternating bars are active-channel bars, not point bars. These active-channel bars do not show: (1) a depositional form in which the top of the bar is connected to the floodplain (bankfull elevation), (2) an active cutbank that has retreated laterally as a consequence of point-bar deposition and expansion, (3) lateral movement of the channel and development of channel sinuosity as a consequence of point-bar deposition, and (4) a meander length that is typically 10-14 times channel width and a radius of curvature at the apex of the bend that is 2-3 times the channel width. The radius of curvature displayed here is less than the channel width.

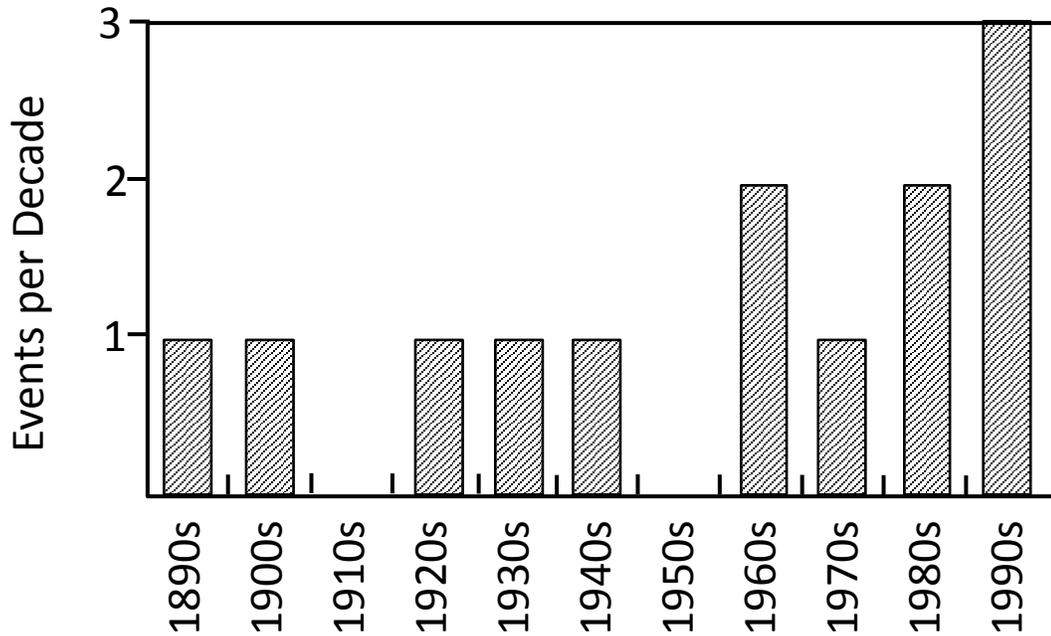
Figure 15. From the 1890s through the 1970s, flood events that generated establishment of new cohorts of cottonwood trees occurred on average once per decade, and only in the 1960s was there more than one establishment event per decade (from Stromberg, 1998). During the 1980s and 1990s, there were 2 and 3 recruitment events per decade, respectively (from Stromberg 1998). However, even though the 40-year interval from 1960s through 1990s had more frequent establishment events, the spatial area of galleries established since the 1950s is less than that established prior to the 1950s. The decrease in spatial area is directly related to the change in channel evolutionary processes at about this time. As Hereford (1993, pp. 21-24) demonstrated through study of a time series of aerial photographs, the San Pedro floodplain was evolving primarily through lateral migration (i.e., channel meandering) until the 1950s and has been evolving through vertical aggradation (i.e., by storing suspended sediment on the floodplain) and channel narrowing since the 1950s.

The NRST believes that the smaller size of galleries since the 1950s creates the illusion of lower cottonwood establishment. In truth, there have been more frequent establishment events since the 1950s than in the decades earlier (Figure 15; Stromberg 1998).

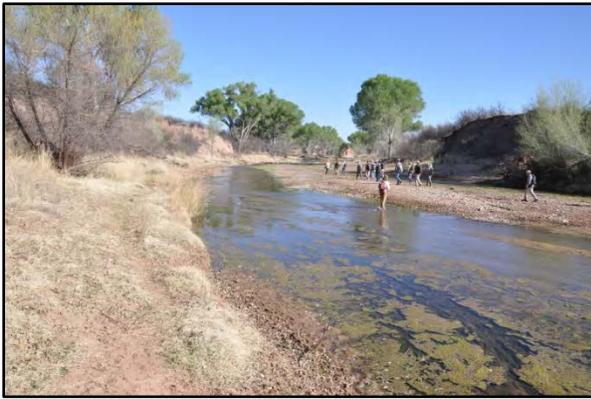
Figure 16a. Mature cottonwood trees of approximately equal age line both banks of the San Pedro River a few hundred meters downstream of Boquillas Wash in reach G. These mature trees all have full canopies, broad, thick branches, and large diameter trunks.

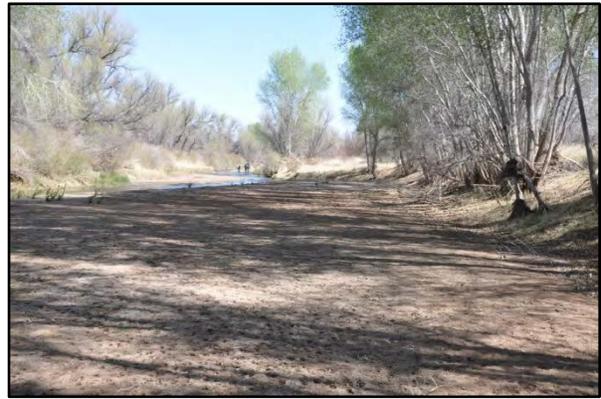
Figure 16b. An equal-age stand of young cottonwood trees occurs on the streambank in reach G. This gallery is much younger than the one depicted in Figure 14a, as suggested by the shorter tree height, narrower crown profile, thinner branches, and smaller trunk diameter.
