San Pedro River Expedition 2023

Appendix A

Site Photos

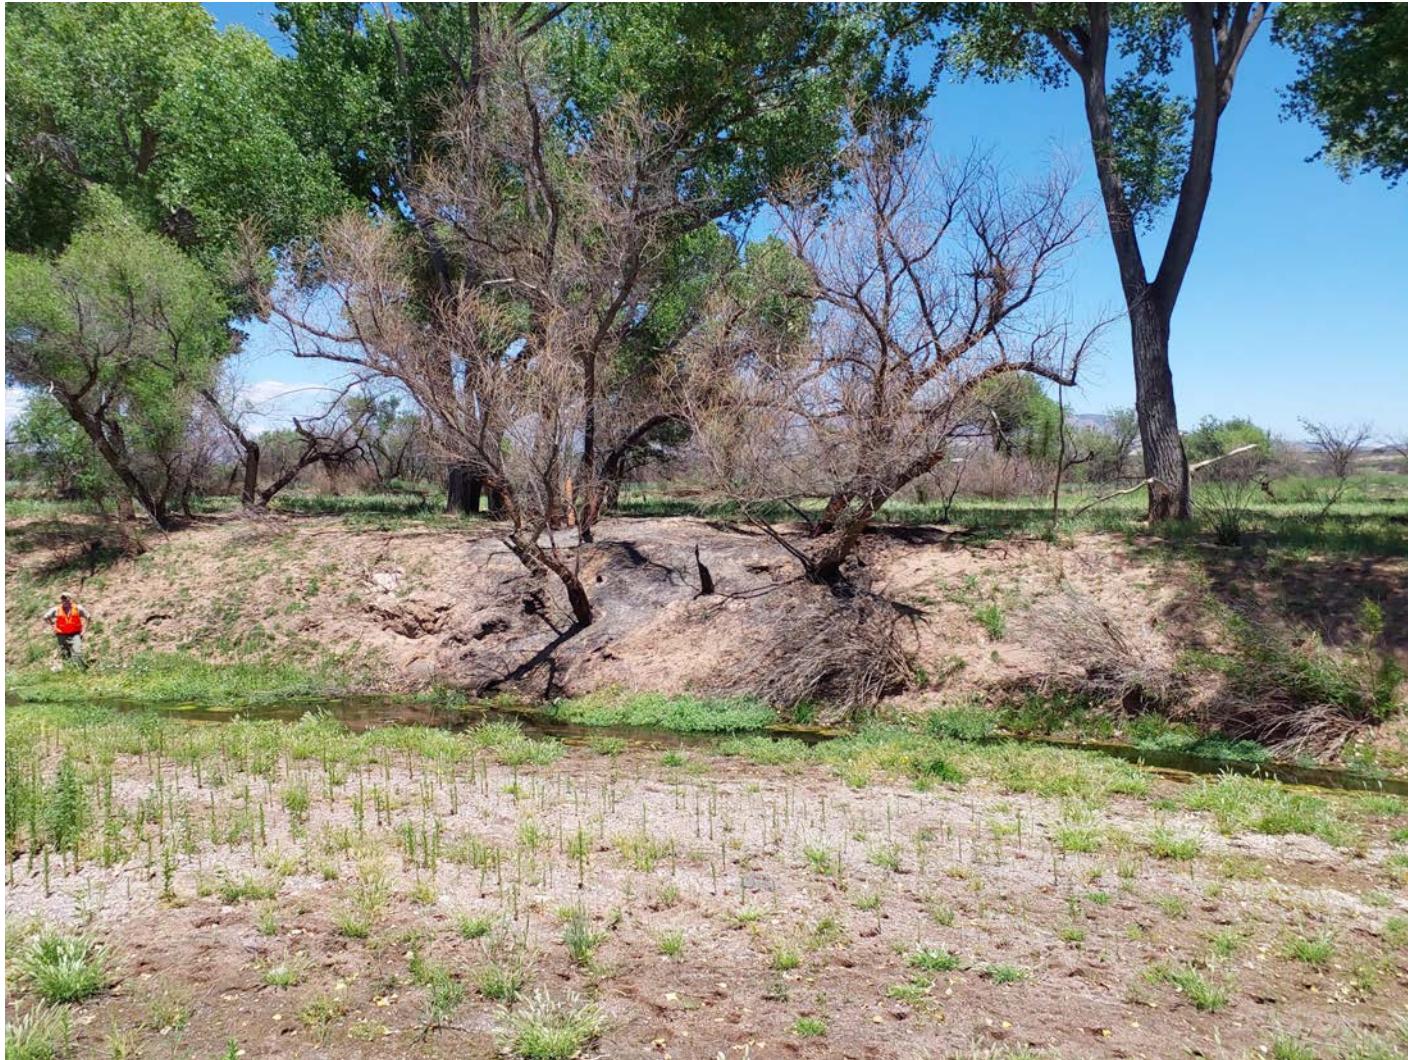
Position: View to east; recent burn

Reach	Transect	Longitude	Latitude	Date	Notes:
2	GPS Middle	-110.10488569	31.41454011	29 May 2023	Burned SAGO on east side of San Pedro. Cattle hoof prints and dung in channel. JR sampling streamside herbs.

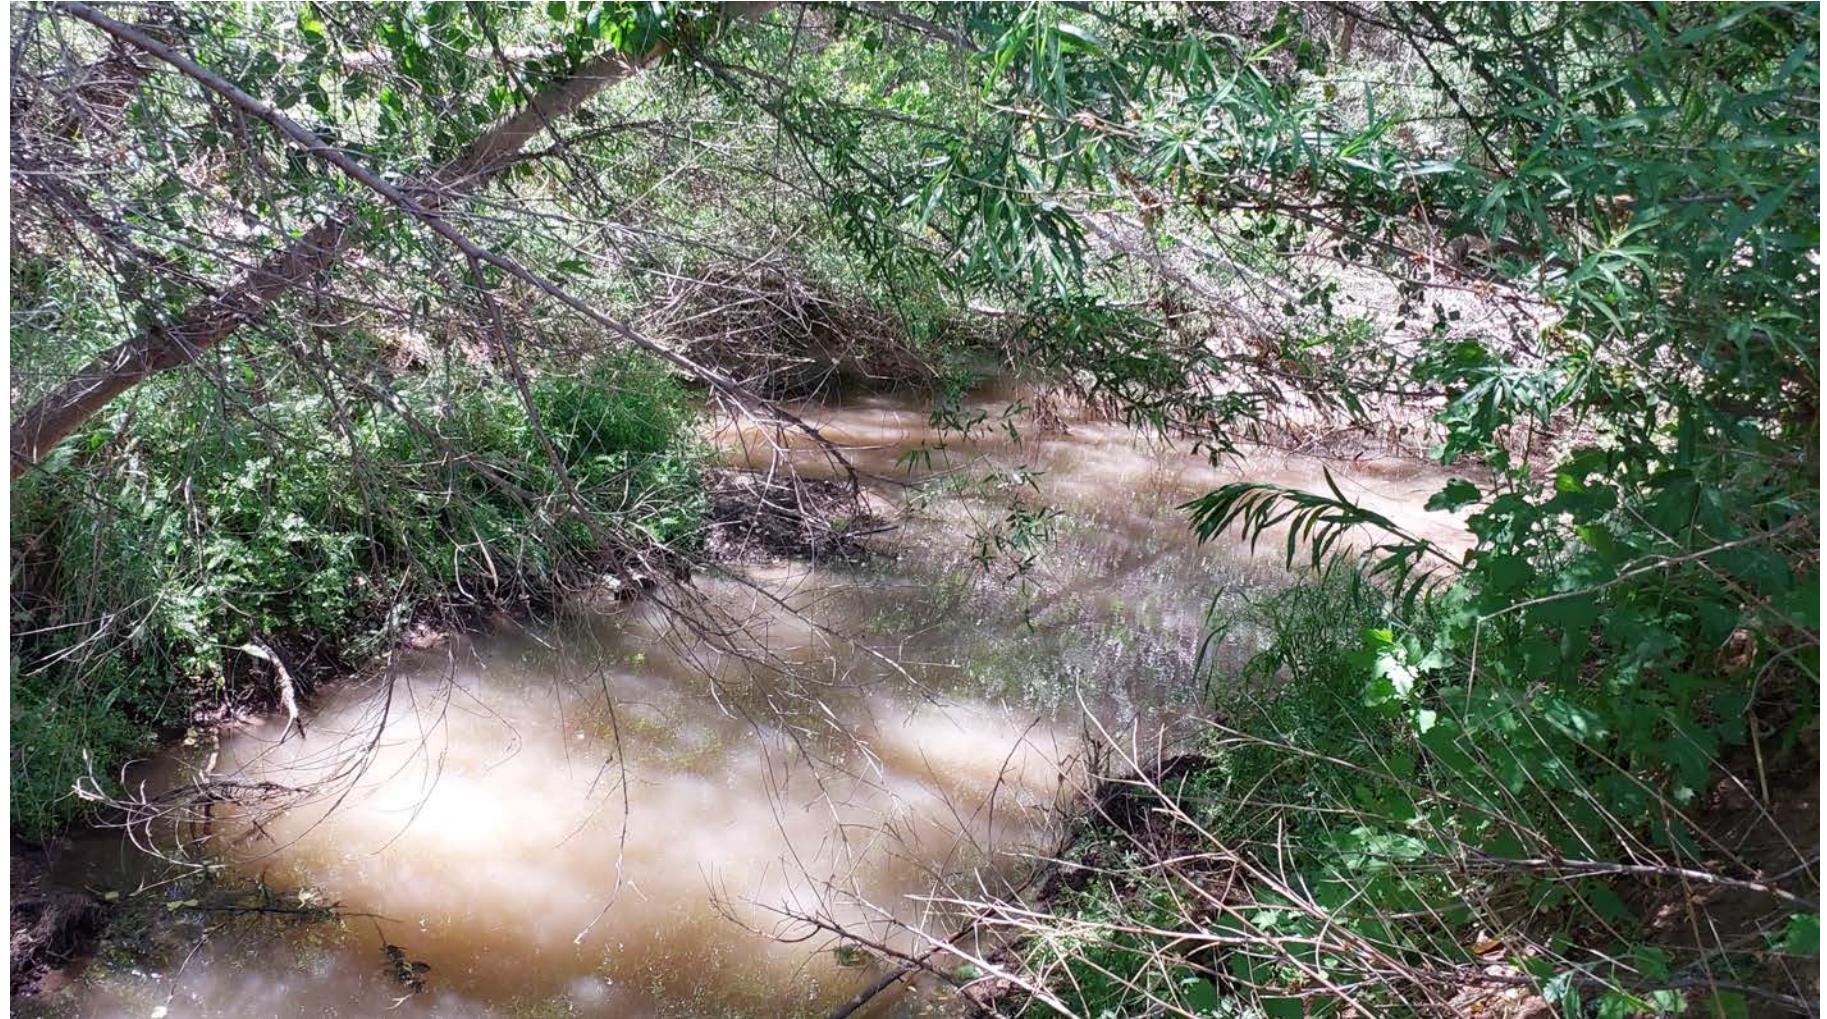
Position: Upstream

Reach	Transect	Longitude	Latitude	Date	Notes:
2	GPS Middle	-110.10971293	31.454445928	29 May 2023	Recent flooding rerouted the river through an old, overgrown channel along the middle transect.

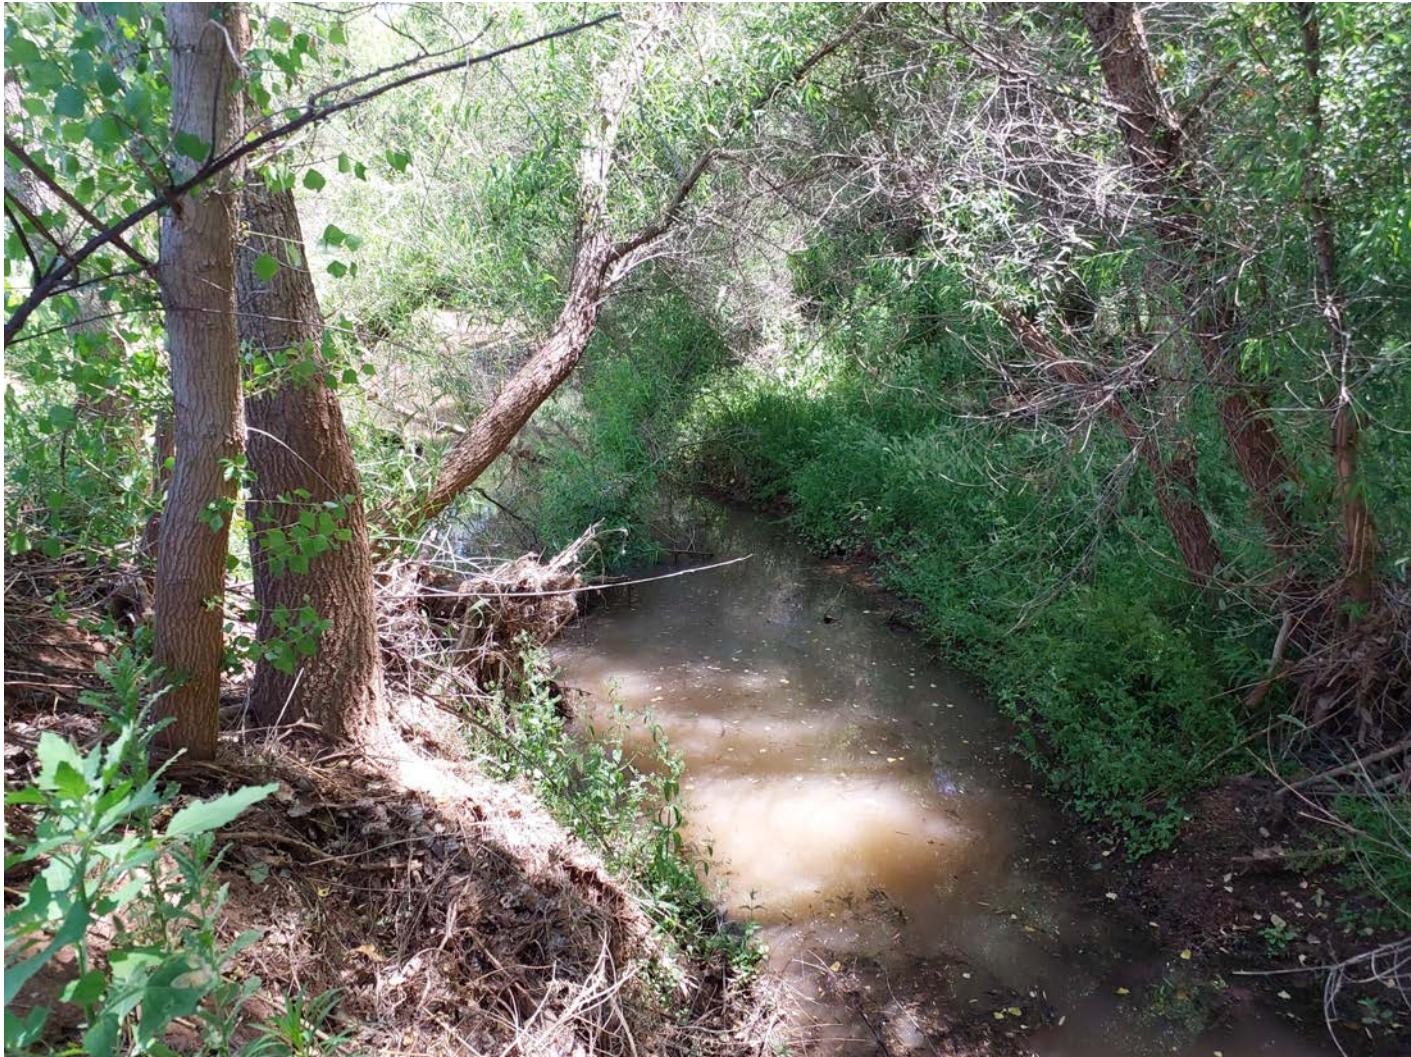
Position: Downstream

Reach	Transect	Longitude	Latitude	Date	Notes:
2	GPS Middle	-110.10971293	31.45445928	29 May 2023	Recent flooding rerouted the river through an old, overgrown channel along the middle transect.

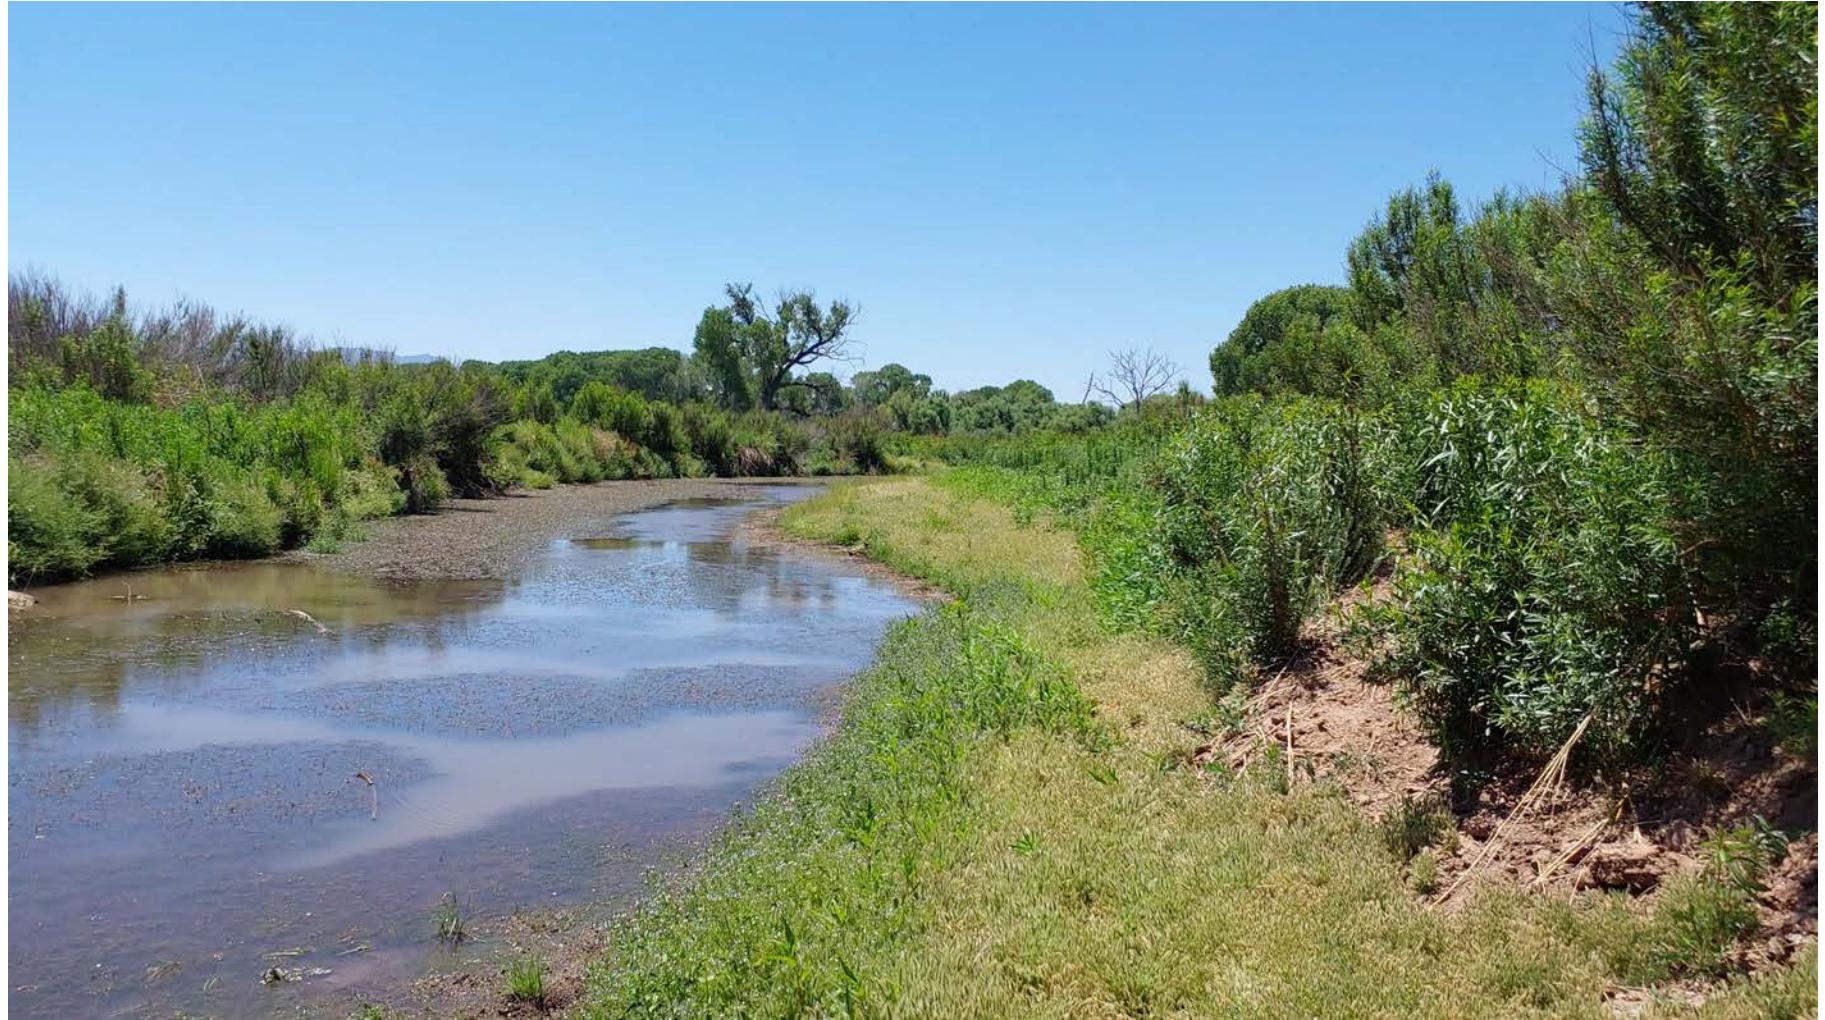
Position: Avulsed channel; upstream

Reach	Transect	Longitude	Latitude	Date	Notes:
2	GPS Middle	-110.10912596	31.45417428	29 May 2023	Slightly upstream of middle transect looking upstream along avulsed, newer channel.

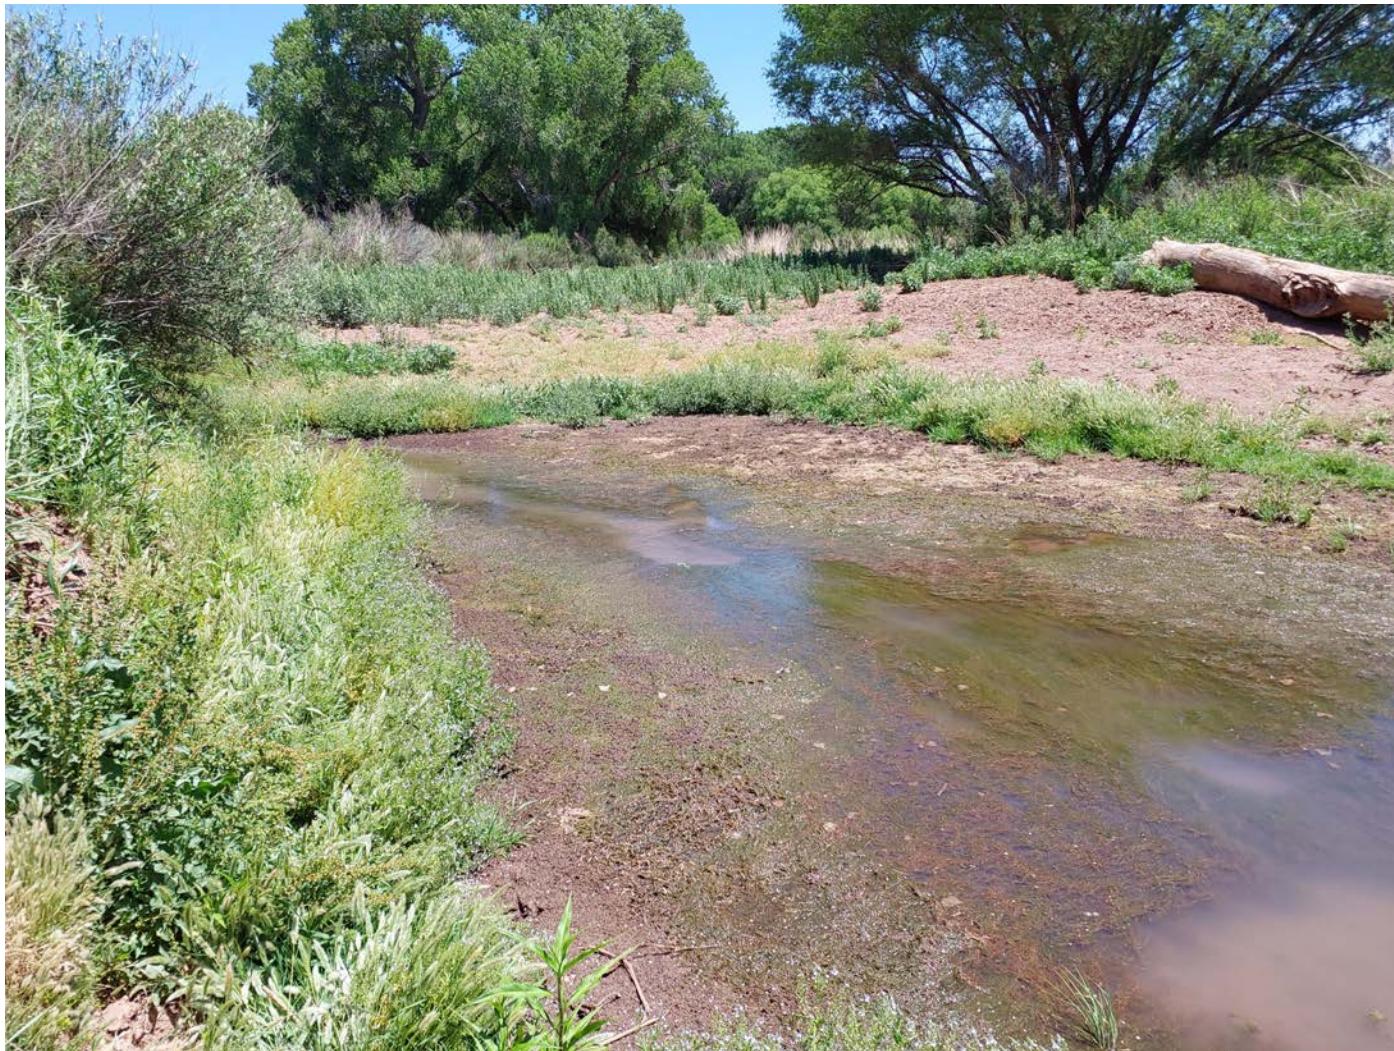
Position: Avulsed channel and reroute; downstream

Reach	Transect	Longitude	Latitude	Date	Notes:
2	GPS Middle	-110.10912596	31.45417428	29 May 2023	View of avulsed channel and recent reroute as river cuts away to left (west) to join older, overgrown channel.

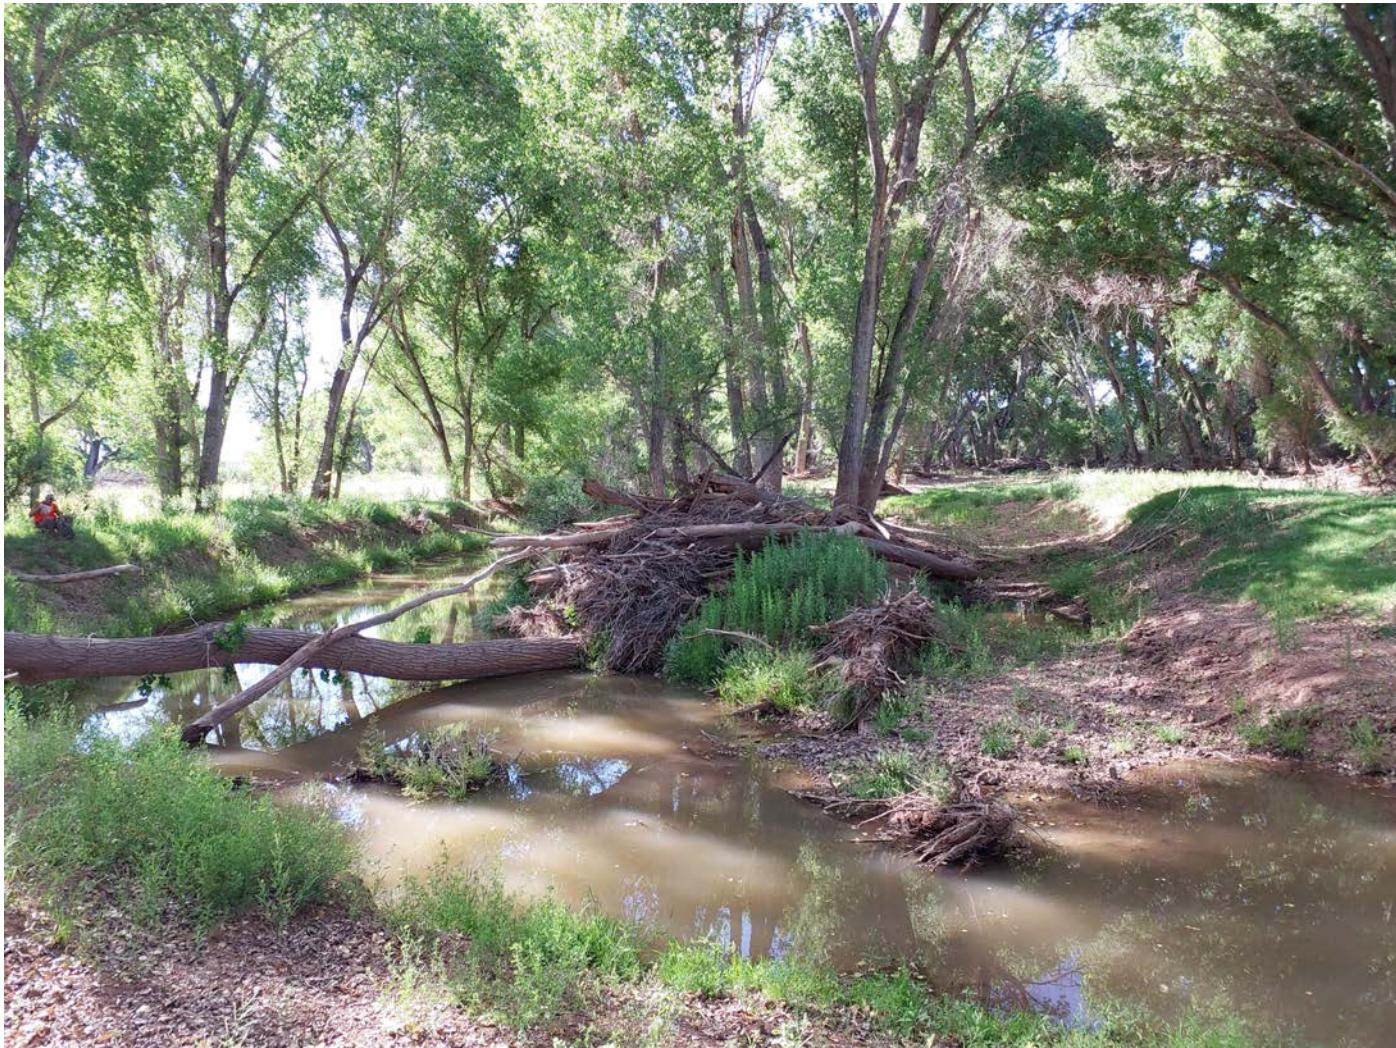
Position: Downstream; flood debris

Reach	Transect	Longitude	Latitude	Date	Notes: From upstream of middle transect showing split channel and flood debris. Felled bole on left also on page 14.
3	GPS Middle	-110.11817647	31.48275939	28 May 2023

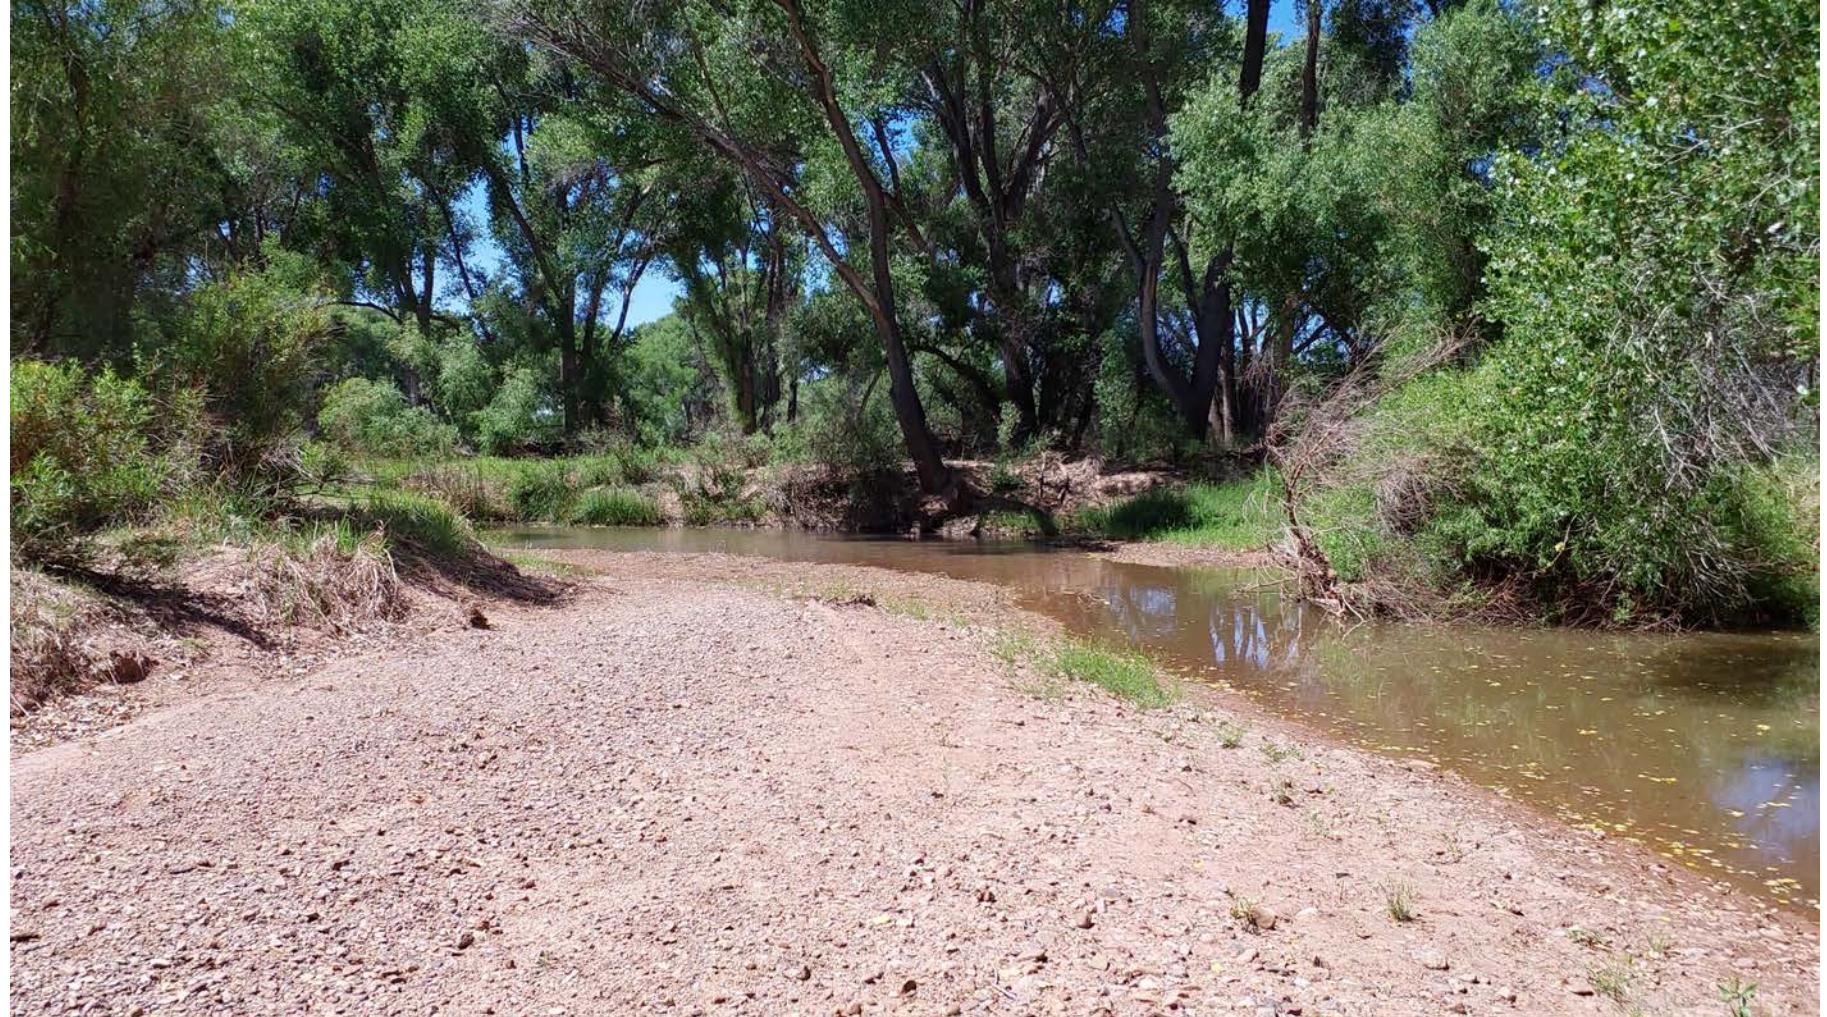
Position: Upstream

Reach	Transect	Longitude	Latitude	Date	Notes:
4	GPS Middle	-110.12890968	31.5198936	28 May 2023	Primary channel; note small secondary channel branching to right (west) upstream of snag.

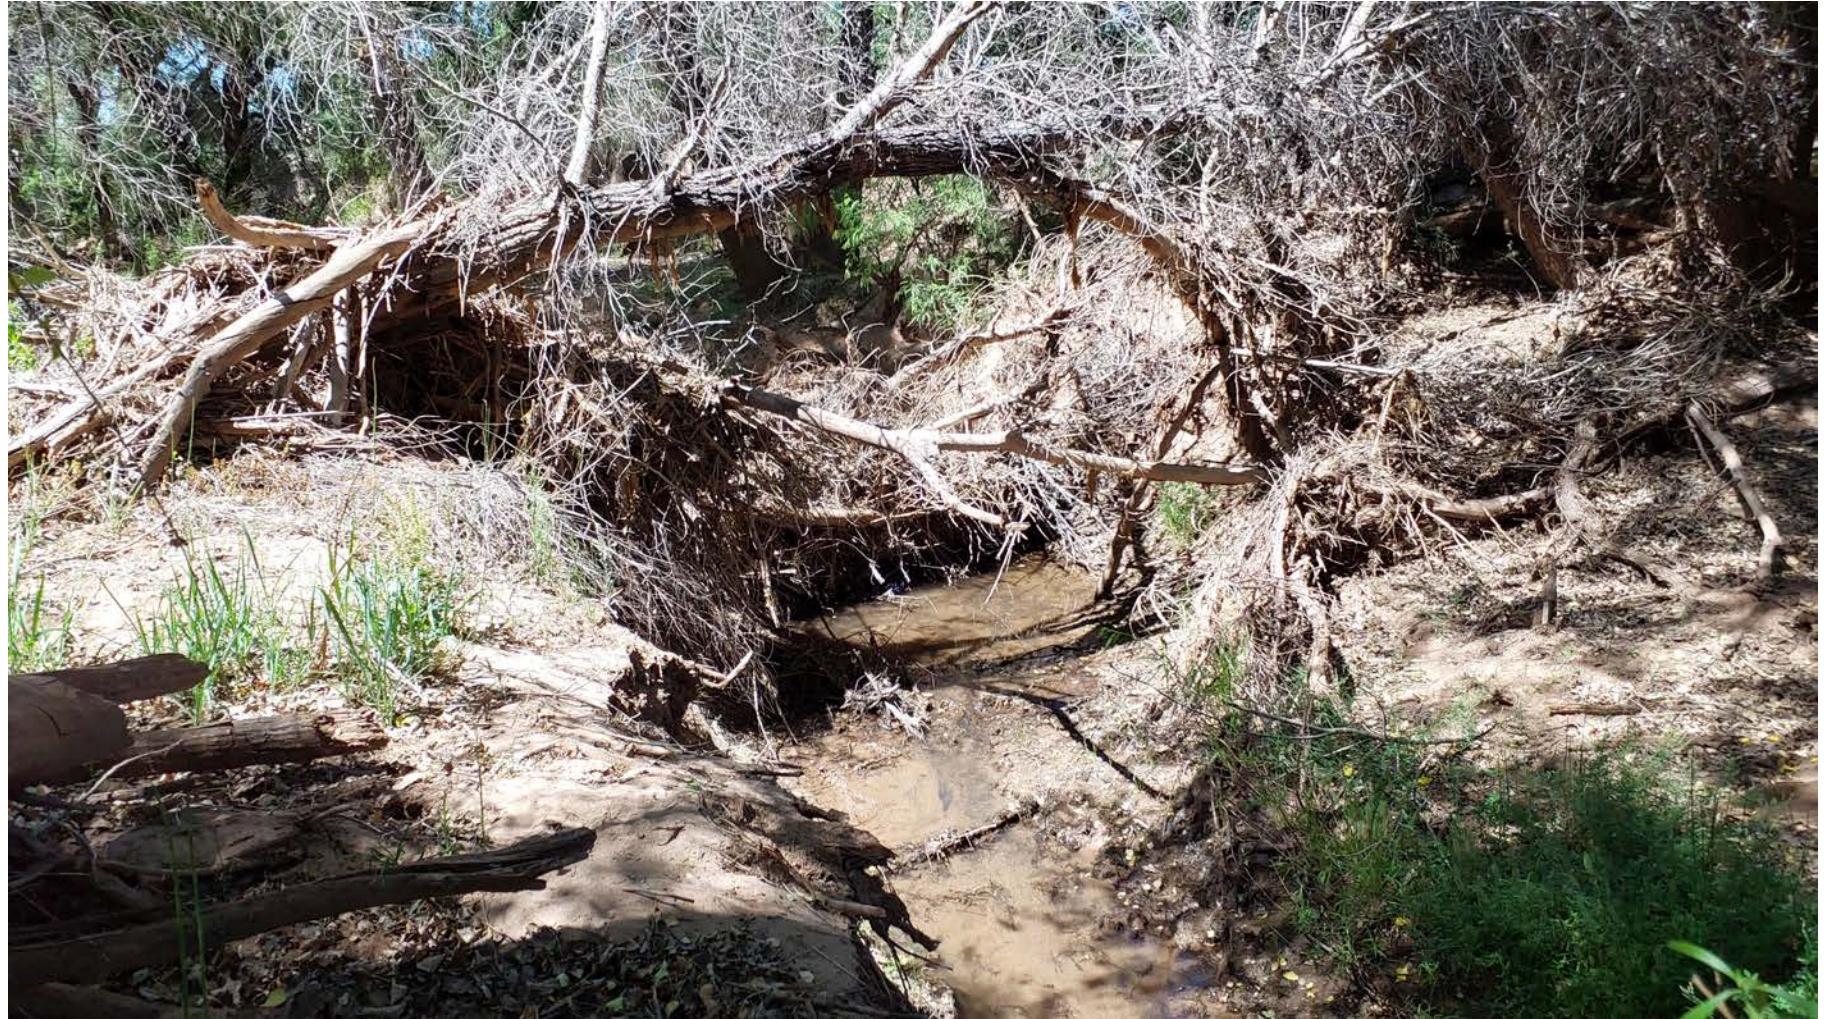
Position: Side channel; upstream

Reach	Transect	Longitude	Latitude	Date	Notes:
4	GPS Middle	-110.12890103	31.51992611	28 May 2023	Small secondary channel to the west of the main.

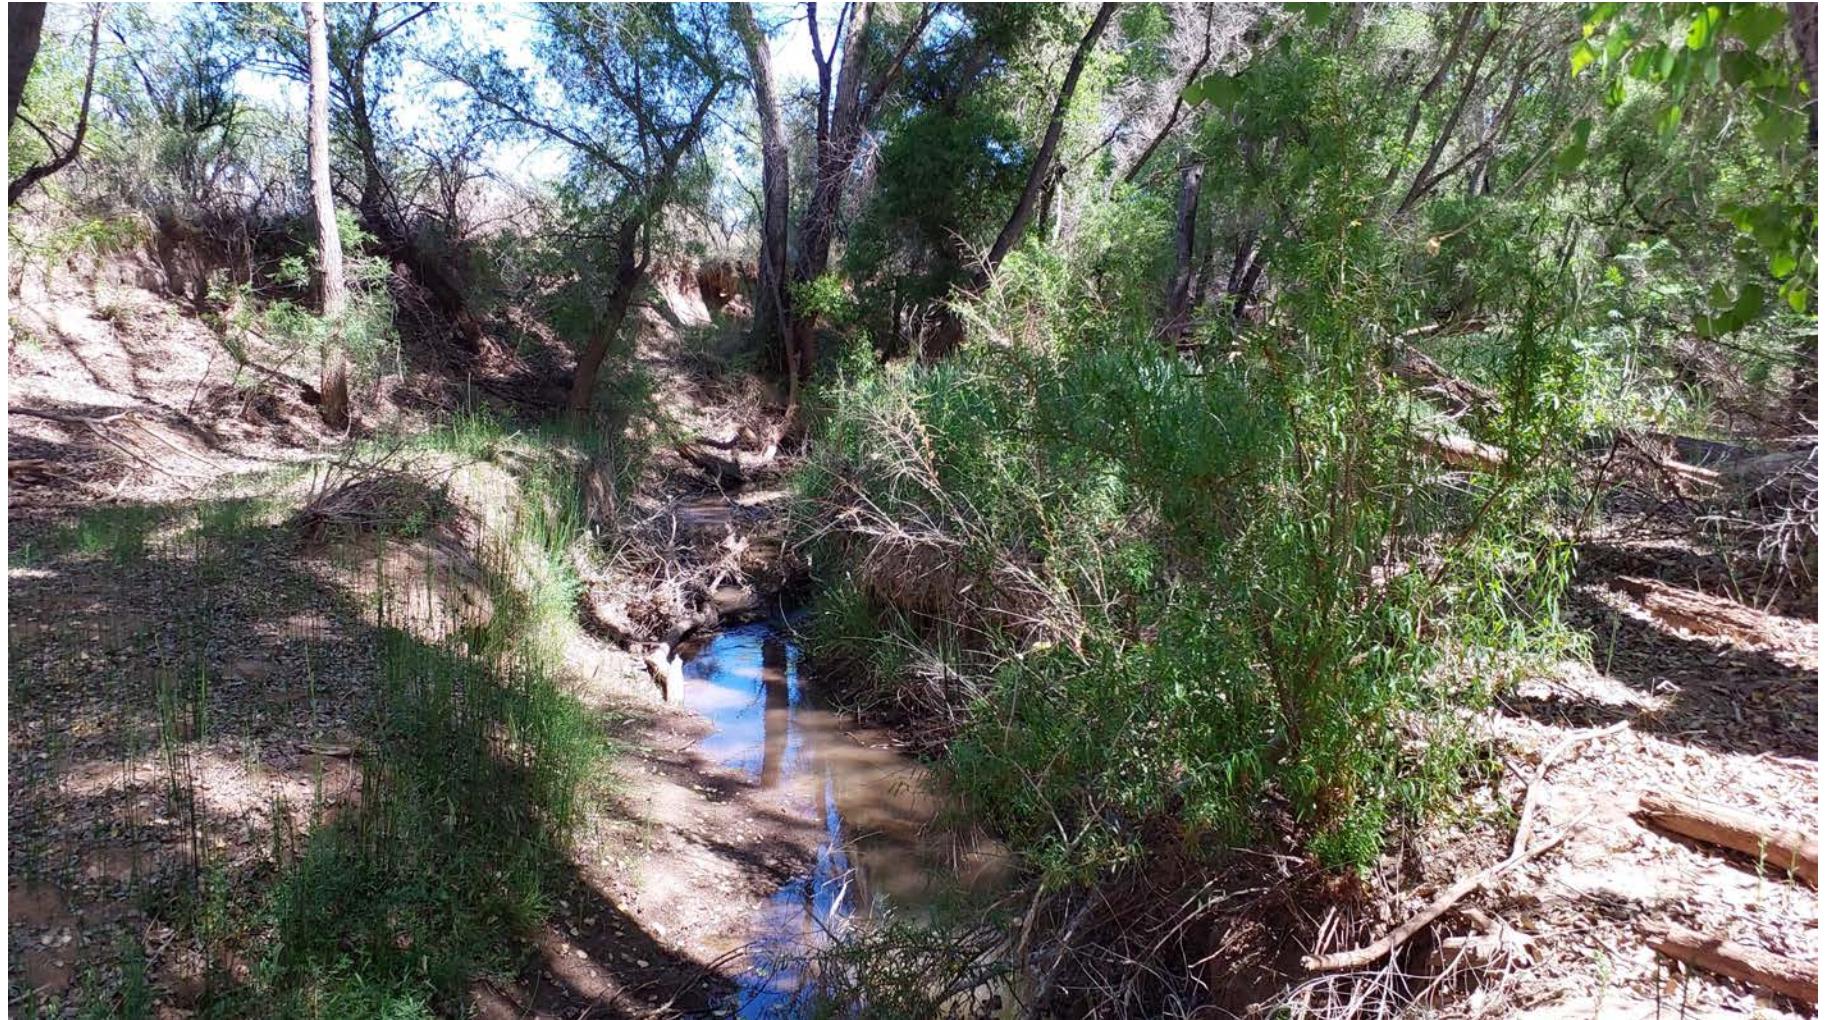
Position: Side channel; downstream

Reach	Transect	Longitude	Latitude	Date	Notes:
4	GPS Middle	-110.12890103	31.51992611	28 May 2023	Small secondary channel to the west of the main.

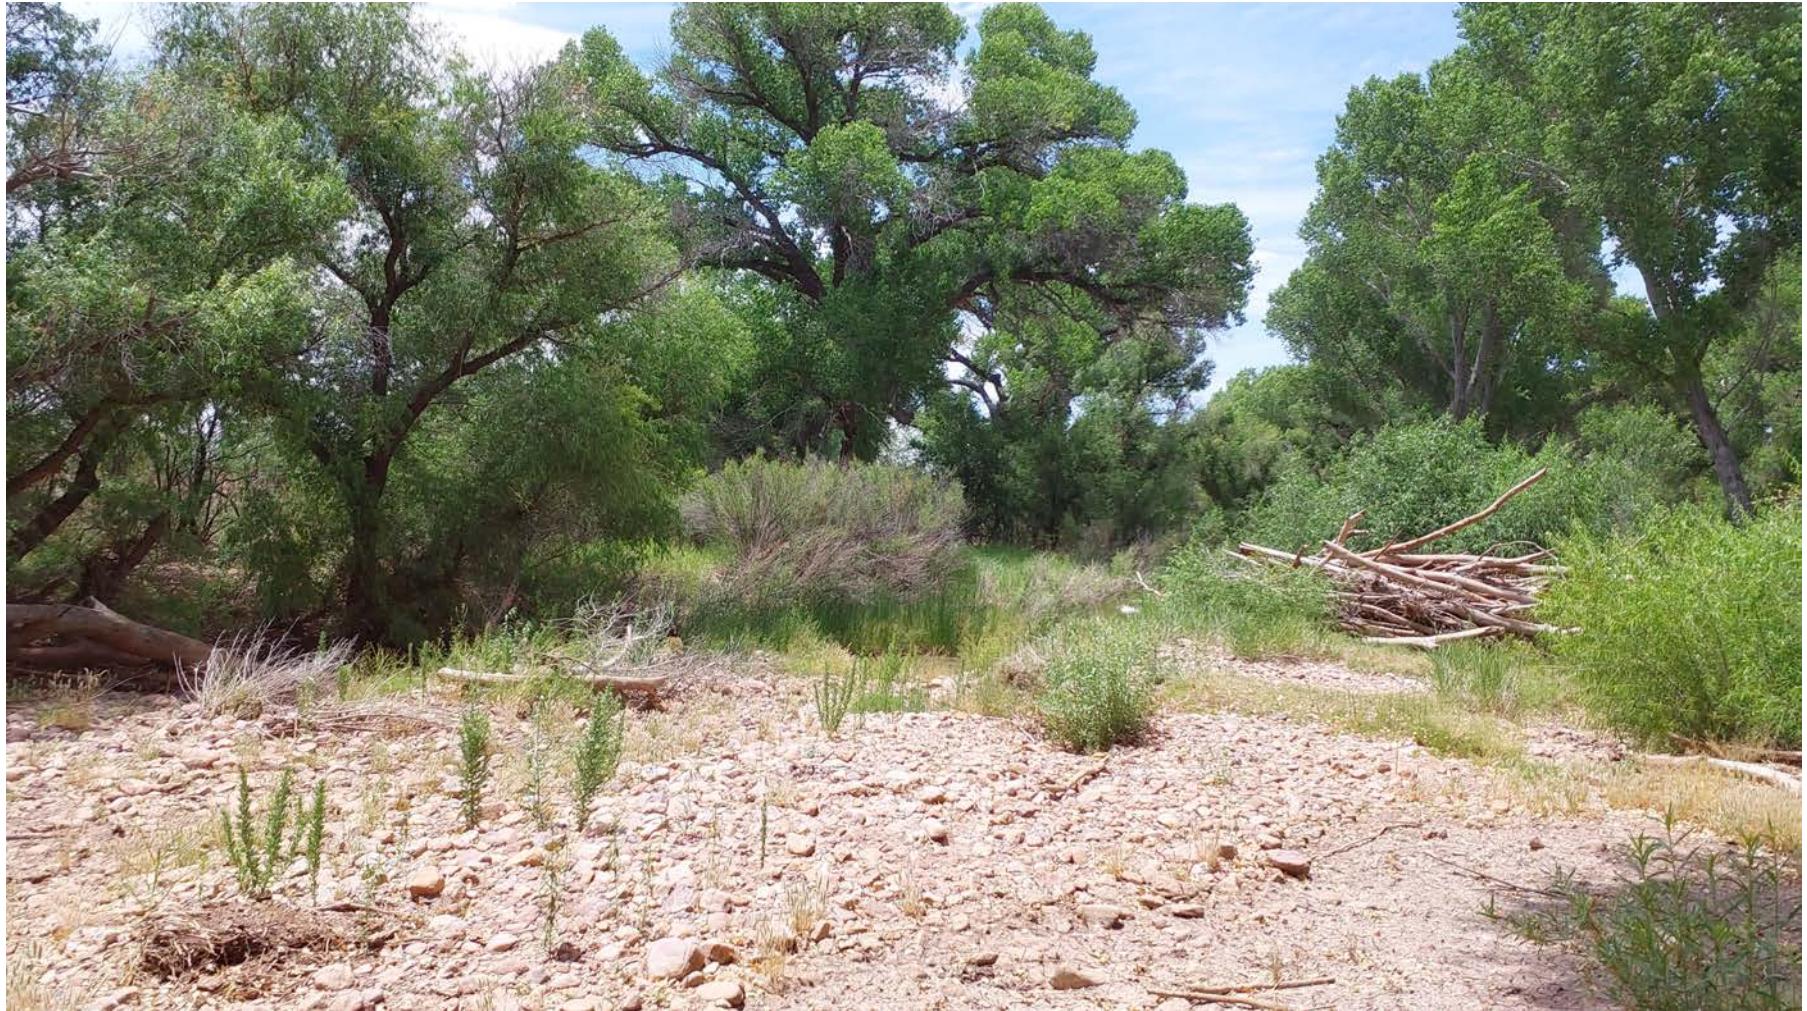
Position: North transect; downstream

Reach	Transect	Longitude	Latitude	Date	Notes:
4	100m North	-110.12957549	31.53131505	19 June 2023	Channel and flood debris viewed from upstream of north transect.

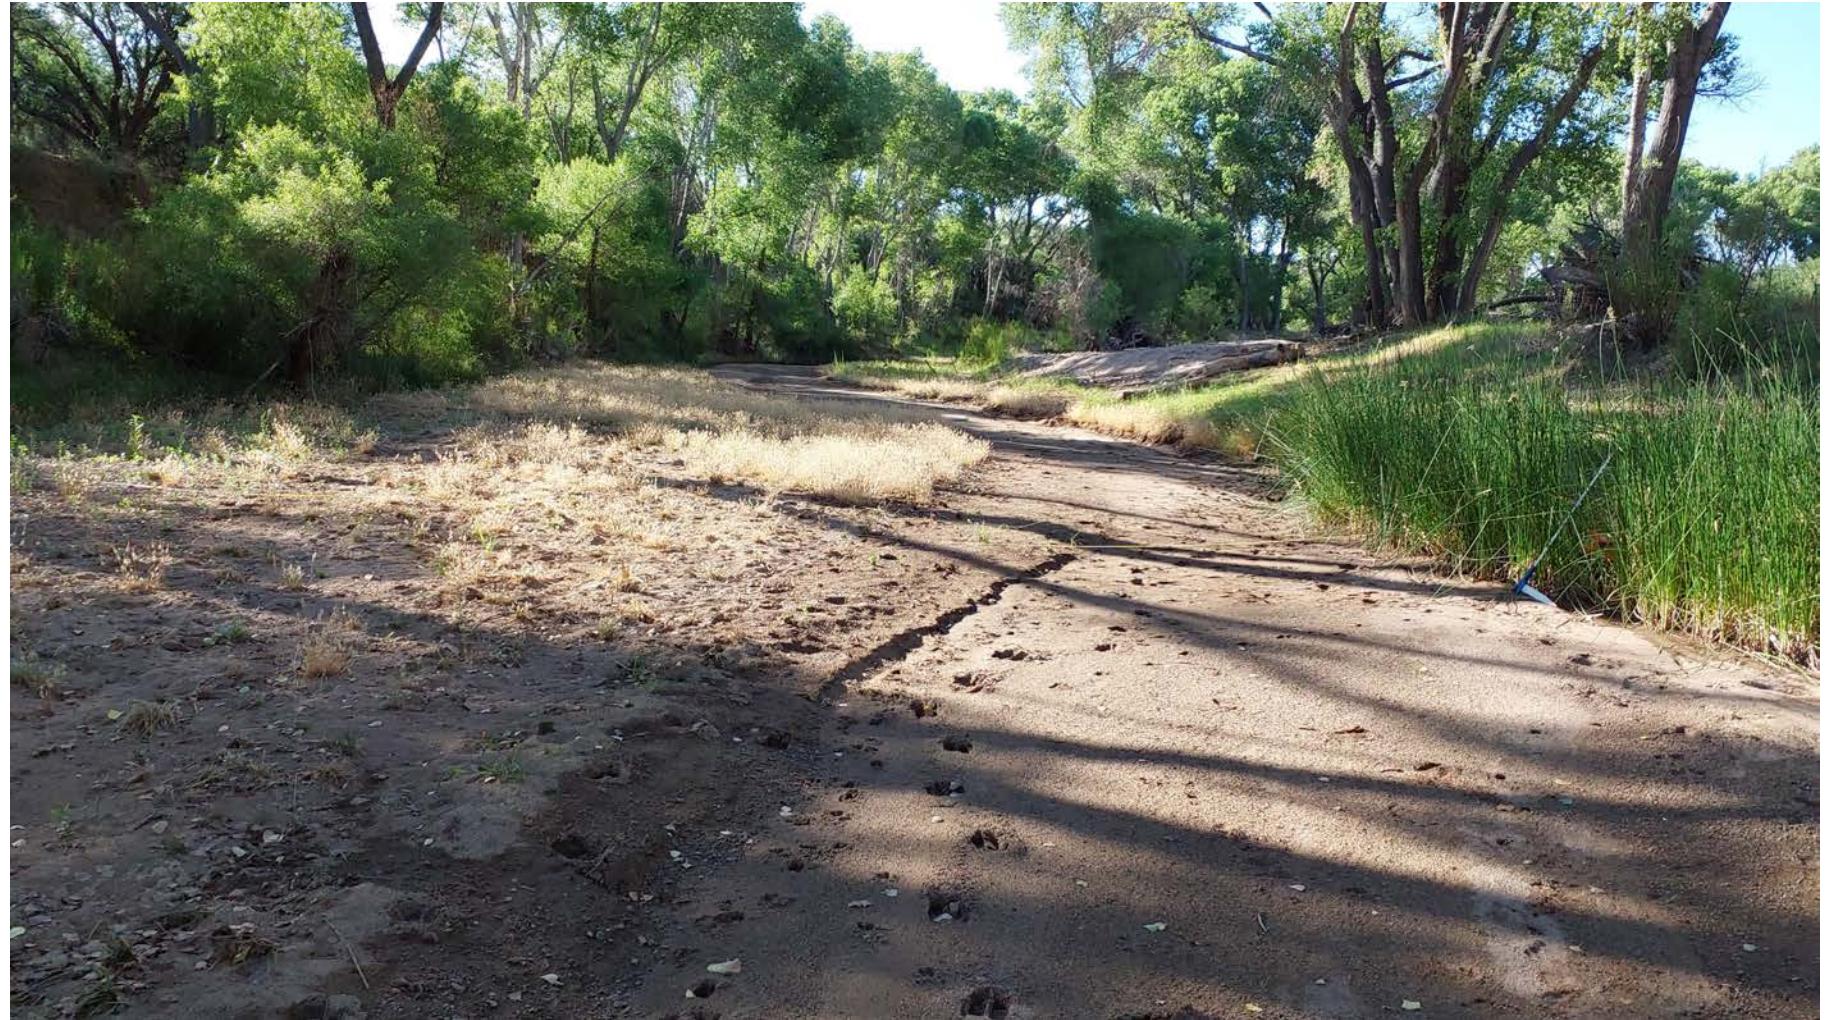
Position: North transect; upstream

Reach	Transect	Longitude	Latitude	Date	Notes:
9	100m North	-110.18106184	31.70103397	20 July 2023	View upstream from north transect; cattle hoof prints.

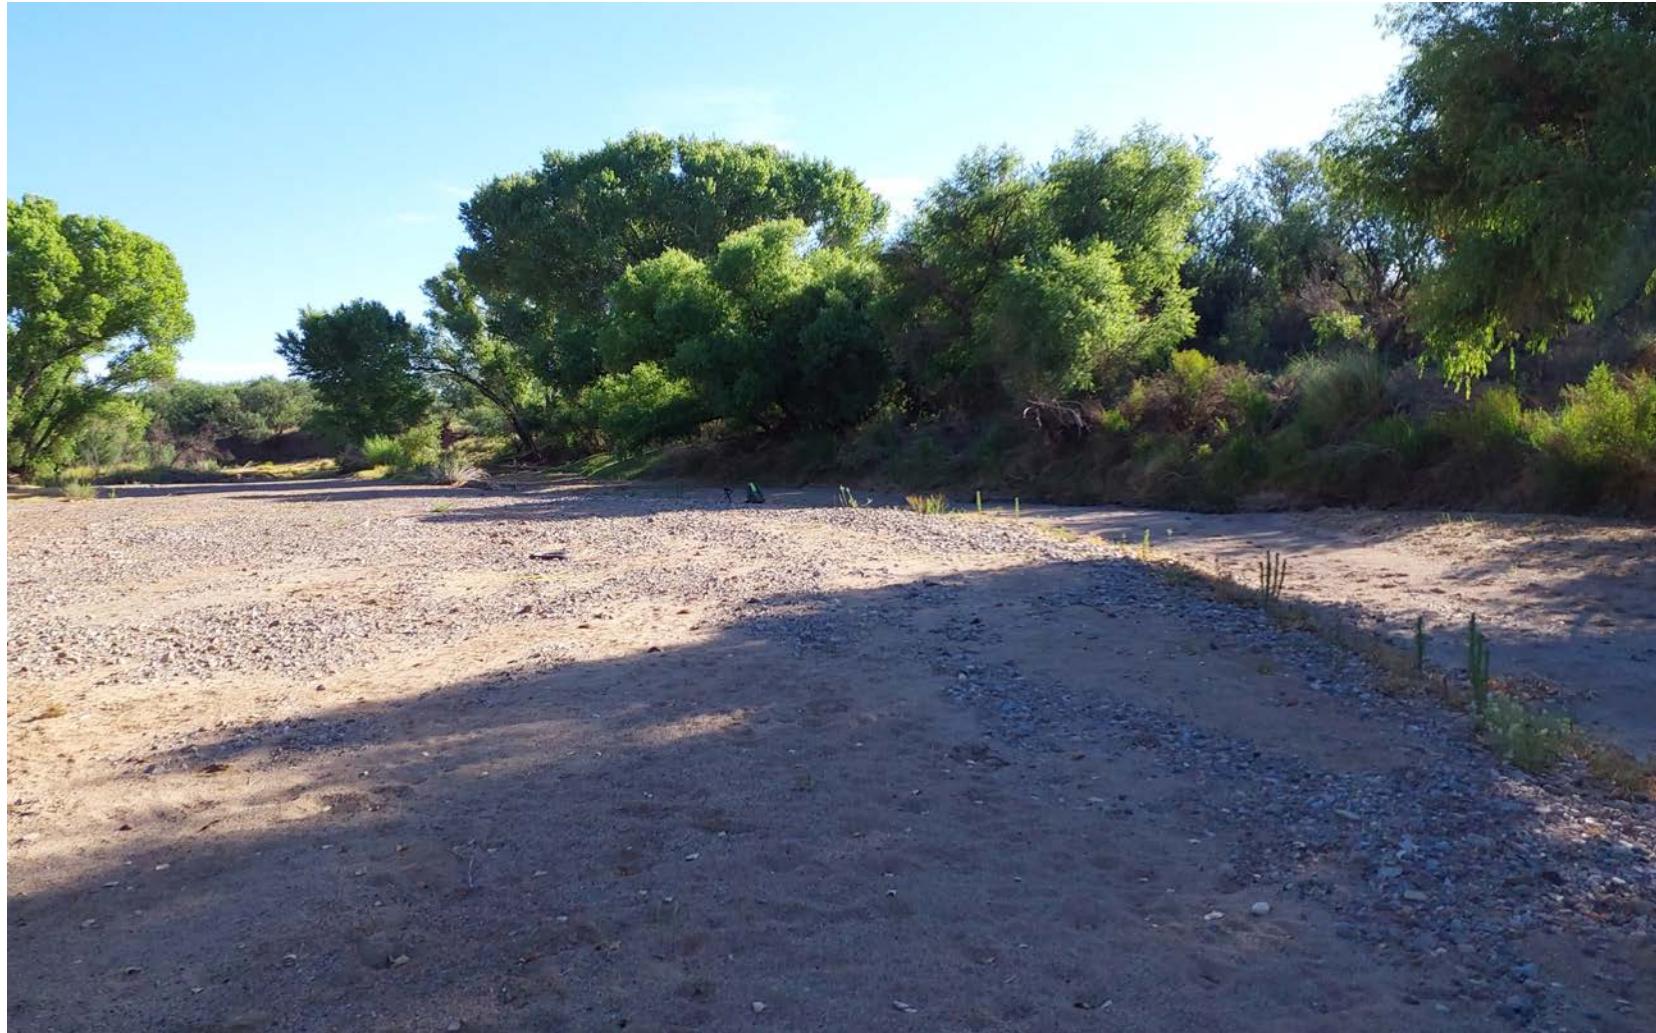
Position: North transect; downstream

Reach	Transect	Longitude	Latitude	Date	Notes:
10	100m North	-110.19521261	31.7407924	18 July 2023	View downstream to north transect over broad alluvial flat; cattle hoof prints.

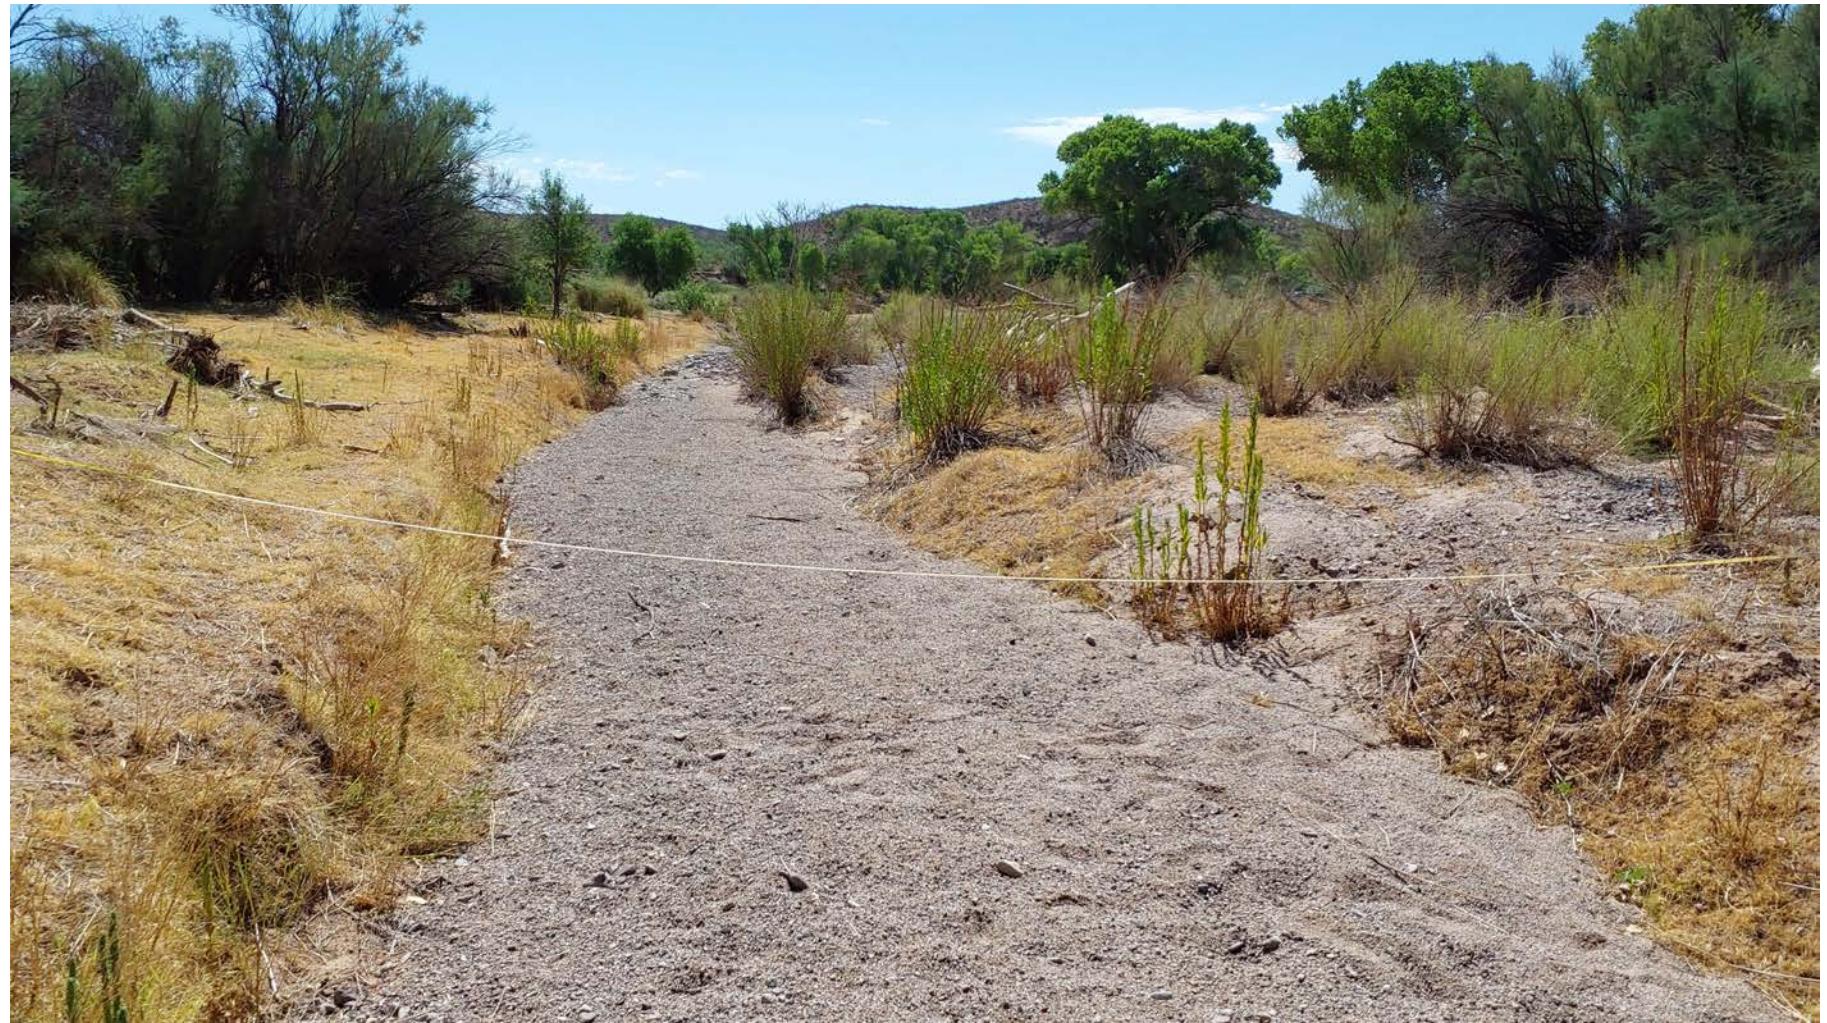
Position: North transect; side channel upstream

Reach	Transect	Longitude	Latitude	Date	Notes:
12	100m North	-110.20475763	31.76775708	19 July 2023	Upstream view from north transect along side channel; abundant TAMRAM between channel braids.
