San Pedro River Expedition 2023

Appendix A

Site Photos

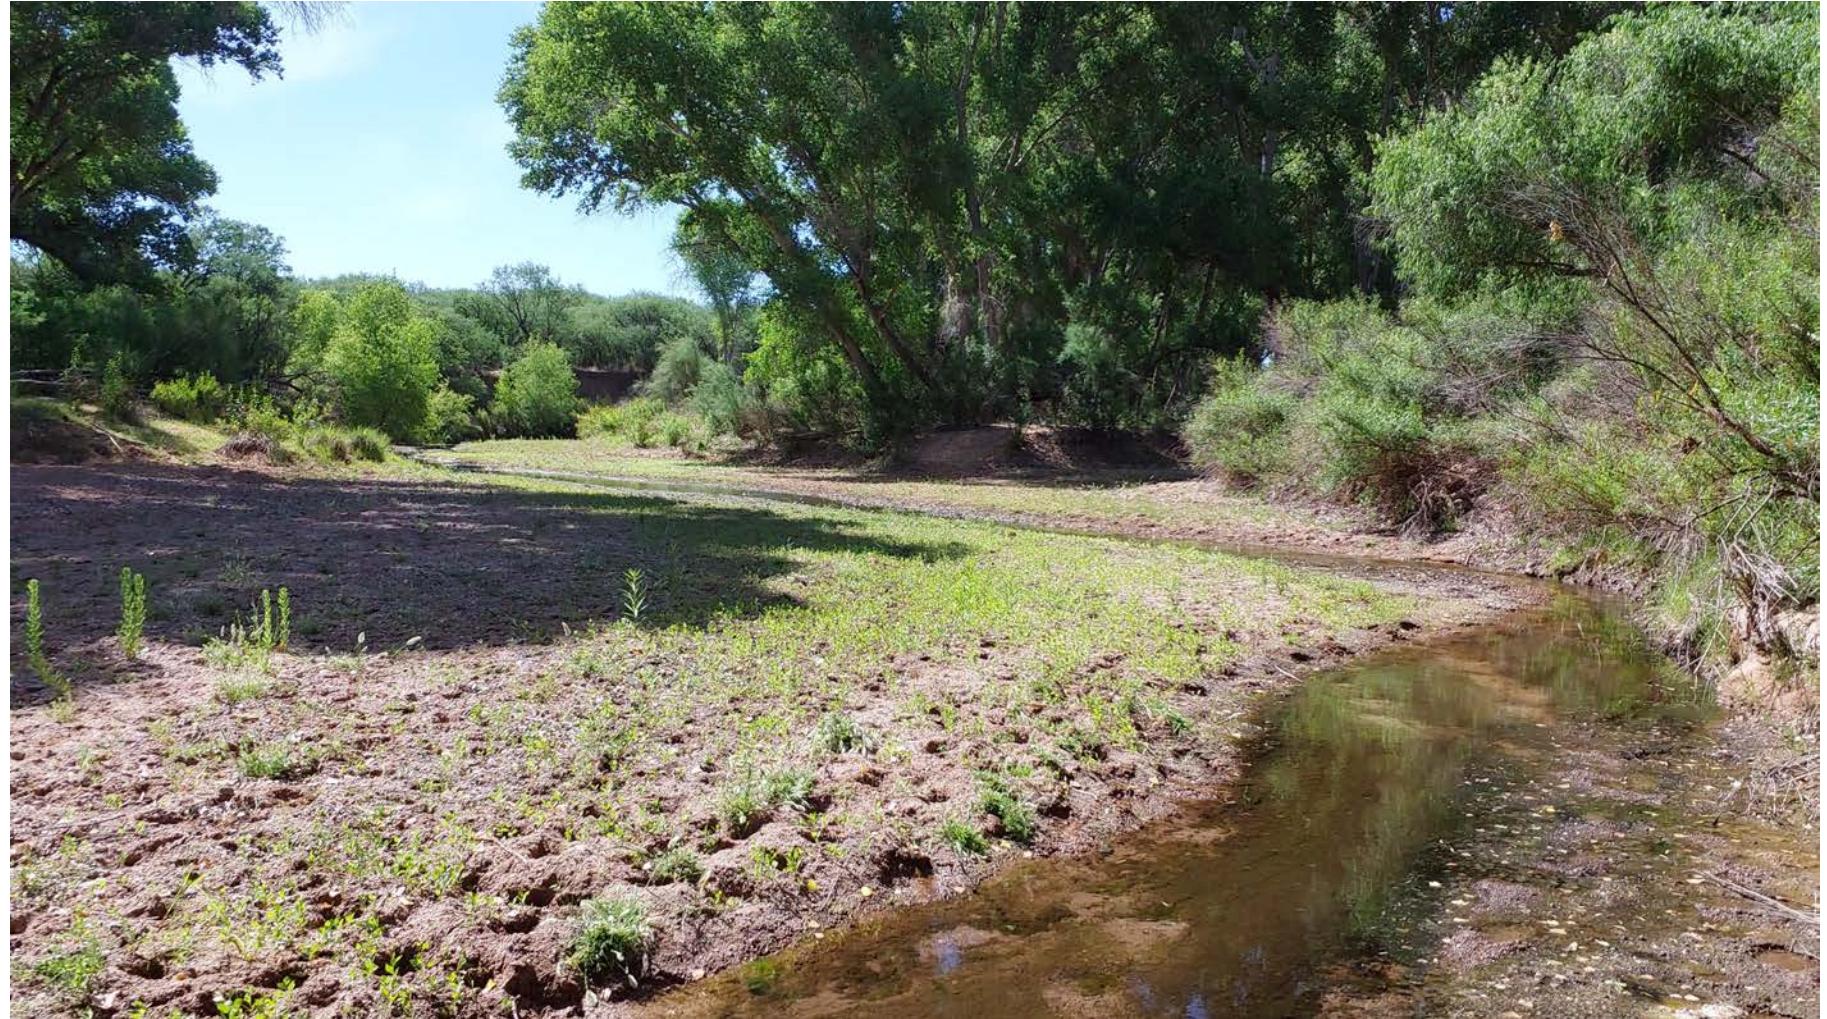
Position: Upstream

Reach	Transect	Longitude	Latitude	Date	Notes: Note entry of abandoned channel along right bank.
12	GPS Middle	-110.21844823	31.79338174	05 June 2023

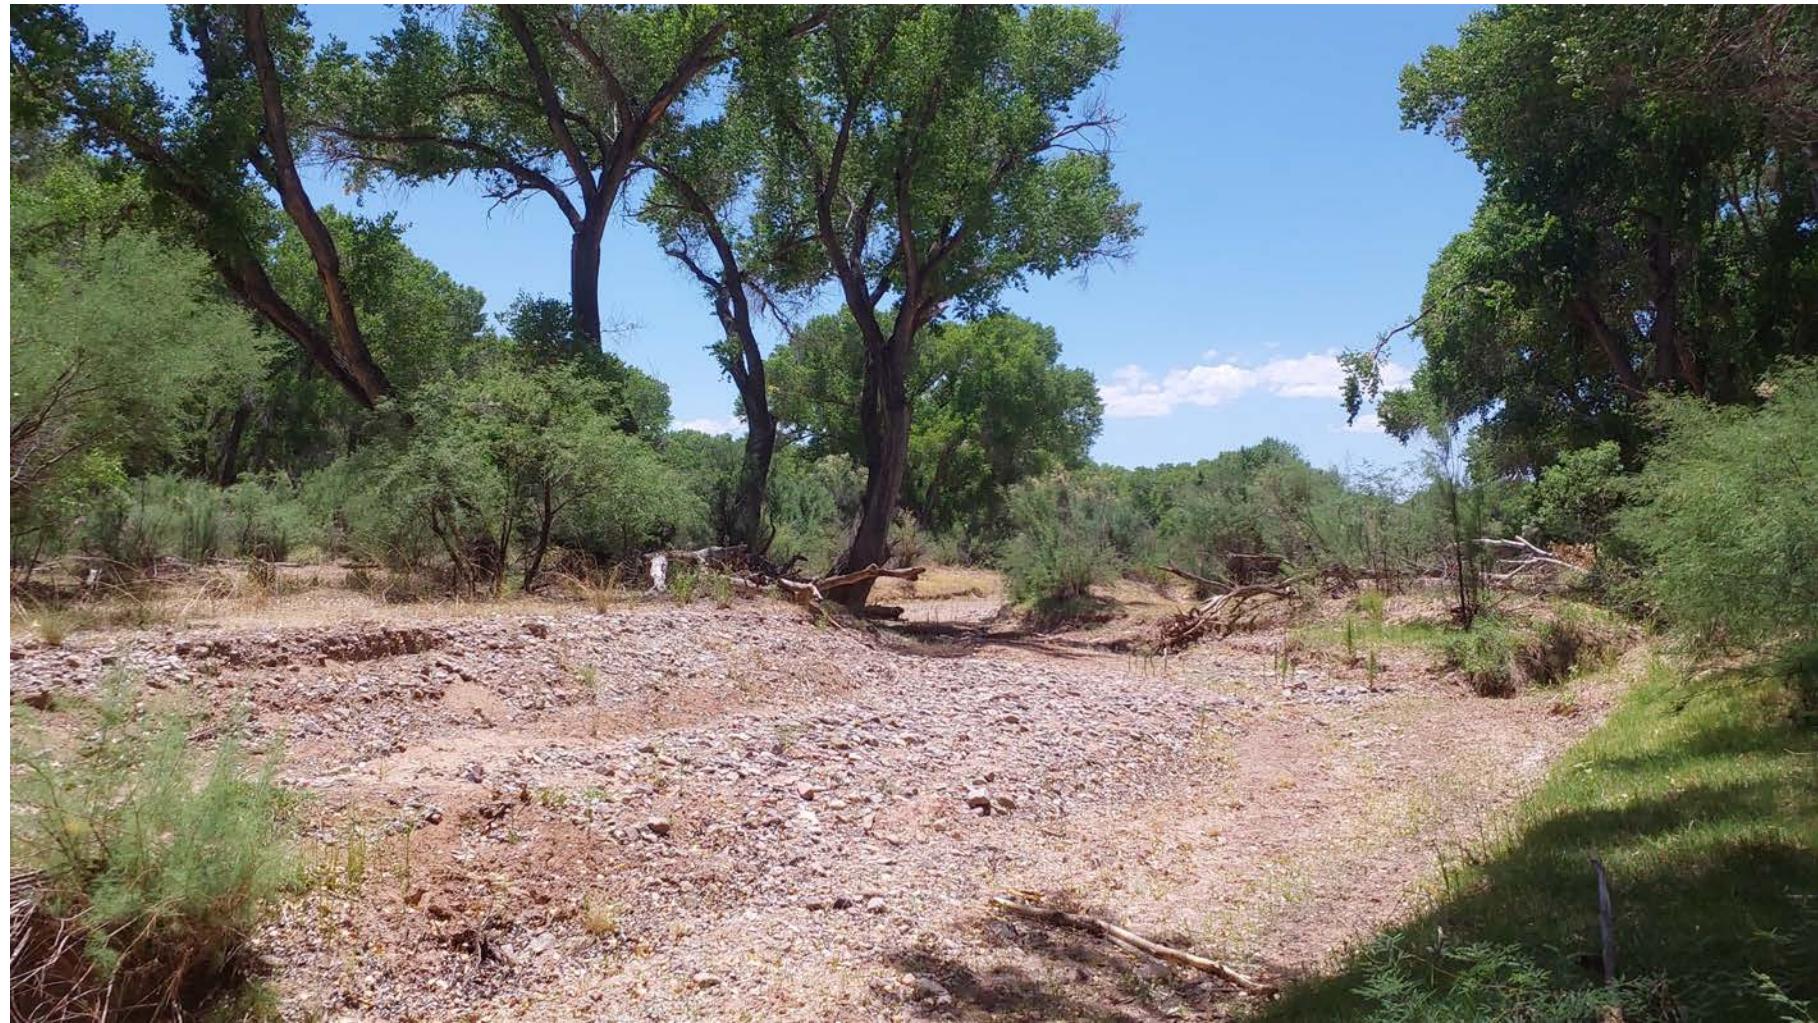
Position: South transect; abandoned channel upstream

Reach	Transect	Longitude	Latitude	Date	Notes:
12	100m South	-110.21881992	31.79262099	06 July 2023	View upstream of abandoned channel where intersected by south transect.

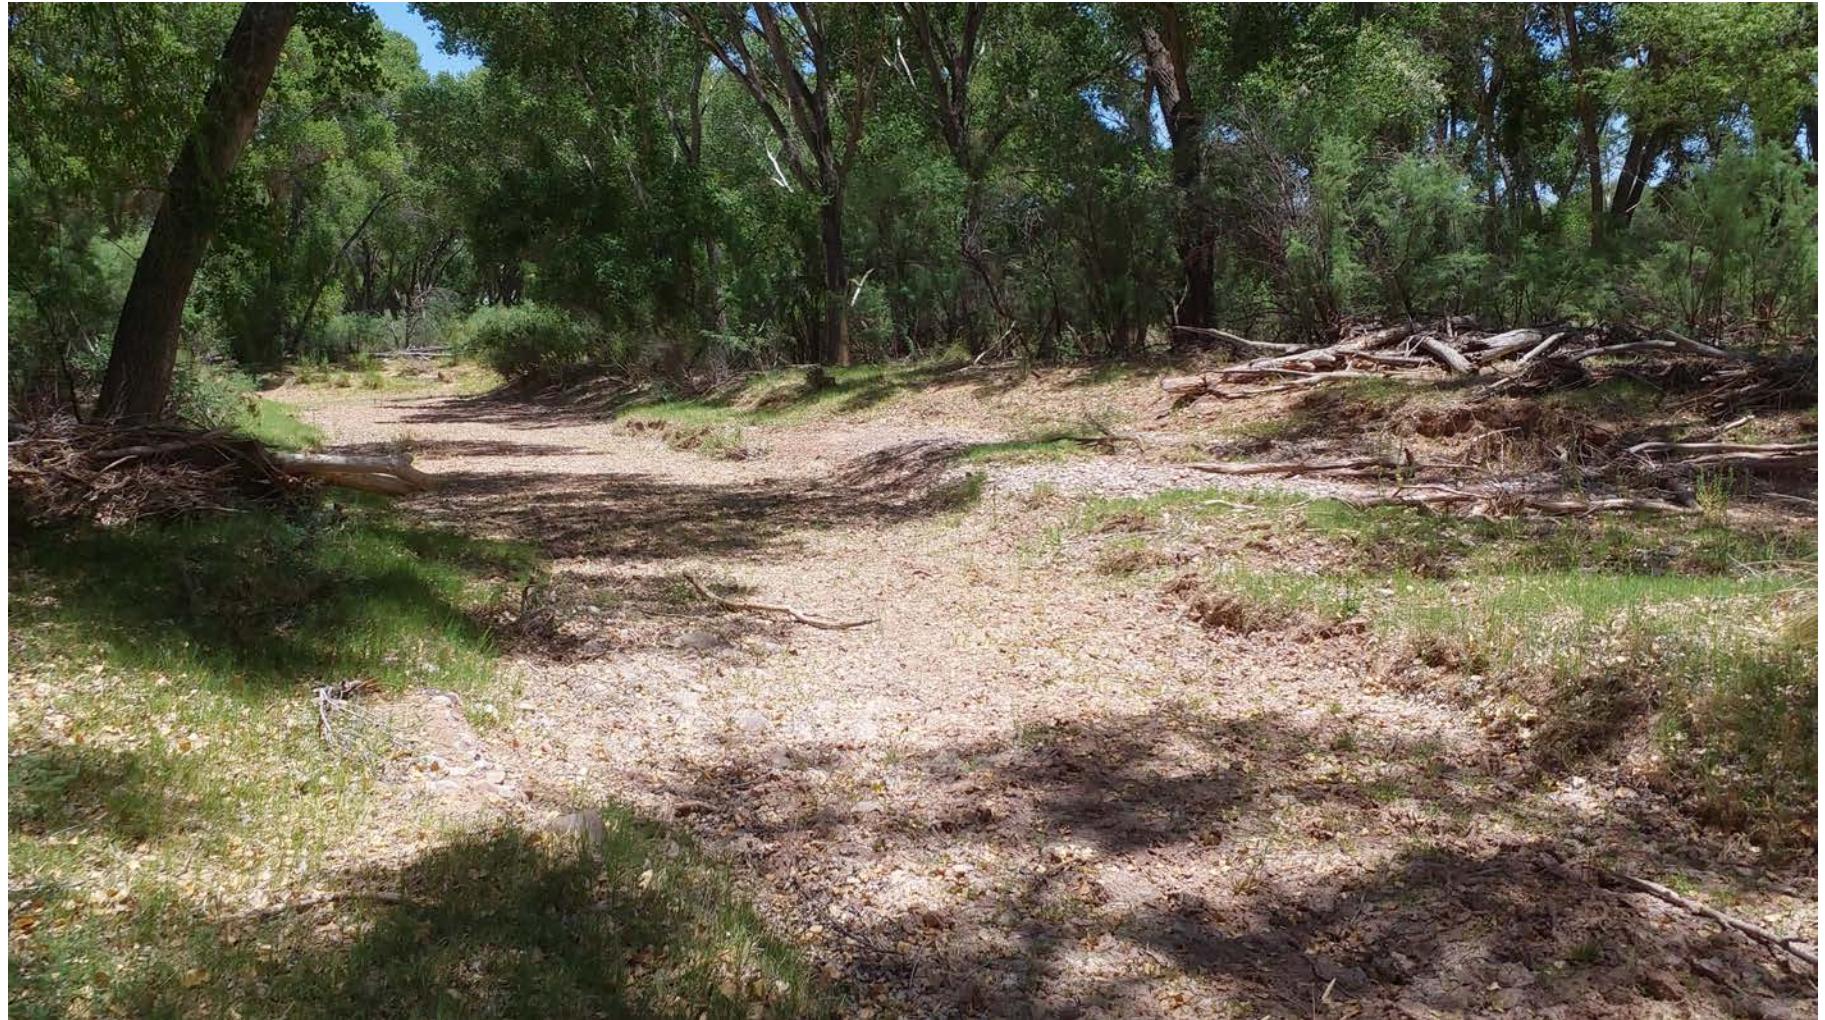
Position: South transect; abandoned channel downstream

Reach	Transect	Longitude	Latitude	Date	Notes:
12	100m South	-110.21881992	31.79262099	06 July 2023	View downstream of abandoned channel where intersected by south transect; flood debris.

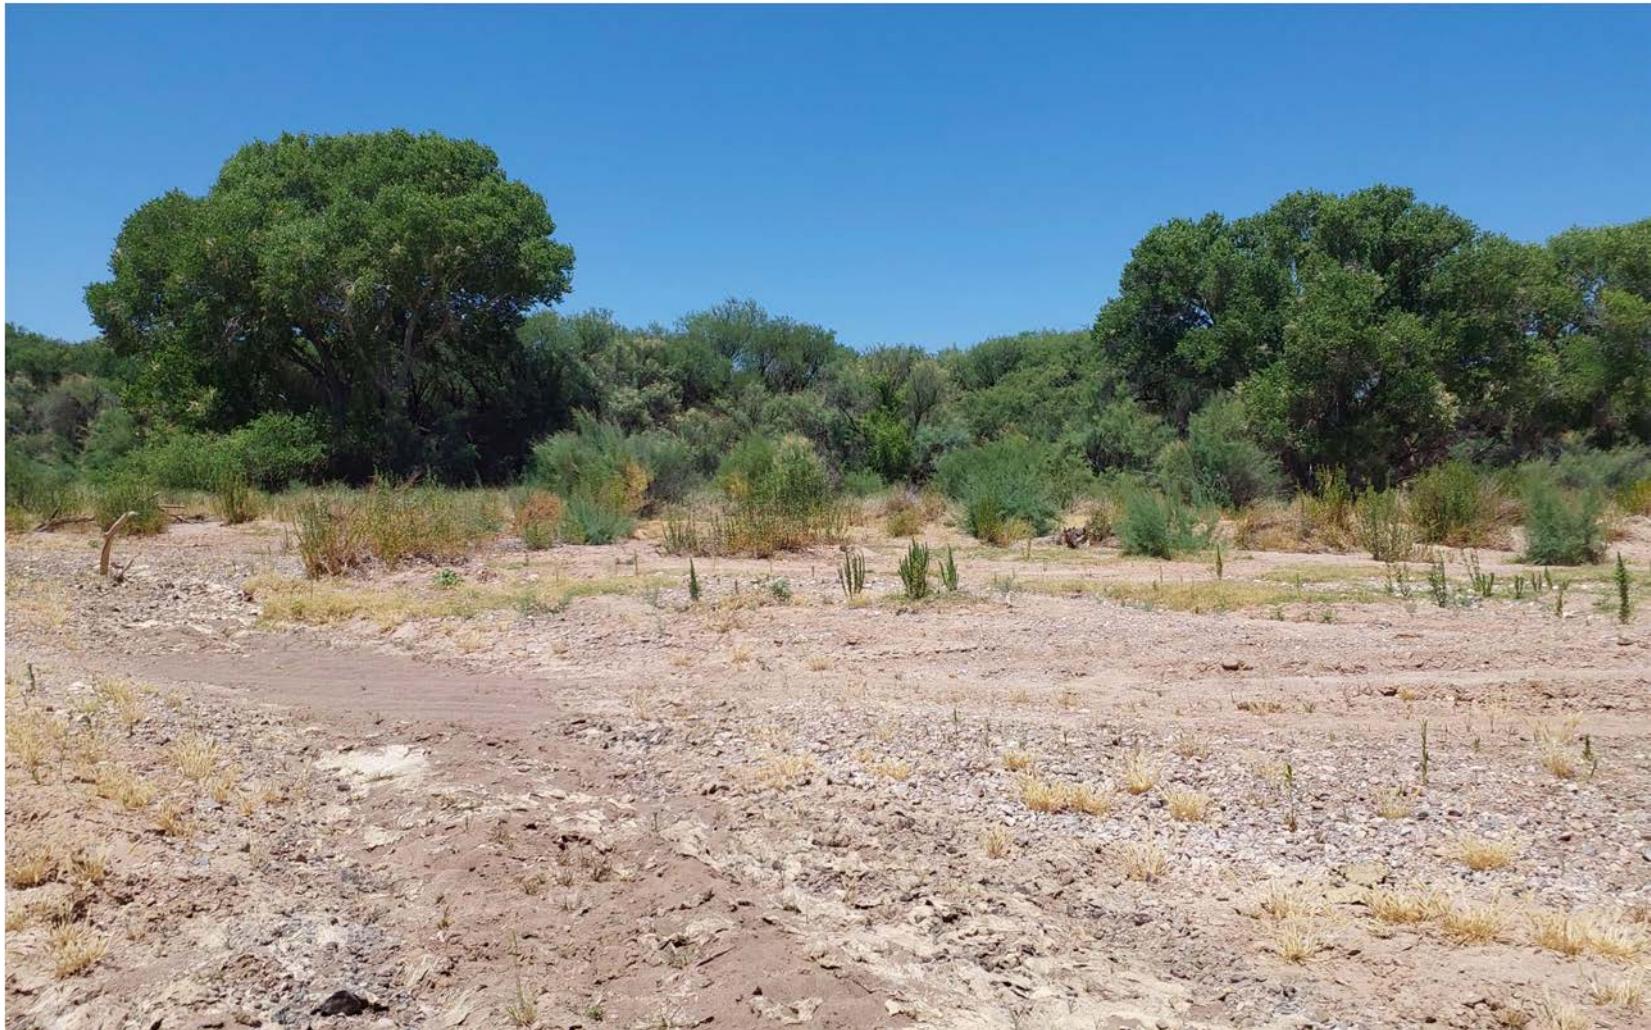
Position: South transect; view to west

Reach	Transect	Longitude	Latitude	Date	Notes:
13	100m South	-110.21702351	31.82094766	04 July 2023	View to west along south transect; channel braiding and TAMRAM on floodplain.

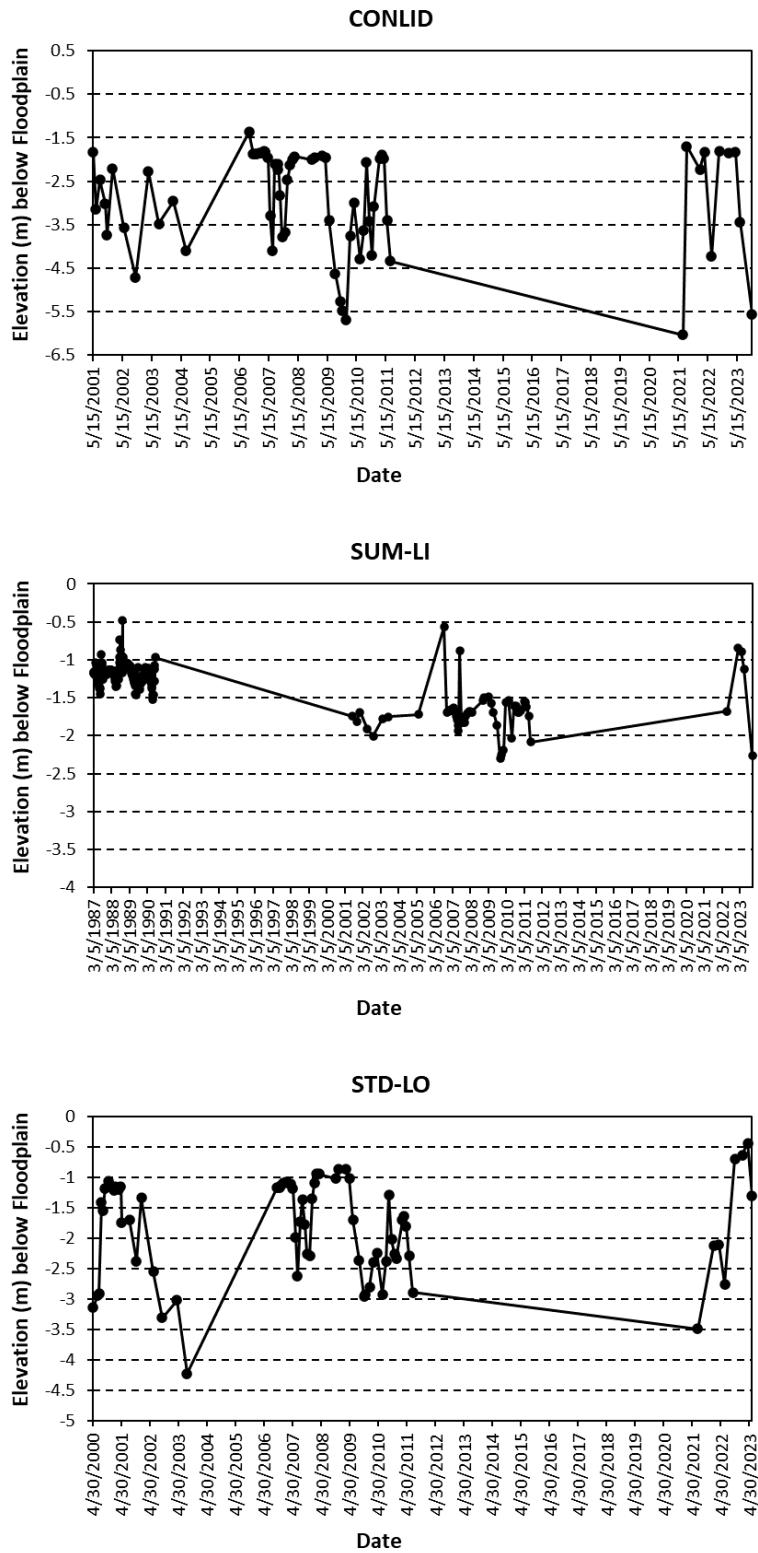
Appendix B: Graphs. Historical measurements of alluvial groundwater levels for 15 USGS groundwater wells (see Appendix II, Table 1) along the upper San Pedro River, adjusted for land surface elevation of well and approximate mean floodplain elevation. Only data for 2022-2023 were used in the report.

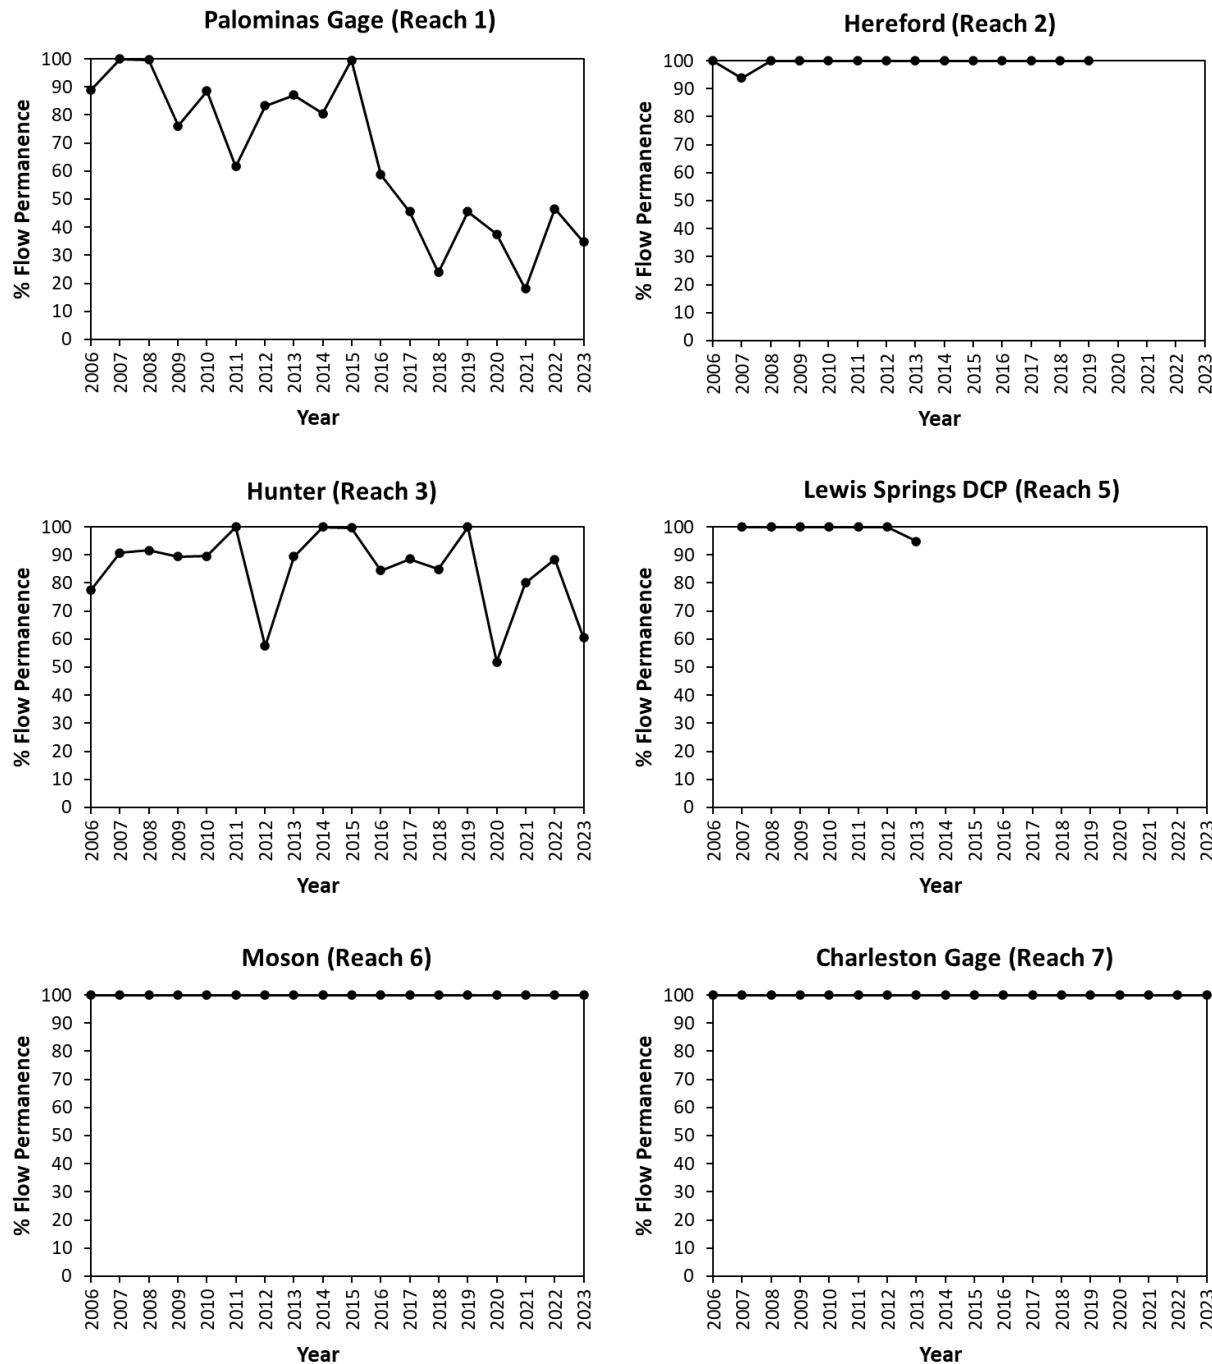
Appendix C. Flow permanence data (2006-2023), based on calendar year, for camera stations and USGS gaging stations (Palominas, Charleston, and Tombstone). Flow data for 2023 are up to early October for camera stations and December 18 (provisional data) for USGS gaging stations.

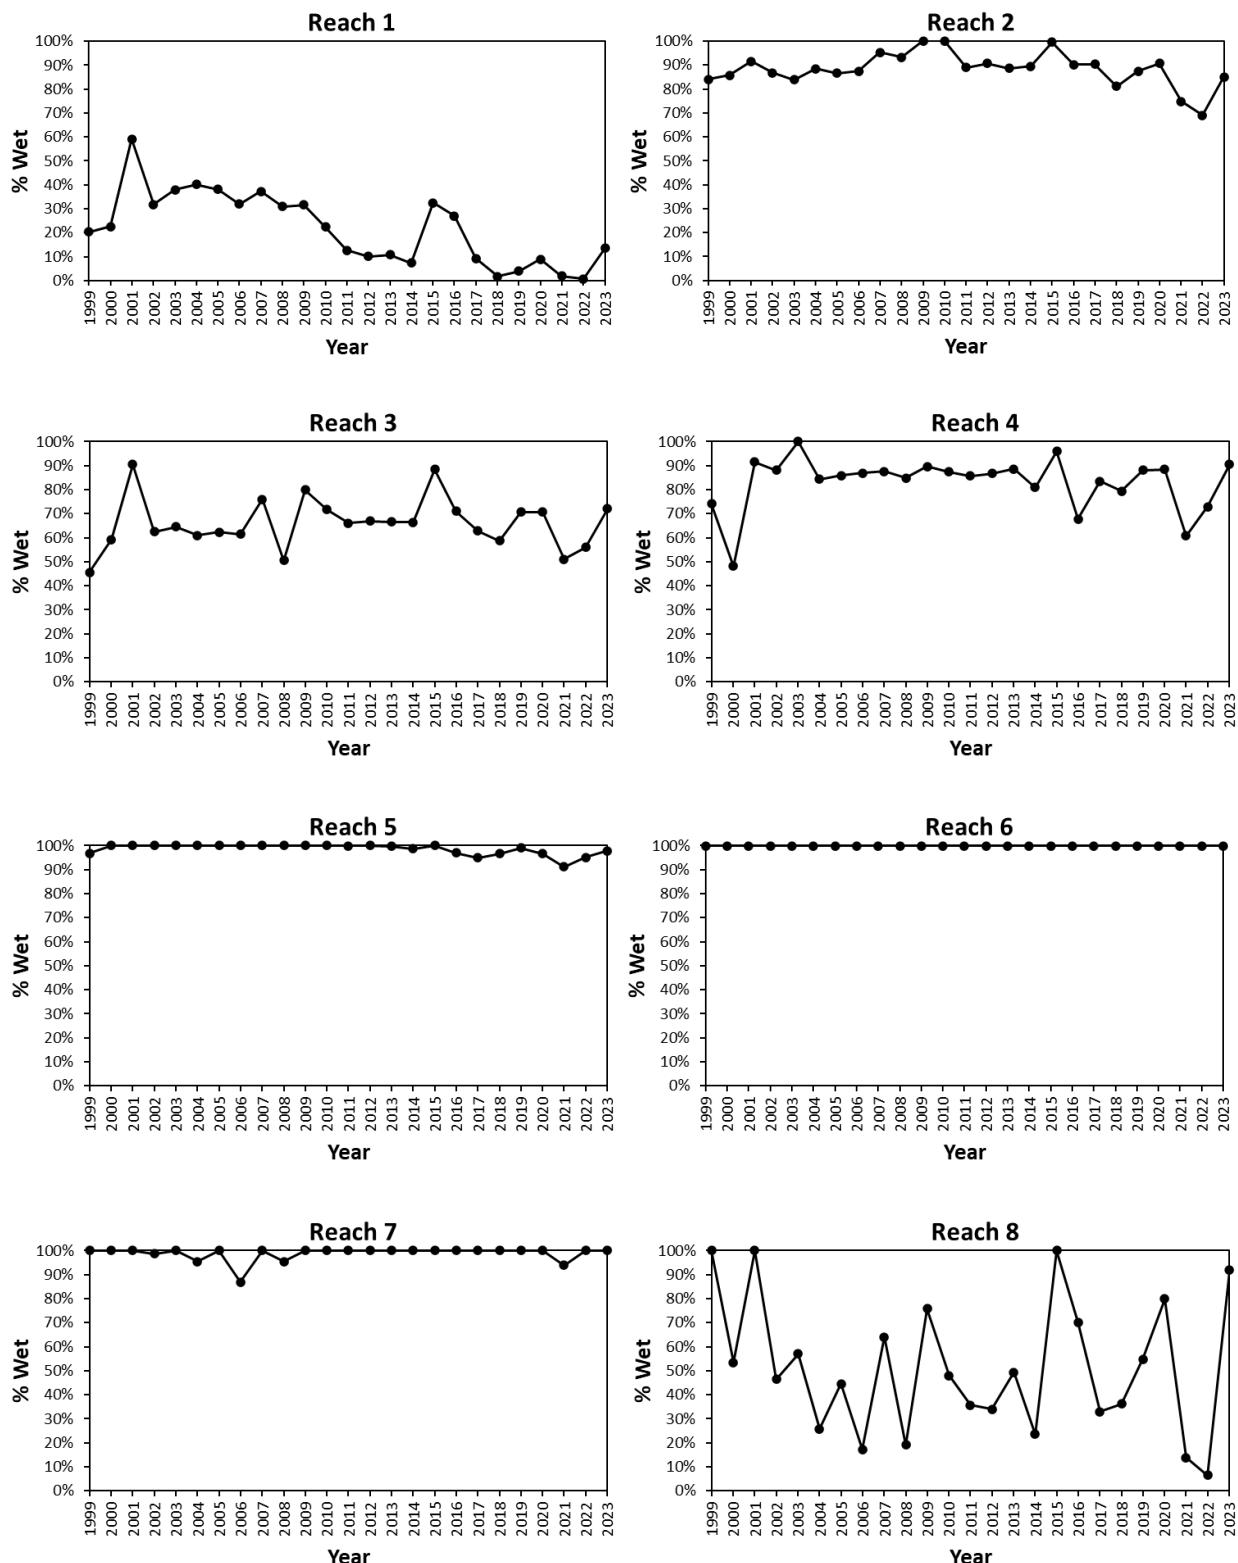
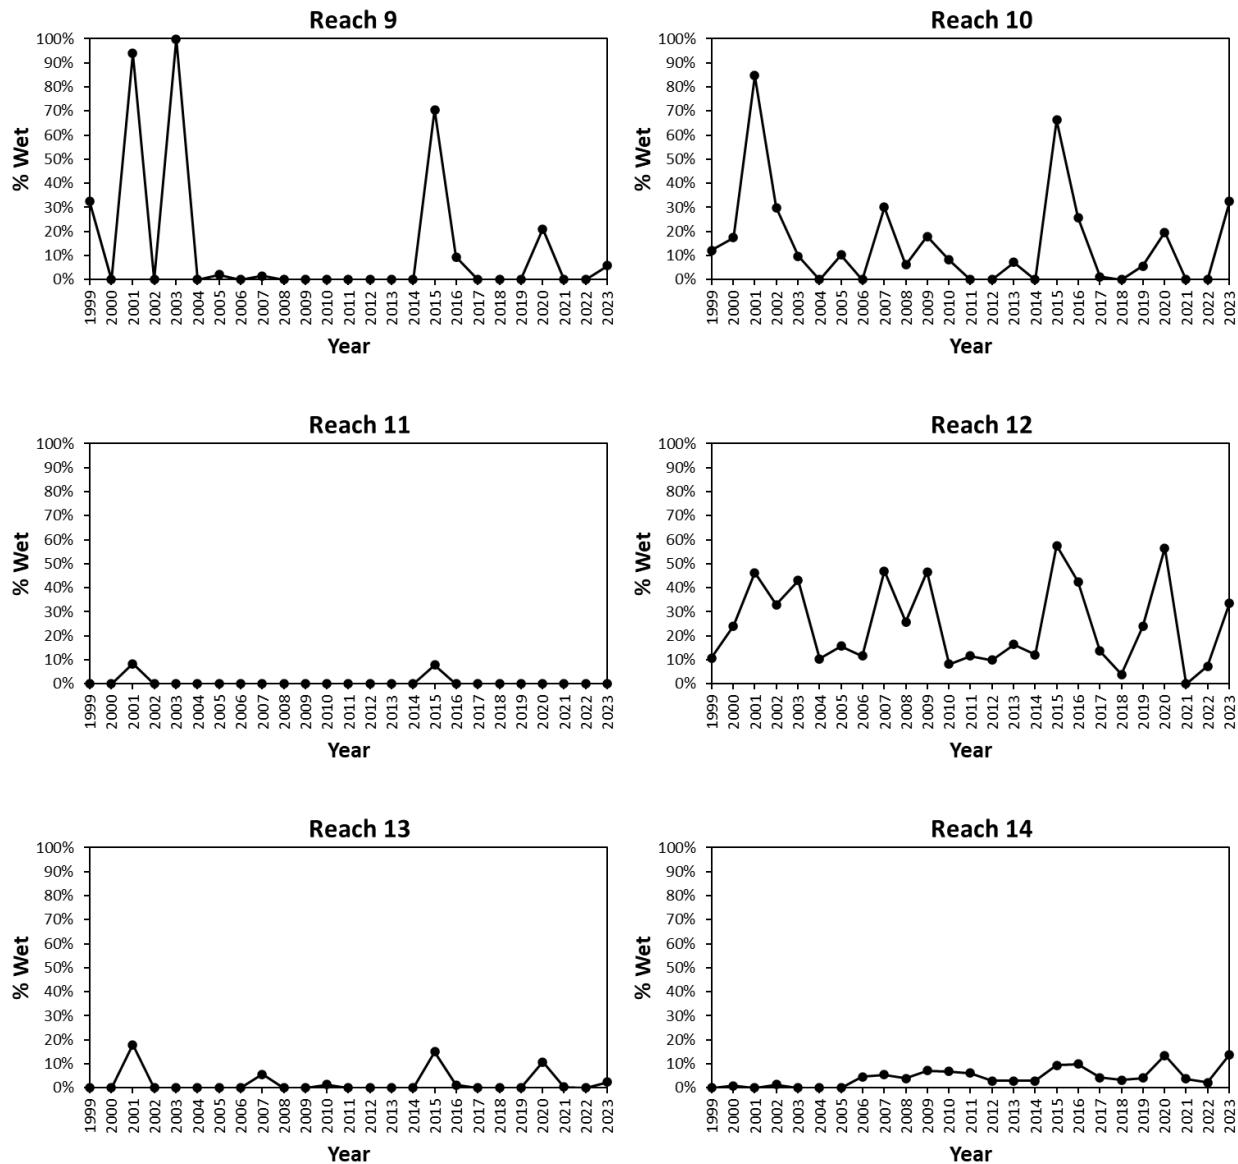
Appendix D. Percentage of surveyed river length within each reach with surface water present (wet) during June wet-dry mapping within the San Pedro Riparian National Conservation Area, 1999-2023. Data were obtained from The Nature Conservancy, Arizona Office (Lisa McCauley, pers. comm.).

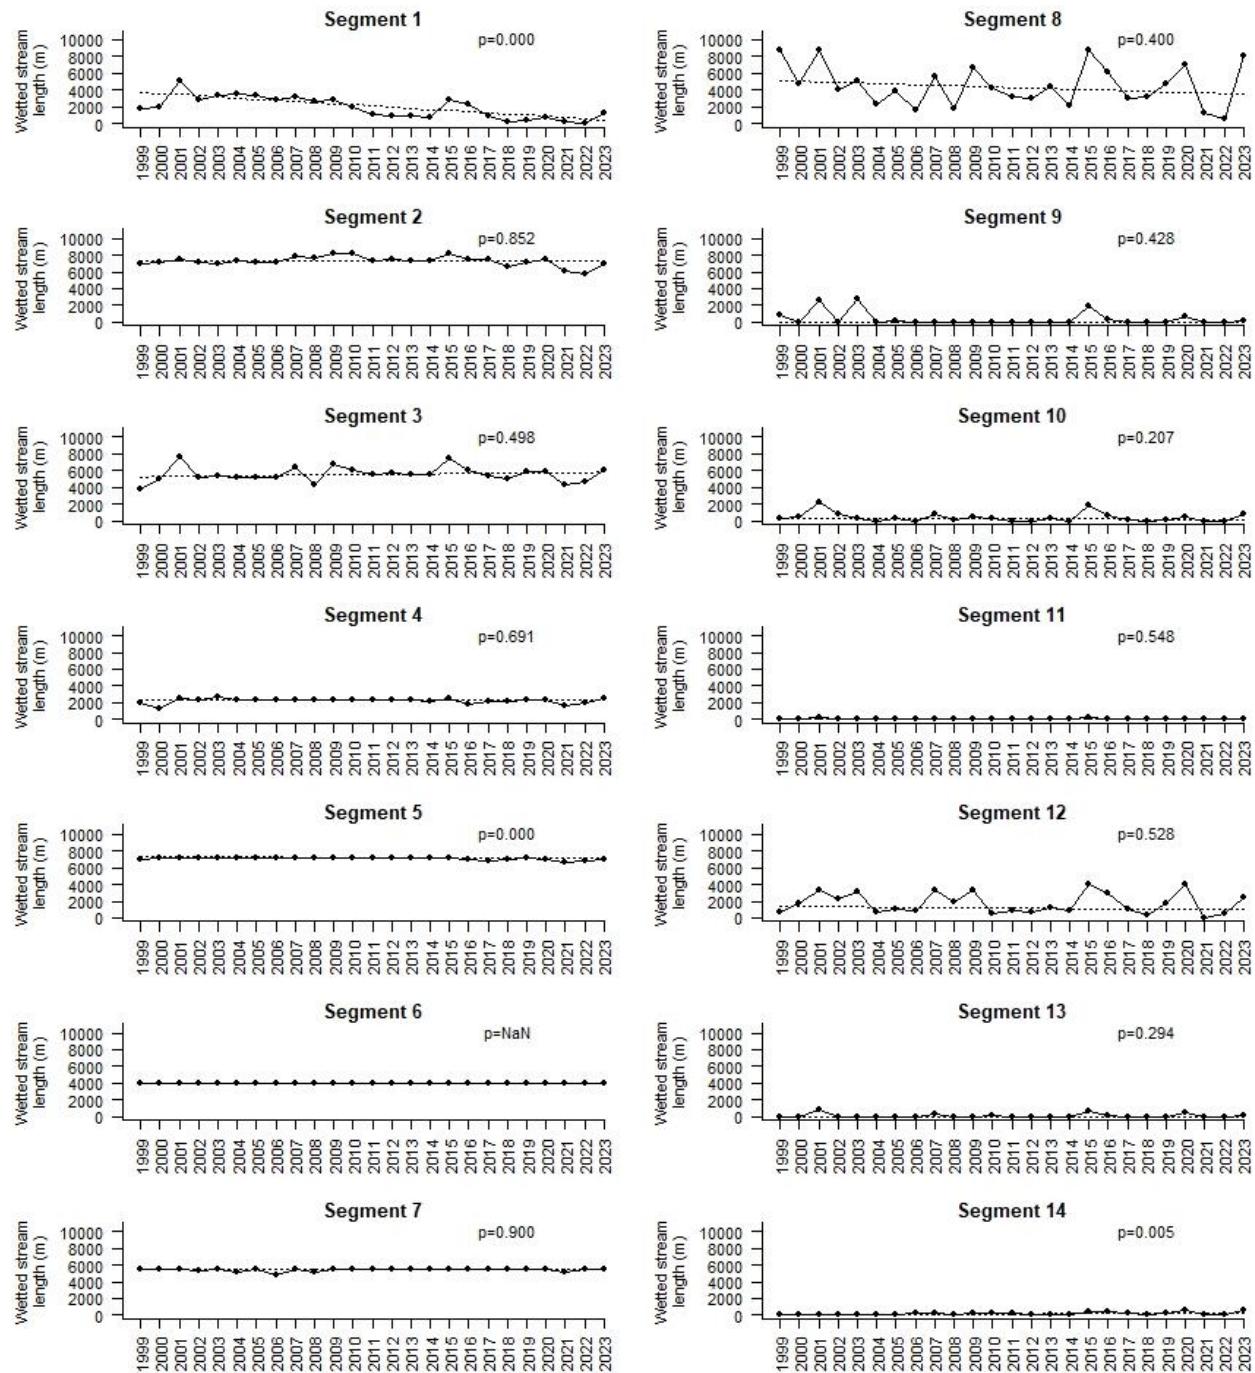
Appendix E. Trends in wetted stream length recorded in the June wet-dry mapping program within the San Pedro Riparian National Conservation Area, 1999–2023, by segment (reach). Probability (p-values) are for Mann-Kendall trend analysis. A p-value <0.05 traditionally signifies a statistically discernable (i.e., statistically significant) trend. NaN indicates no difference in wetted length values (and no trend) across years in segment 6. Data and trend analysis results were obtained from The Nature Conservancy, Arizona Office (Lisa McCauley, pers. comm.).
