SPRNCA MOU Adaptive Management Committee

Update to the USPP Technical Committee February 21, 2024

2023 Riparian Health Assessment

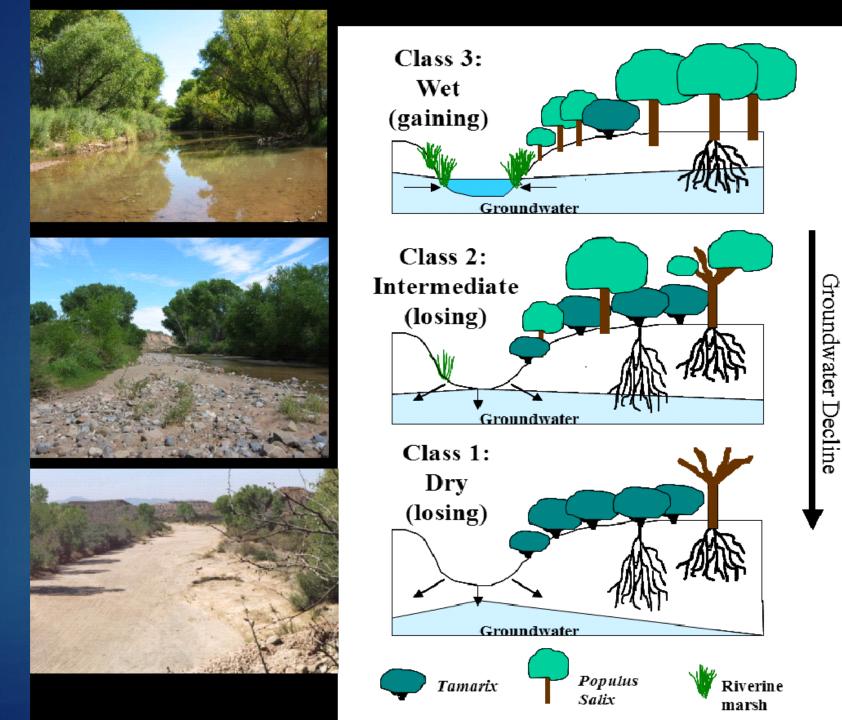
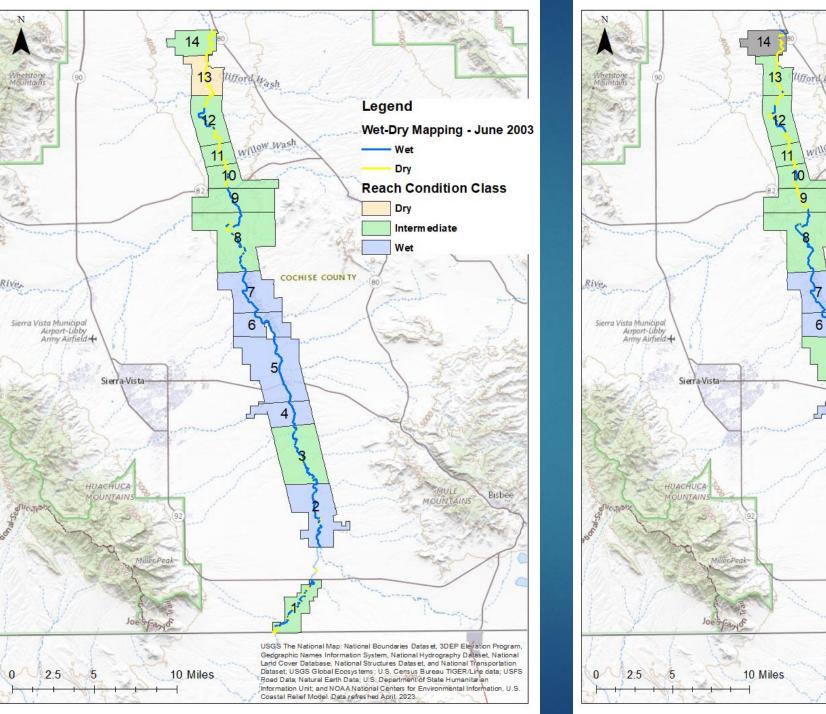
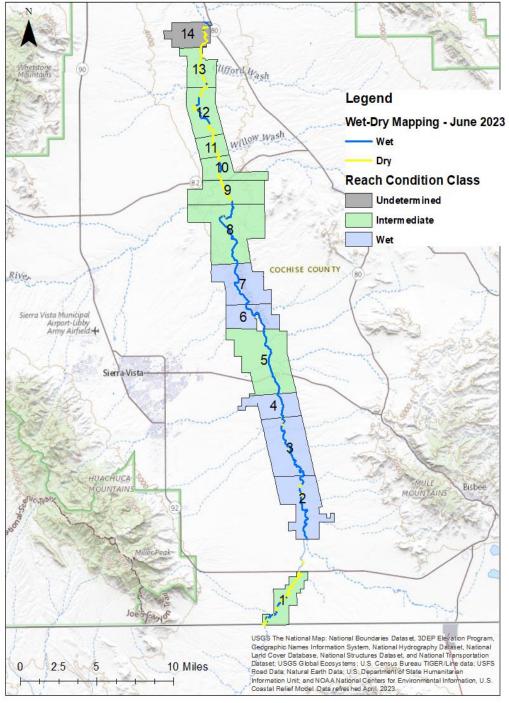
Interim Decision Matrix for 2024

SPRNCA Reach	2023 Condition Classes	1999-2023 Wet Dry Trend	2024 Decision Matrix Results
	Class 1, 2, 3	Significant Improvement, No Change, Significant Decline	MOU Objectives Satisfied (Yes/No) Monitoring and/or management needs
14	Undetermined	Improvement	Add riparian health transect
13	2 (Improvement)	No Change	Additional monitoring and management may be considered
12	2 (No Change)	No Change	Additional monitoring and management may be considered
11	2 (No Change)	No Change	Additional monitoring and management may be considered
10	2 (No Change)	No Change	Additional monitoring and management may be considered
9	2 (No Change)	No Change	Additional monitoring and management may be considered
8	2 (No Change)	No Change	Additional monitoring and management may be considered
7	3 (No Change)	No Change	MOU Objectives Satisfied
6	3 (No Change)	No Change	MOU Objectives Satisfied
5	2 (Decline)	Decline	Additional Monitoring and Action Required

4	3 (No Change)	No Change	MOU Objectives Satisfied
3	3 (Improvement)	No Change	MOU Objectives Satisfied
2	3 (No Change)	No Change	MOU Objectives Satisfied
1	2 (No Change)	Decline	Additional Monitoring and Action Required

Legend Site Condition Class Interm ediate Wet Wet-Dry Mapping - June 2023 **Reach Condition Class Undetermined** Interm ediate Wet COCHISE COUNTY Charleston South Mosor 5 Springs Sierra-Vista-4 Cottonwood Hunter South Hereford Palominas South

- Reaches 1, 2, 4, 6, 7, 8, 9,10, 11, 12
 No change
- Reach 3 changed to Class 3 (+)
- Reach 13 changed to Class 2 (+)
- Reach 5 changed to Class 2 (-)
- Reach 14 undetermined (?)
